Campaign No. 2017010005, February 2017

SUBJECT: **Model 447, Model Year 2017**
Replace Front Passenger-side Air Bag

Daimler AG ("DAG"), the manufacturer of Mercedes-Benz vans, has determined that in certain Metris vans, the front passenger airbag may have been produced with an incorrect Tether Activation Unit (TAU). In the event of a crash necessitating deployment of the front passenger airbag, the TAU may not open the vent and the airbag may not vent properly. An improperly vented airbag may not protect the seated occupant as expected, and therefore may increase the risk of injury. An authorized Mercedes-Benz Sprinter dealer will replace the front passenger airbag on affected vehicles.

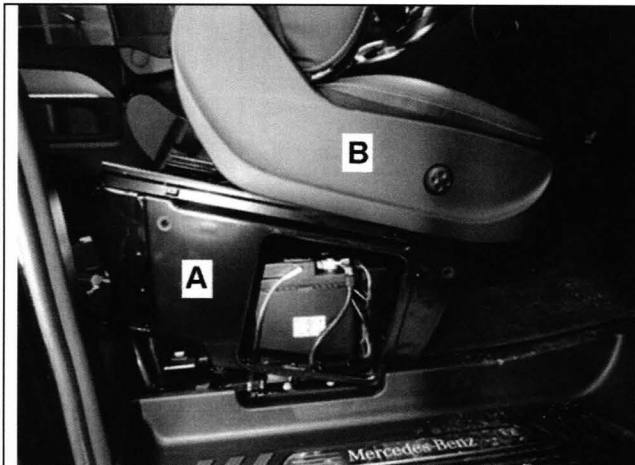
Figure 1

Negative battery cable (arrow, Figure 3) of eco start/stop battery (1, Figure 2) is covered by seat base (A, C Figures 1, 2) and is not accessible with battery (1) mounted under seat base (A, C). Seat base (A, C) must be unbolted and leaned forward to disconnect negative battery cable (arrow, Figure 3):

- Remove seat base mounting bolts (refer to WIS: AR91.10-S-3000E). Do not remove seat (B) or seat base (A, C).

Rear seat base mounting bolts are hex head, front are counter-sunk torx head and are attached to the seat base mounting bracket. Do not remove front hex head bolts that are bolted to the floor.

- Lift up back of seat base (C) then support with wooden blocks (D).

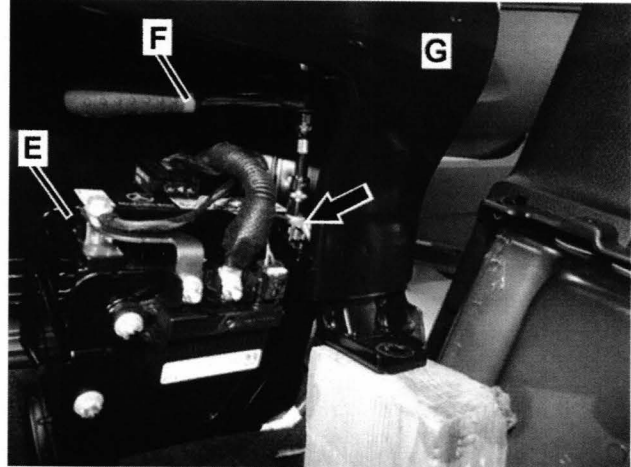
Figure 3

- Unbolt and disconnect negative battery cable (arrow) from eco start/stop battery (E) using a ratchet (F) with short extension and socket.
- Lower seat base (G) and continue with Procedure.

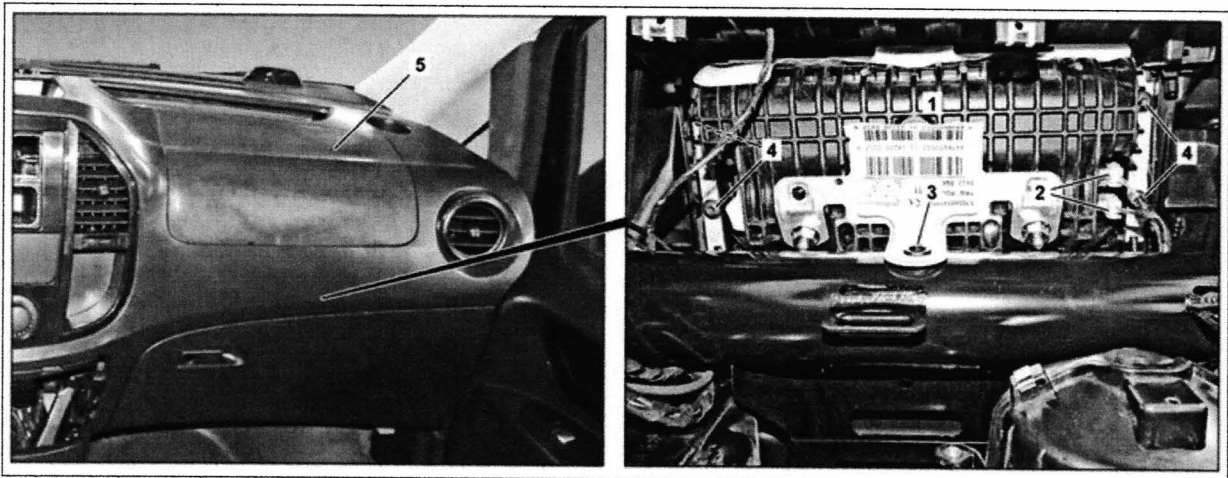
Figure 4 (1 Front passenger airbag 2 Air bag connectors 3 Bolt 4 Air bag mounting bolts 5 Cover)

Disconnect air bag connectors (2, Figure 4).

**Installation note:** Ensure that air bag connectors (2) are correctly locked.
-

Remove air bag bracket bolt (3, Figure 4)

**Installation note:** Torque airbag bracket bolt (3, Figure 4) to: **Nm** 4 Nm.
-

Remove air bag mounting bolts (4, Figure 4.)

**Installation note:** Torque airbag mounting bolts (4) to: **Nm** 5 Nm

Push front passenger airbag (1, Figure 4) with cover (5, Figure 5) upwards out of dashboard and remove.
8. Record 22-digit characters (8, Figure 6) for new front passenger airbag (1) found on adhesive label with barcode (7) prior to installation.
9.

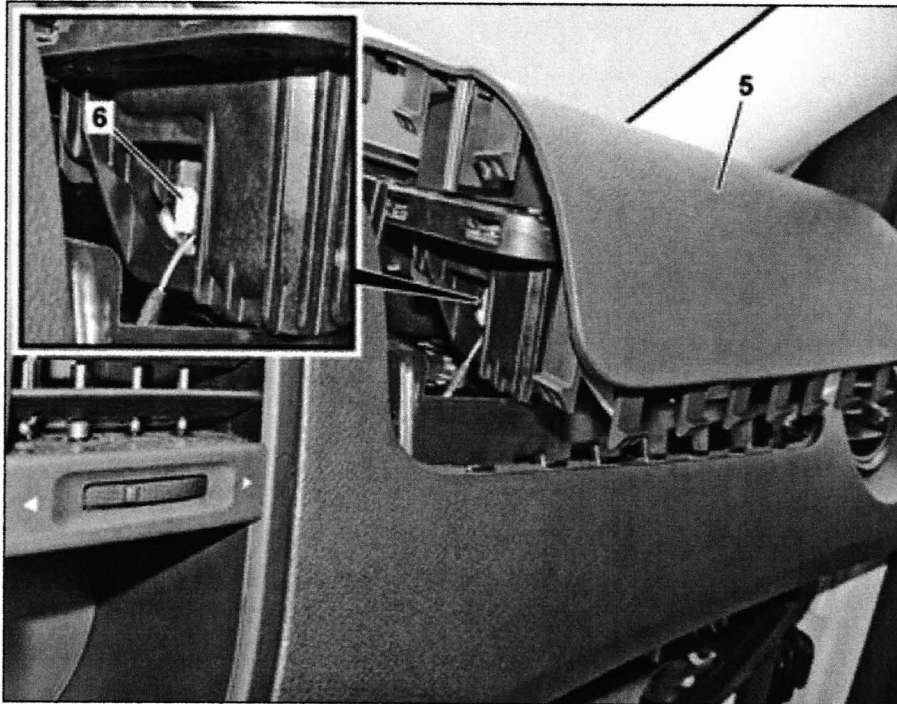
Figure 5 (5 Cover 6 Electrical connector)

Disconnect electrical connector (6, Figure 5).
-

**Installation note:** Ensure that electrical connector (6) is correctly locked.
7.

**Installation notes:**
 - Install new front passenger airbag (1, Figure 6) with cover (5, Figure 5).
 - New front passenger airbag (1, Figure 6) with cover (5, Figure 5) is supplied as a unit.
 - When installing new front passenger airbag (1, Figure 6), check cover (5, Figure 5) is correctly seated in dashboard.

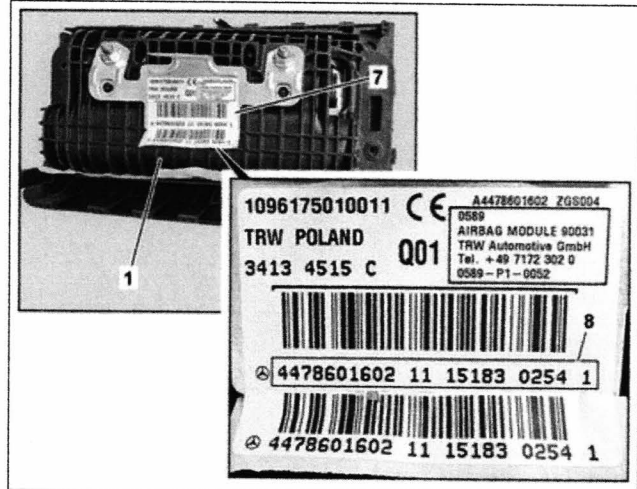
Figure 6 (1 Air bag 7 Label with barcode 8 22 digit characters)

Install new air bag (1, Figure 6) in reverse order.
-

Check Supplemental Restraint System (SRS) with Star Diagnosis/Xentry; refer to WIS: AD00.00-S-2000-04E.
11. Record 22-digit characters (8, Figure 6) found on adhesive label with barcode (7) of new front passenger airbag (1) on repair order.

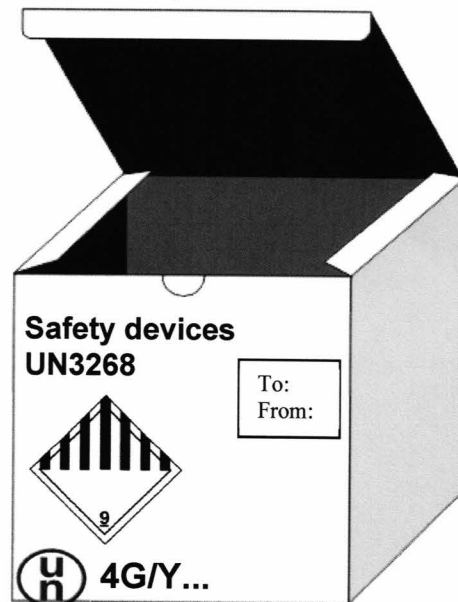
- Carefully open received box and remove new airbag. Keep box intact & save all contents!
- Place used airbag into replacement airbag box, re-using any packaging material (e.g., cardboard inserts) used for the new airbag. Package as the new airbag was packaged.
- Use plastic adhesive tape 50 mm wide to secure the box closed. Do not obscure labels or text on the box with the tape.
- Ensure that the 4G fiberboard box is not ripped or damaged.

- A **Class 9 Miscellaneous** label must be clearly visible on one side of the box.

- The following words ("marking") must also be clearly visible on the same side of the box as the Class 9 label:
Safety devices
UN3268 (font size must be $\geq \frac{1}{2}$ inch)
- Affix "To/From" address label to same or adjacent packaging face as the hazardous markings/labels.
- The UN 4G code preprinted near the bottom edge of the box must also be clearly visible.

- Note:** The Packing Group and the EX# are no longer required to be printed on the HAZMAT bill of lading.
- Package example:**

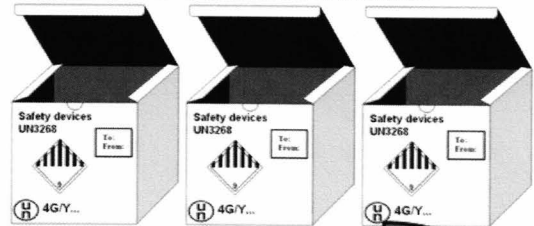
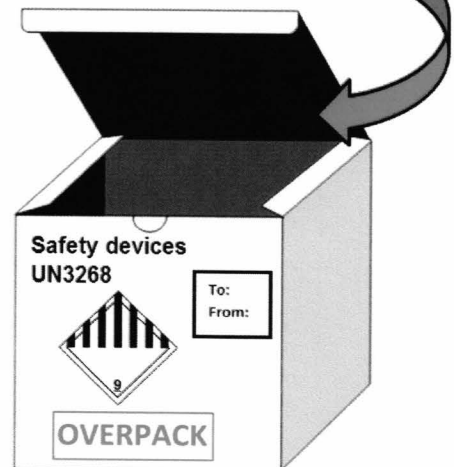
- Place each individual airbag box (noted above) inside a larger non-UN spec box to keep shipment together.
- This larger box is called an "OVERPACK."

- The OVERPACK must have the identical markings and label as the boxes contained inside.
- The OVERPACK must have the "OVERPACK" statement on the same face as the hazard markings and labels. **Package example:**
