Technical Bulletin

55 16 02 February 8, 2016 **2038992** Supersedes Technical Bulletin V551404 dated December 4, 2014 to include additional model and model year applicability.

Corrosion on the Rear Lid around License Plate Lights

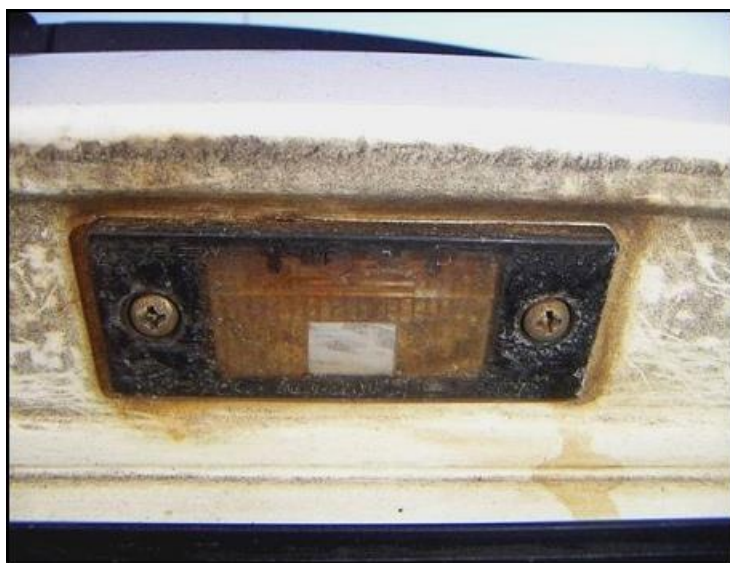
Figure 1: Corrosion on and around the license plate light

Electrolytic corrosion around the license plate lights (opening/contact surface, inside and outside) because of water ingress via the seal of the license plate lights.

1a. Repair (Remove corrosion and restore paint structure).

1b. Replace the rear lid.

- Remove the license plate lights from the rear lid according to the repair manual. See Repair Group 94 in Elsa.
- Remove all trim panels from the rear lid to prepare for corrosion removal according to the repair manual. See Repair Group 70 in Elsa.
- Remove the corrosion on the rear lid contact surface around the license plate light (inside and outside) with a pneumatic brush grinder.

- Prepare the rear lid for painting according to manufactures guidelines - it is not necessary to remove the glass.
- Apply a VOC compliant epoxy primer as an anti-corrosion treatment and primer (locally sourced).
- Repaint the rear lid according to manufactures guidelines.

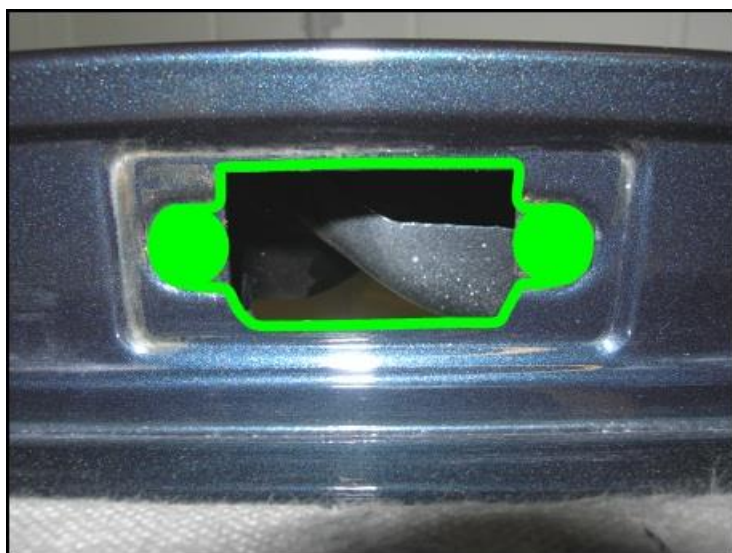
Figure 2) License plate light, butyl sealing cord areas

2. Additionally seal the contact surface of the license plate lights with butyl sealing cord (part number: AKL 450 005 05).

- Apply butyl sealing cord (0.2 cm x 20 cm) on the contact surface and attachment area of the license plate lights (Figure 2 and 3 in green).

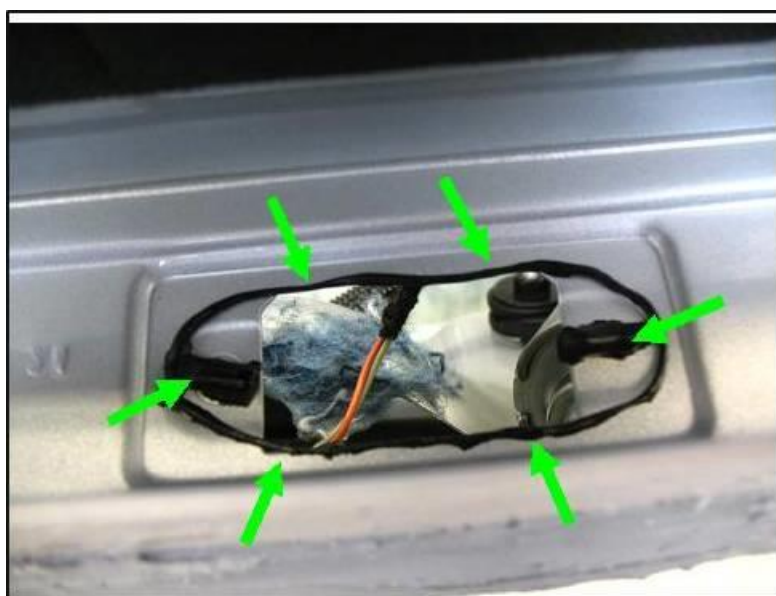
Figure 3) License plate light, contact surface and hole sealed with butyl sealing cord
