Service Bulletin

Bulletin No.: 15-NA-090

Subject: Power Steering Cooling Lines and/or Engine Oil Cooler Line Leak

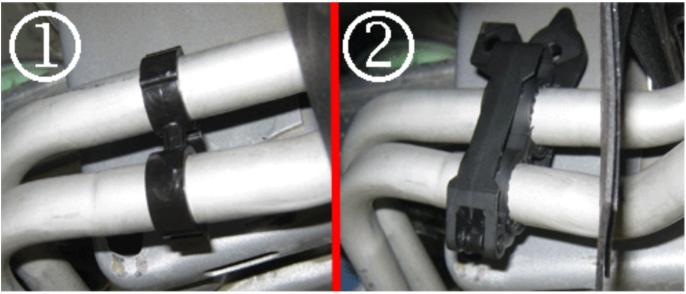
4331681

Condition	Some customers may comment on a power steering cooling line leak and/or an engine oil cooler line leak.	
Cause	This may be caused by the lines rubbing causing a leak.	
Additional Options	Equipped as Police Car (RPO 9C1 or 9C3)

During the installation of the new line, replace the clips holding the lines (1) with the new clips (2) as illustrated above.
