Field campaign

Topic	V8T & W12 Incorrect warning label fitted (SC12/12)
Market area	Russische Föderation (5RU), Russian Federation 935 Volkswagen Group RUS (6935), United Kingdom E01 Bentley UK (6E01), Germany E02 Bentley rest Europe (6E02), Australia E04 Bentley rest Asia and Australia (6E04), United States E05 Bentley USA and rest America (6E05), United Arab Emirates E06 Bentley Middle East and Africa (6E06)
Brand	Bentley
Transaction No.	2030735/1
Campaign number	E772
Note	
Type	
US code

Technical background

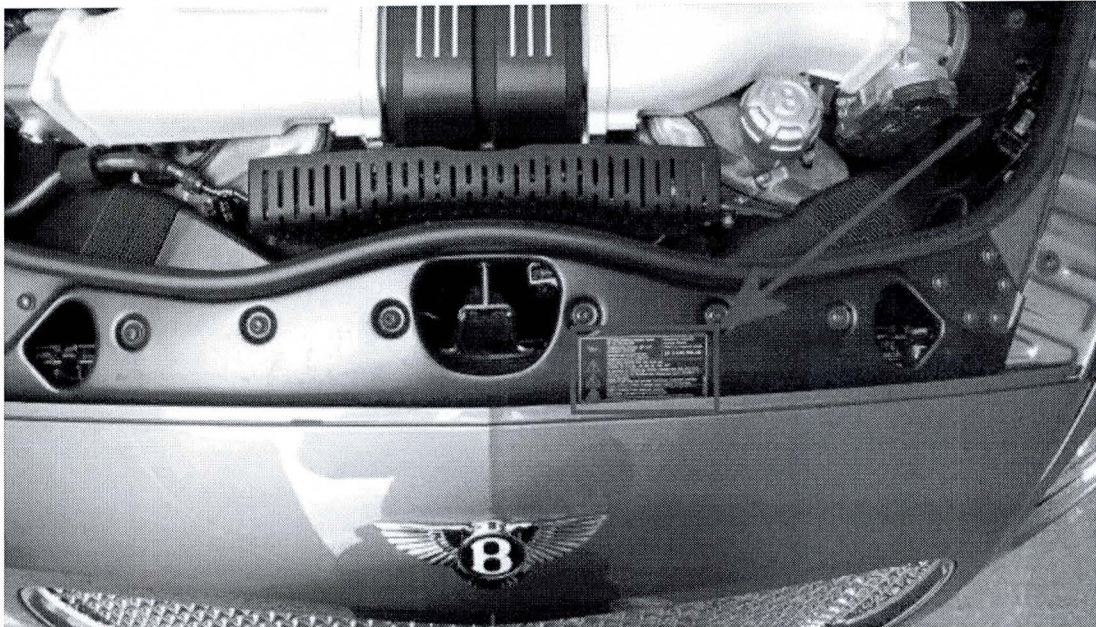
A small number of Continental Series vehicles may have had the incorrect warning label fitted at the time of production. Figure 1 shows the fitting location of the label, the labels are very similar in appearance to each other, the main difference relates to the oil grade which must be used dependent on engine derivative. W12 Continental Series vehicles should have the label as shown in Figure 2, the V8T Continental Series vehicles should have the label as shown in Figure 3

The warning label is fixed to the front end module closing plate, all cars post VIN SCBEN53W5EC [REDACTED] are fitted with the correct label at the time of production extra quality checks have been implemented to ensure correct warning label fitment.

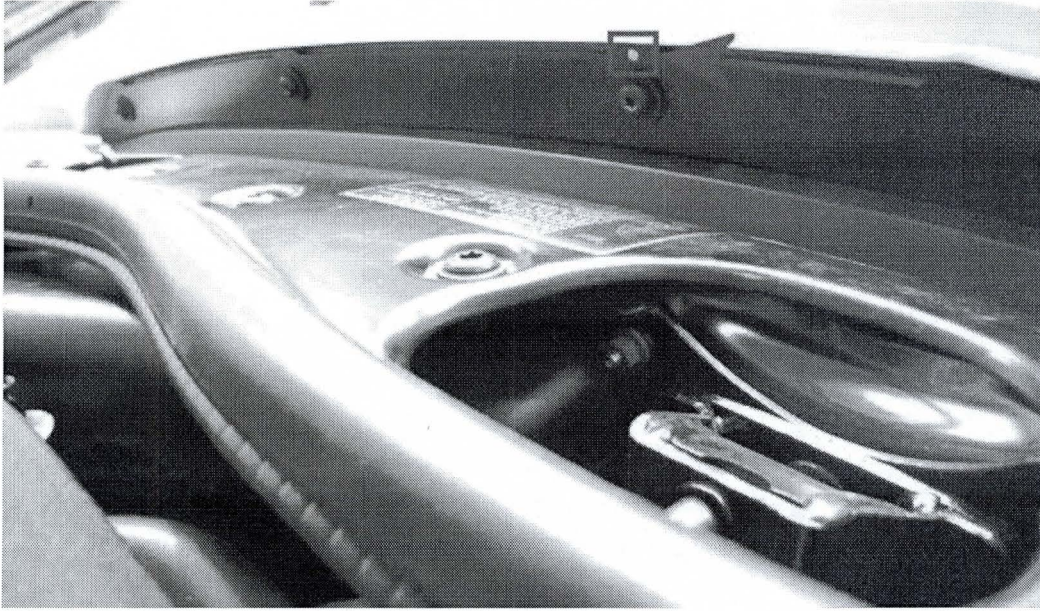
Figure 4

If the vehicle is not already listed as repaired in the "Repair history" (in Elsa pro), check for the campaign identification mark which is a small White paint dot located above the radiator shell fixing directly above the label (Figure 4) should neither be evident carry out the required work in accordance with instructions

2. Once the check has been conducted or the label has been replaced place a small white confirmation mark above the radiator shell fixing which is directly above the label (Figure 4)

Small White confirmation paint dot above the radiator shell fixing (Figure 4)
