Field campaign

Topic	V8T De-gas hose engine radiator connection-incorrect clip and fuel hose clipping right hand air filter housing (SC12/09)
Market area	Worldwide Bentley (1WBE)
Brand	Bentley
Transaction No.	2031114/1
Campaign number	E769
Note	
Type	Service campaign
US code

Continental V8T

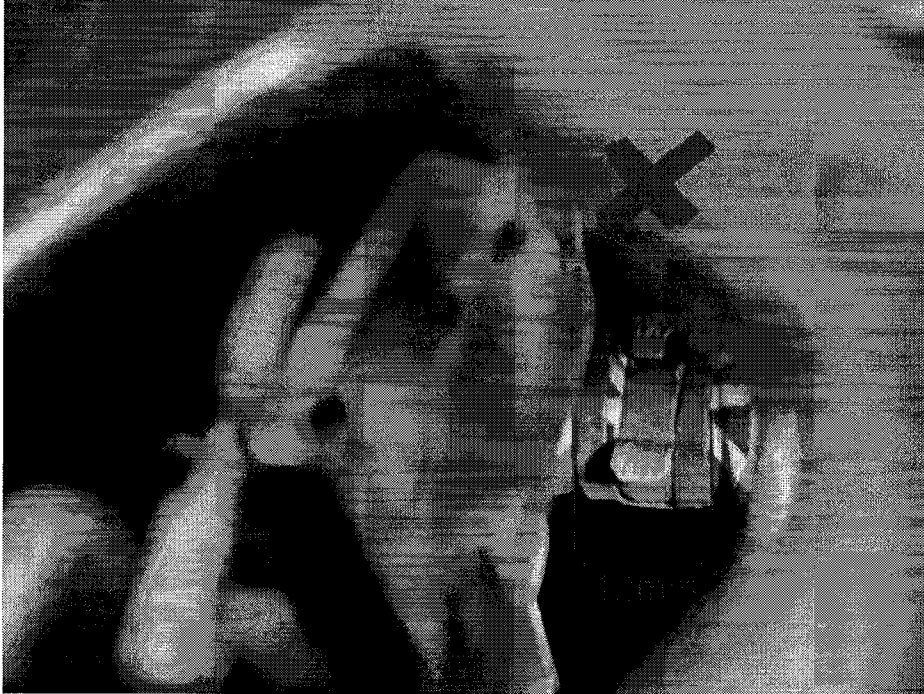
Using a measuring device, in this example a nylon spatula has been cut to 8mm, gauge the width of the spring band hose clamp at the engine coolant radiator stub pipe.

The specification calls for a hose clamp that is 8mm wide some vehicles have been fitted with a clamp that is 12mm wide. If the clamp is 8mm wide then no further action is required in respect to procedure 1, apply the yellow paint campaign marker as per figure 5 and carry out procedure 2.

On vehicles where the incorrect 12mm hose clamp has been fitted then carry out the following replacement procedure.

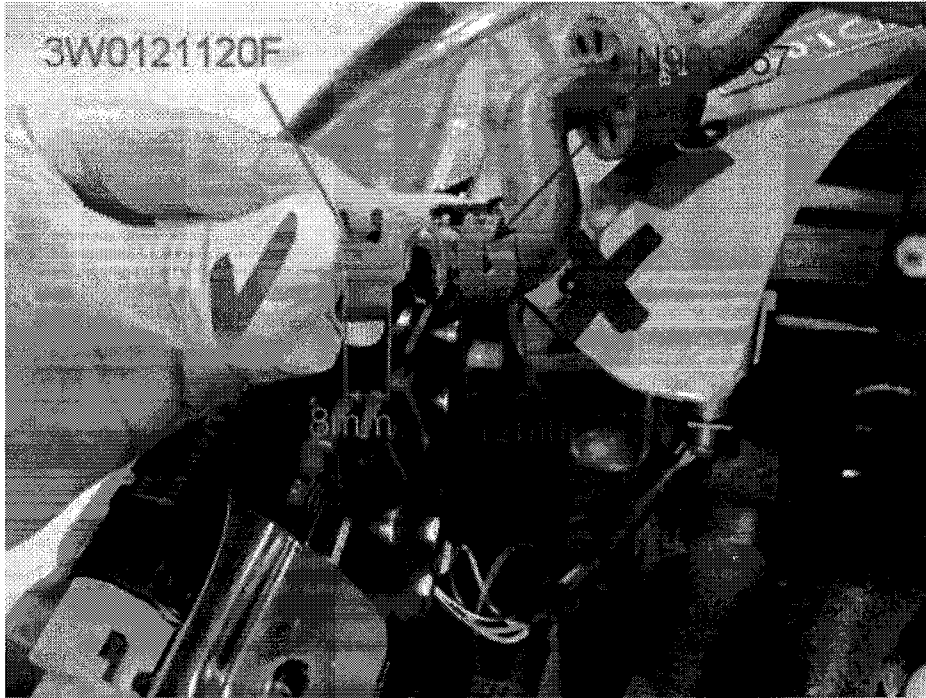
1. Remove the bonnet crossmember. Rep.Gr.50 Bonnet Crossmember – To Remove and Fit
2. Remove the right hand air cleaner assembly. Rep Gr.24 Air cleaners RH - To remove and fit
3. Release the spring band clamp and withdraw the de-gas hose from the coolant radiator stub pipe. Fit a blanking plug to the coolant radiator stub pipe to stem coolant lose whilst the clamp is replaced

4. Remove and discard the 12mm spring band clamp
5. Fit the new 8mm wide spring band clamp (part number 3W0121120F)
6. Remove the temporary blanking plug from the radiator stub pipe before refitting the de-gas hose to the radiator with the new clamp
7. Wash off any coolant spill
8. Refit the removed parts. Ensure new fasteners (N90737105) are used to secure the bonnet crossmember. Torque M6 bolts to 9Nm
9. Correct the coolant level in the header tank
10. Apply yellow and white campaign identification marks (see Figure 5)
