<b>Topic</b>	W12 De - gas hose radiator connection - incorrect hose clip (SC12/11)
<b>Market area</b>	Worldwide Bentley (1WBE)
<b>Brand</b>	Bentley
<b>Transaction No.</b>	2031352/1
<b>Campaign number</b>	E771
<b>Note</b>	
<b>Type</b>	Service campaign
<b>US code</b>

An incorrect hose clamp may have been fitted to the de-gas connection on the main engine cooling radiator.

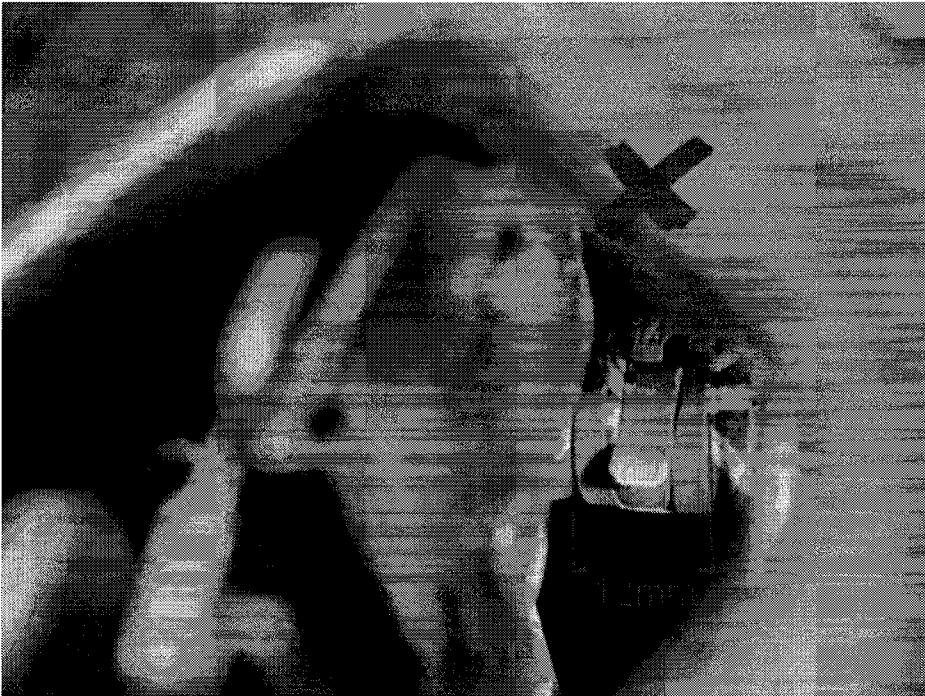
The specification calls for a hose clamp that is 8mm wide some vehicles have been fitted with a clamp that is 12mm wide. If the clamp is 8mm wide then no further action is required, apply the yellow paint campaign marker as per figure 1.

On vehicles where the incorrect 12mm hose clamp has been fitted then carry out the following replacement procedure.
