Technical product information

Topic	Continental Series, Flying Spur and Mulsanne - Main harness identification
Market area	Worldwide Bentley (1WBE)
Brand	Bentley
Transaction No.	2038035/1
Level	EH
Status	Approval
Release date

Section 1 - Main harness information, Continental Series and Flying Spur

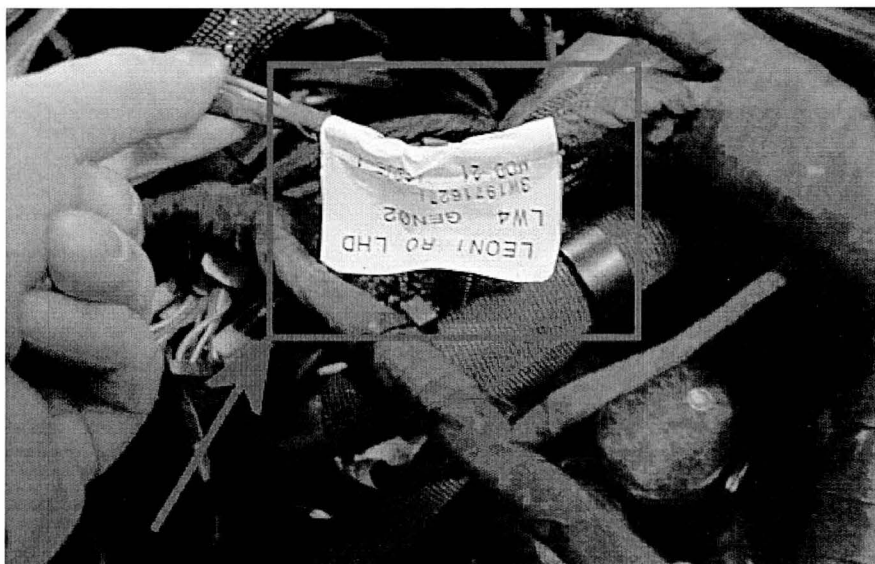
Figure 6

V8T – The engine identification label is fitted to the earth lead branch off section within the plenum (Figure 6)

1. To gain access to the Continental Series and Flying Spur engine harness labels remove the plenum cover - Refer to the workshop manual Rep.Gr 87 - Plenum cover to remove and fit

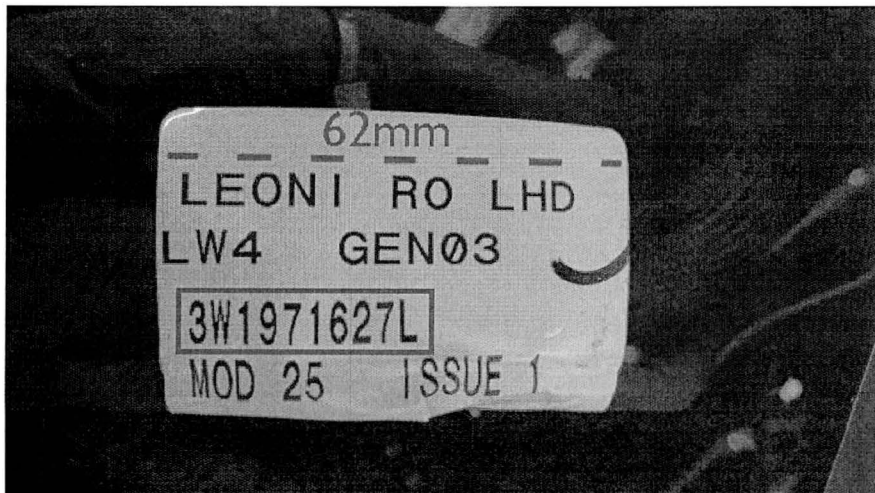
Figure 7

V8T and W12 - To help in clarifying between the engine harness identification label and any other labels within the nearby vicinity, the engine identification label has a Bentley part number printed on it the width of the label is 62mm (Figure 7)

IMPORTANT: For all engine harness issues please attach photographs of the information shown on both sides of the label as shown in Figures 7 and 8.

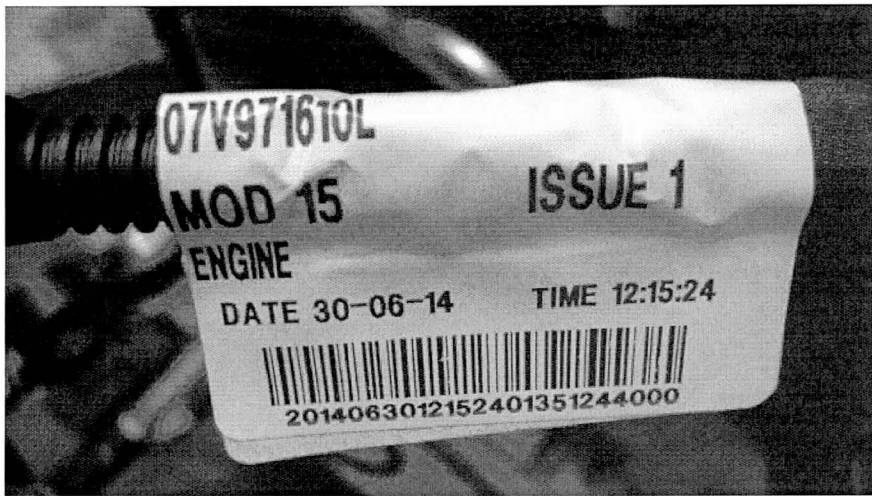
- Ensure clear photographs of the label information is provided within the DISS ticket as shown in Figure 11 and 12
