NUMBER: 08-015-16

Poor GPS Signal Reception

This bulletin involves the replacement of the GPS antenna with a roof mount antenna to improve navigation performance.

2011 - 2014 (JC) Dodge Journey (International only)

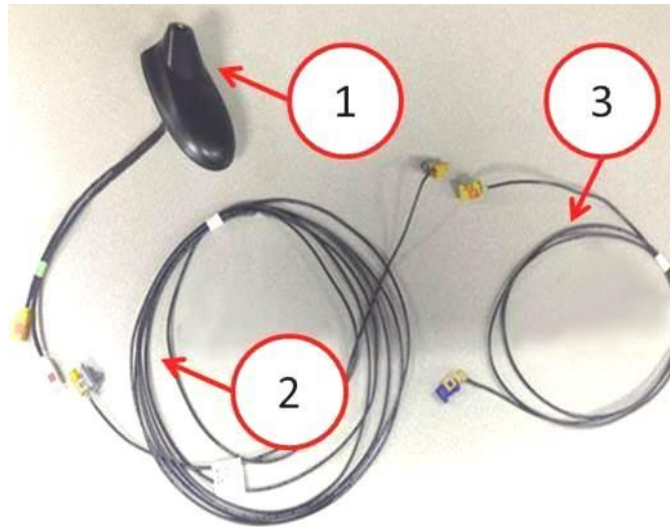
Fig. 1 Rework Kit Description

- 1 - Dual Function Antenna
 - 2 - Body Wiring (from dual function antenna to coupling on A pillar)
 - 3 - Wiring Under the Dashboard (from coupling on A pillar to radio)
-

NOTE: To complete the repair procedure it is necessary to get the parts shown in (Fig. 1) ordering the P/Ns 05091031AA, 68068349AA and 68248758AA. (Fig. 1) shows the routing overview of the body and under-dashboard wiring and the connector connections.

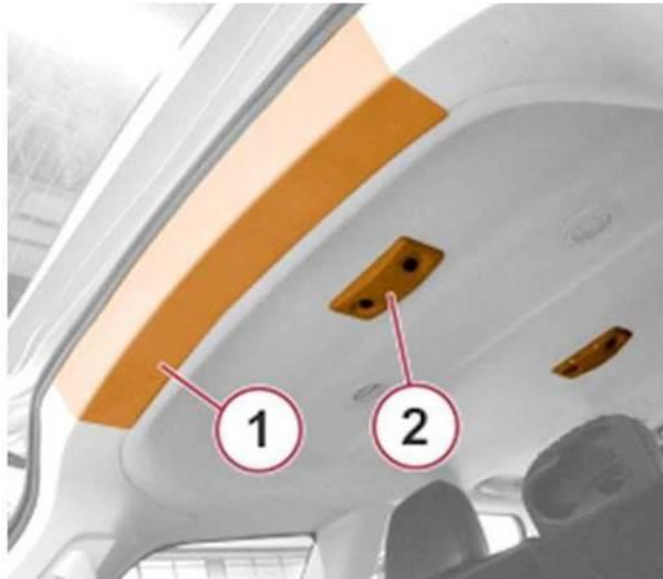
Fig. 3 Rear Crossmember Trim Panel And Rear Roof Light Location

- 1 - Crossmember Trim Panel
 - 2 - Roof Light
-

6. Turn the ignition key to the OFF position and disconnect the battery negative terminal.
7. Remove the rear crossmember trim panel by slightly pulling the trim to release the retaining devices. Using the suitable tool, release the rear roof light and move it to one side without disconnecting it (Fig. 3).

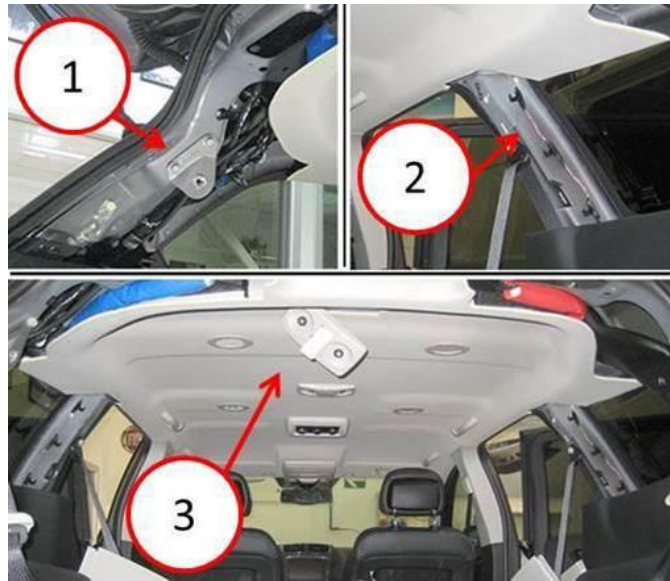
Fig. 4 Pillar Trims And Headliner Removal

- 1 - Trim of Left C pillar
- 2 - Trim of Right B pillar
- 3 - Headliner

8. Remove the upper trims of right and left C pillars (Fig. 4).
9. Remove the upper trims of right and left B pillars (Fig. 4).
10. Lower the headliner until the lower part of the antenna can be accessed (Fig. 4).

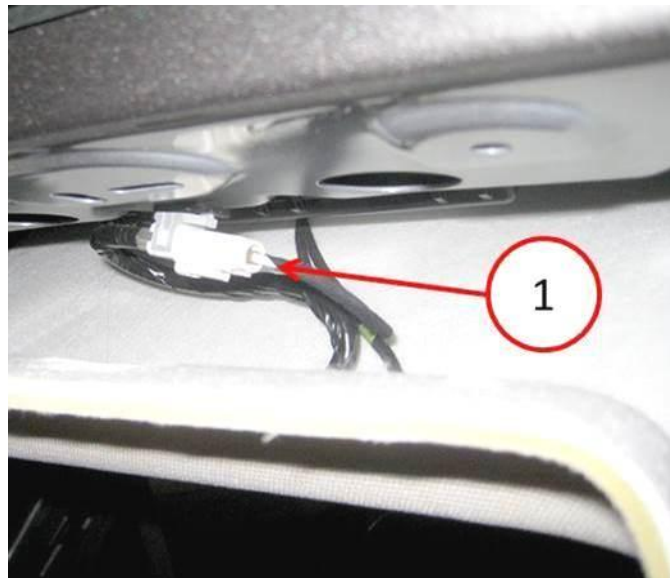
Fig. 5 Antenna Connector

- 1 - Connector
-

11. Disconnect the antenna connector (Fig. 5).

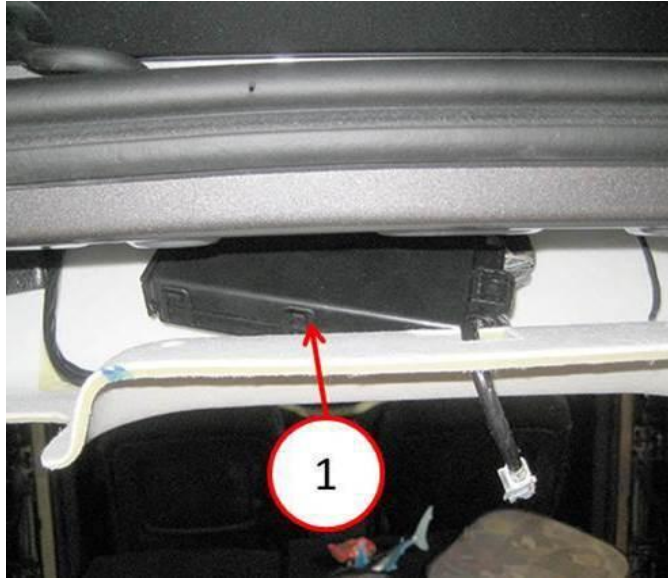
Fig. 6 RF Module

1 - Module

12. Remove two nuts and lower the Radio Frequency (RF) module downward ([Fig. 6](#)).

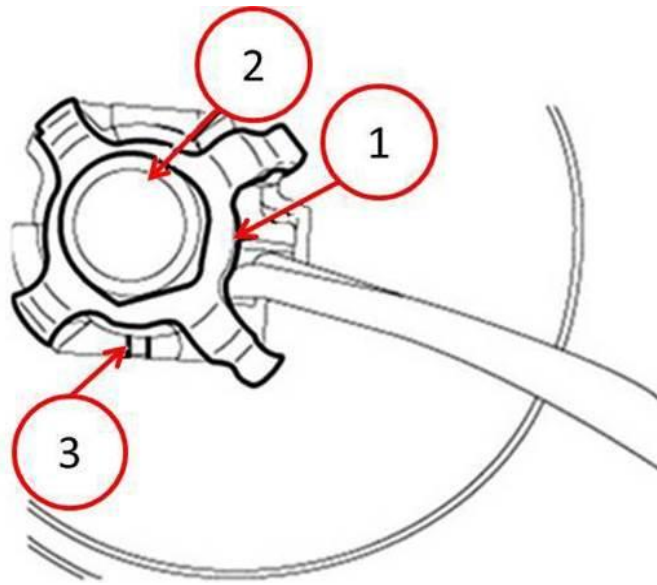
Fig. 7 Antenna Retainer

- 1 - Retainer
- 2 - Nut
- 3 - Retaining Tab

13. Slightly press on the back of the trim and remove the nut and the retainer from the old antenna. Working from inside the vehicle, press one of the retaining tabs on the antenna using a flat-bladed tool. Press one side of the antenna connector through the roof, then press the other side of the connector and remove the antenna ([Fig. 7](#)).

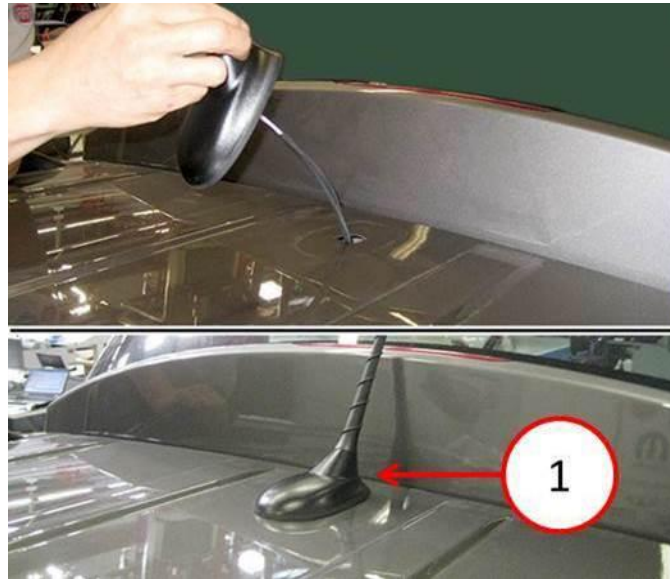
Fig. 8 New Dual Function Antenna Location

1 - Antenna

15. Install the dual function antenna P/N 05091031AA, with two electrical connectors through the hole on the roof. Press antenna into position until the retainer snaps-fit (Fig. 8).

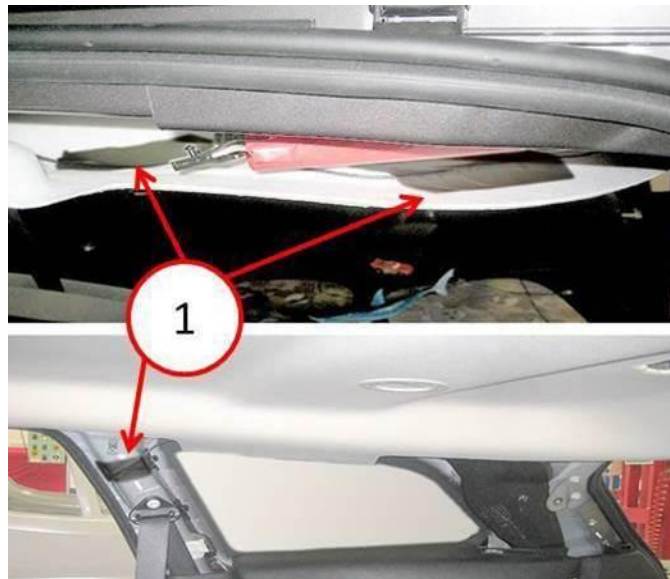
Fig. 10 Body Wiring Routing

1 - Tape Application Points

20. Install the (RF) module with two nuts.
21. Install the body wiring to the interior side of the roof trim, working from the back side to the right B pillar and secure it with the adhesive tape (Fig. 10).

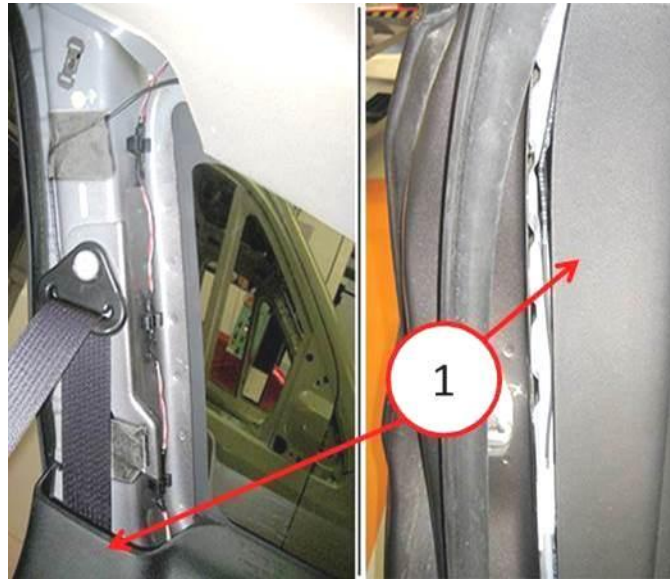
Fig. 11 Body Wiring Routing B Pillar

1 - B Pillar Lower Trim

22. Remove the door weather strip and lay the body wiring along the right B pillar. Secure by applying tape above and below the seat belt attaching point (Fig. 11). Continue by routing the body wiring under the B pillar lower trim (Fig. 11).
