HYUNDAI NEW THINKING. NEW POSSIBILITIES.	GROUP CAMPAIGN	NUMBER 16-01-009
	DATE MARCH 2016	MODEL(S) SONATA (LFa)
Technical Service Bulletin		
SUBJECT:	REAR SEAT BACK LATCH INSPECTION AND REPLACEMENT (SERVICE CAMPAIGN TZ6)

Description: On some Sonata (LFa) vehicles, the rear seat back latch release handle may break when pulled. If the latch handle(s) breaks, the corresponding rear seatback cushion cannot be lowered. This bulletin describes the procedure to inspect and replace the rear seat latch release assembly(s).

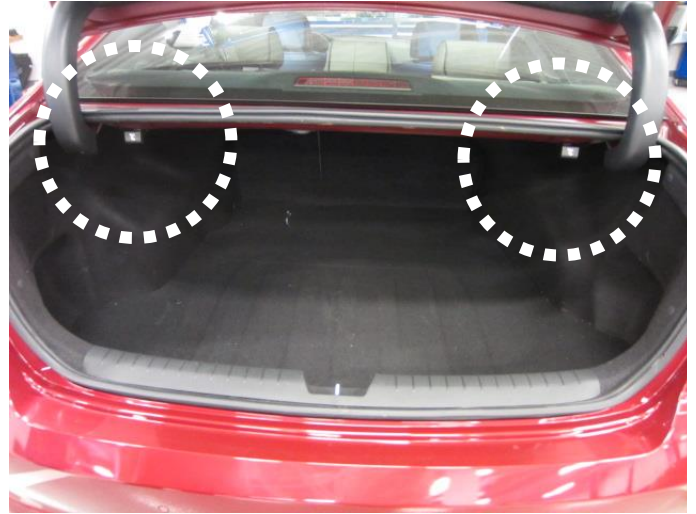
1. Open the trunk to access the two seat back latches.

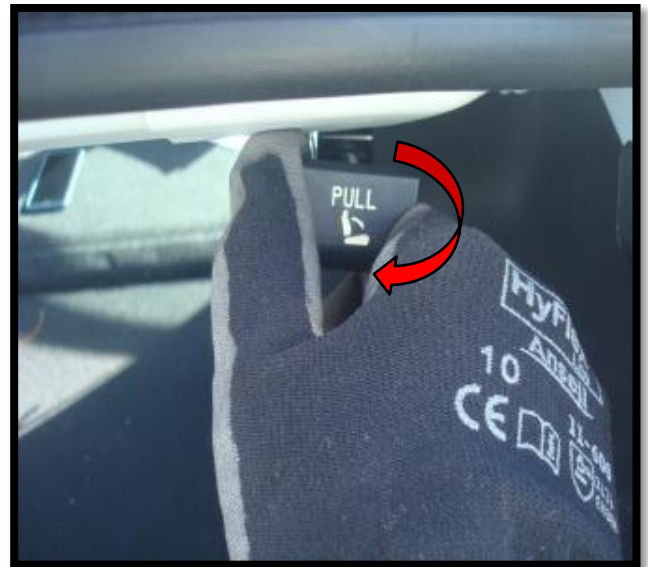
2. On each knob, twist with mild force at the end of the knob for one second.
 - If the knob does not break then the latch is okay. Use OP Code 50CA25R0.
 - If the knob breaks or freely turns, then proceed with the part replacement procedure. (Step 3)

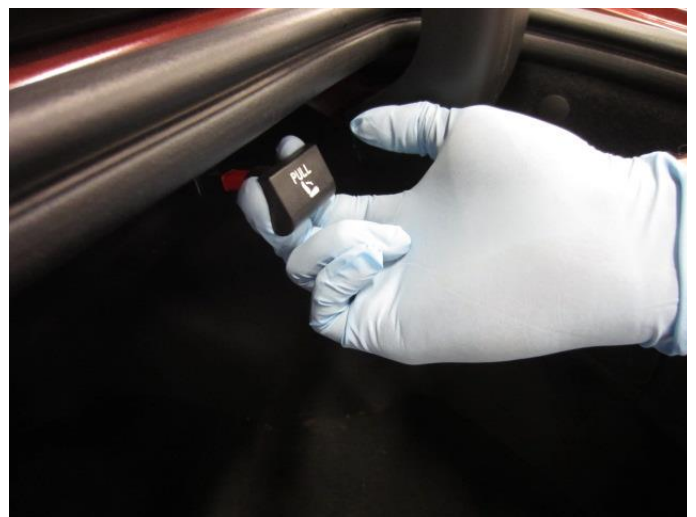
3. Pull knob of the defective latch to release the seat backs.

If the pull knob is broken use pliers to pull on cable end.

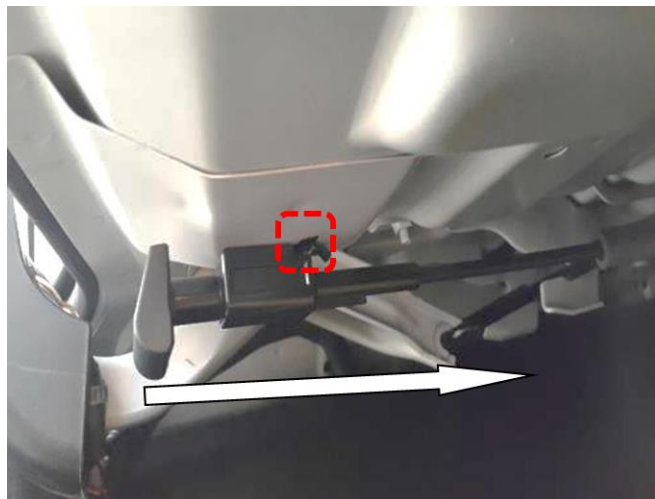
4. While pressing the release tab downward, push the latch handle toward the front of the car.

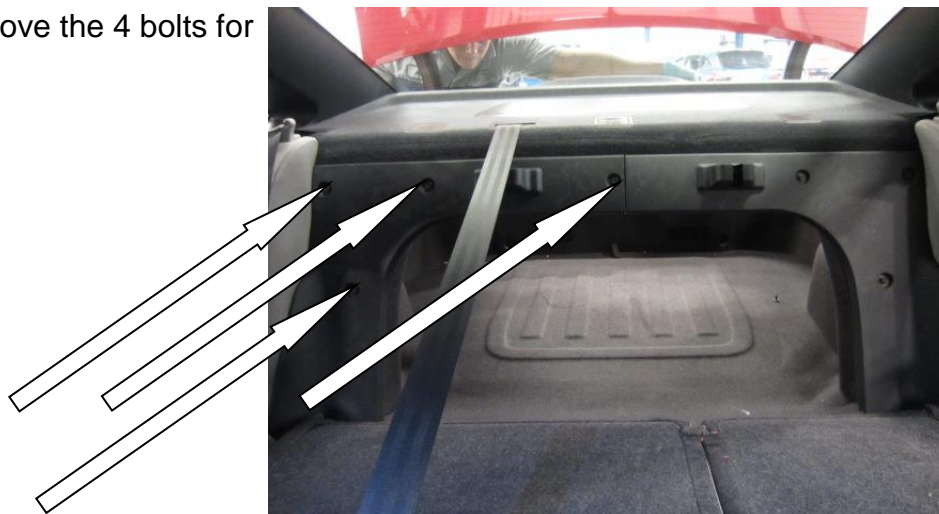
5. Using a 10mm socket, remove the 4 bolts for the right latch.

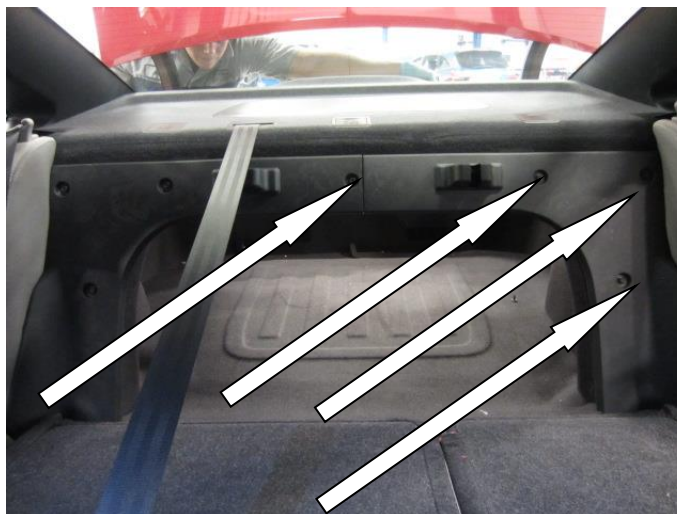
6. Using a 10mm socket, remove the 4 bolts for the left latch.

All 7 bolts need to be removed for both left and right.

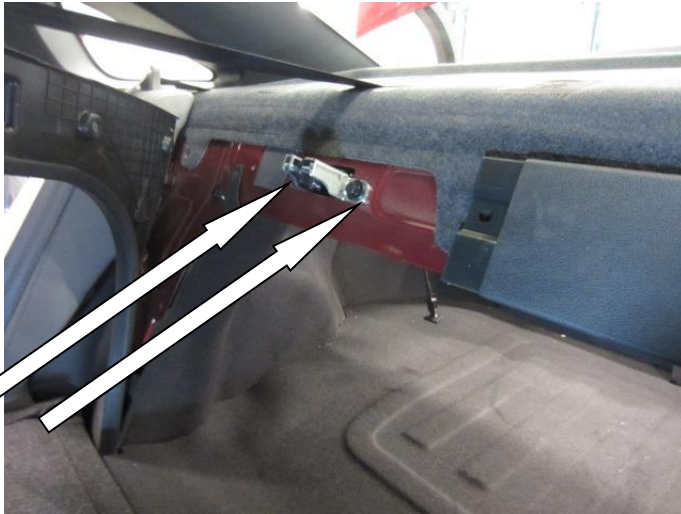
7. Carefully pull back the plastic trim and unbolt the two 12mm bolts.

Tightening torque:
29.4 ~ 39.2 Nm,
3.0 ~ 4.0 kg.m,
21.7 ~ 28.9 lb-ft,
260 ~ 347 lb-in

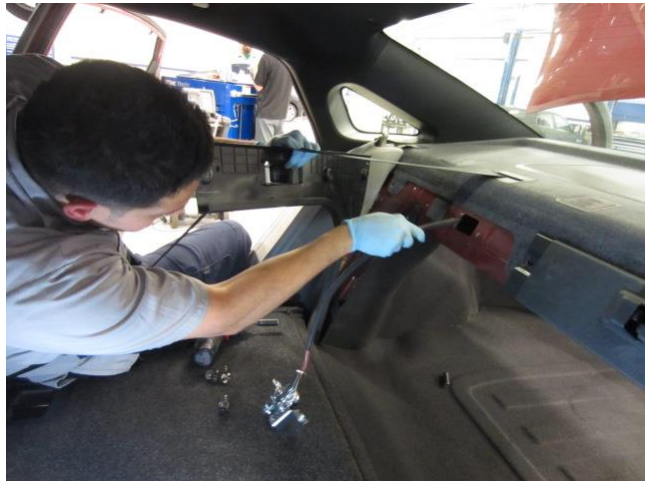
8. Remove existing latch and install new latch. Reassemble and put parts back together in reverse order.

Be careful not to damage the rear center seatbelt when reinstalling the trim.

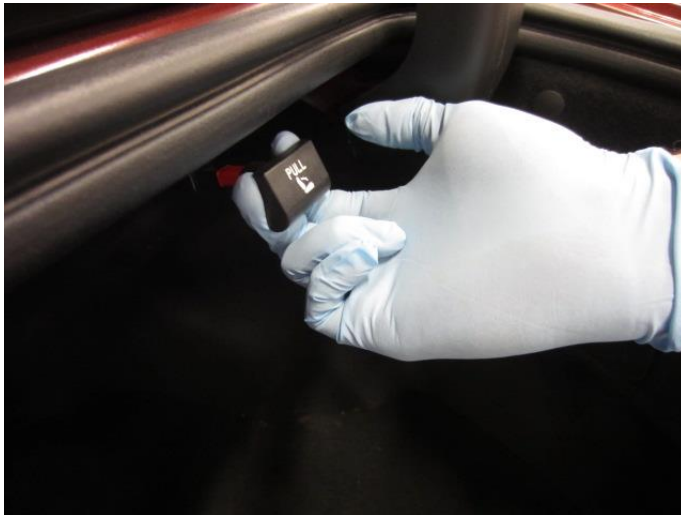
9. Check for proper function of the rear seatback latch release.
