SERVICE BULLETIN

EC14-010a

2014-2015 ROGUE; LACKS POWER DUE TO SNOW INGESTION

APPLIED VEHICLE: 2014 - 2015 Rogue (T32)

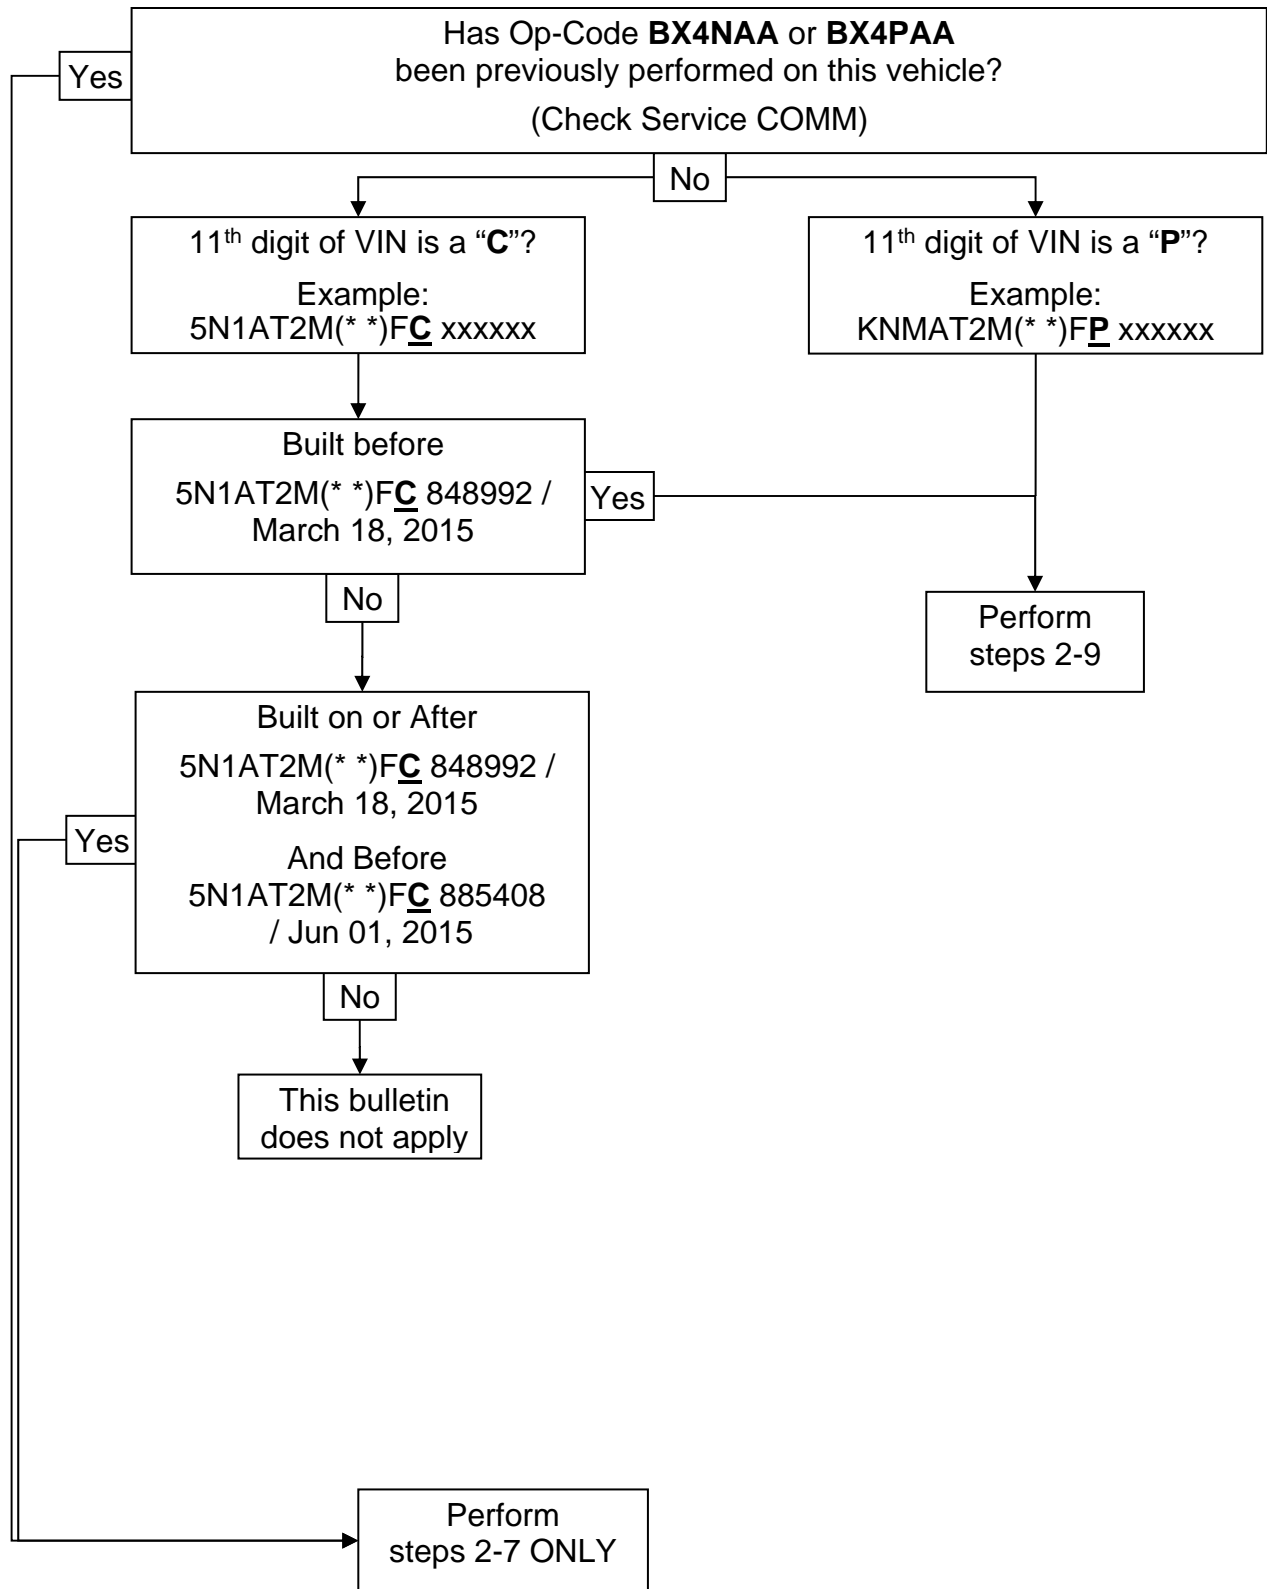
REPAIR FLOW CHART

APPLIED VIN & DATE: See Repair Flow Chart on page 2 for VIN and Date information.

See Repair Flow Chart on page 2 to confirm that this bulletin applies.

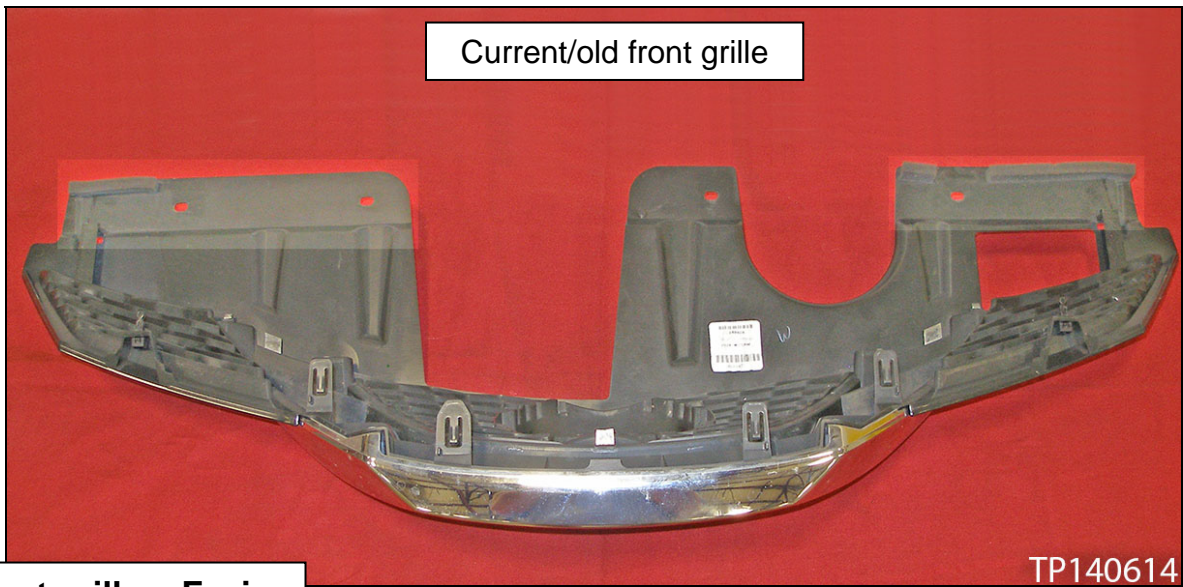
Figure 3

Front grilles: Facing down, viewed from underneath

9. Replace the front grille with the new one listed in the Parts Information.
- If there is a front camera, transfer it from the old grille to the new grille.
 - Refer to the ESM, section **EXT - Exterior**, for front grille installation.
 - If the new grill has a front camera, refer to the ESM, section **AV - Audio, Visual & Navigation System**, for front camera image calibration.
