# SERVICE BULLETIN

Classification: AT15-015b	Reference: NTB15-086b	Date: April 1, 2016
------------------------------	--------------------------	------------------------

## 2013-2015 ALTIMA AND 2014-2016 ROGUE; MIL ON WITH DTC P0776

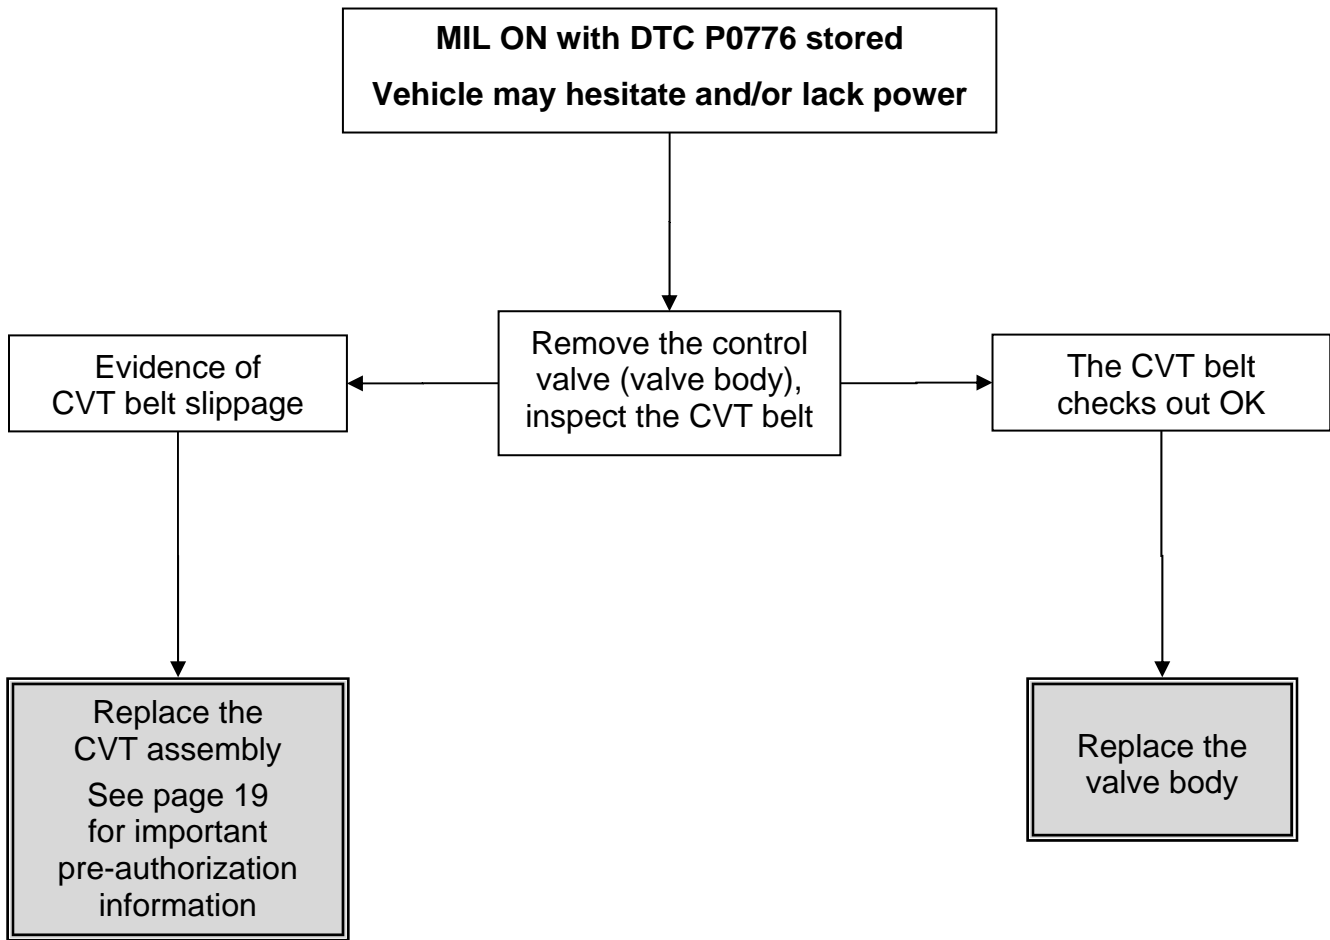
## Repair Flow Chart

Refer to the **Repair Flow Chart** on page 2.

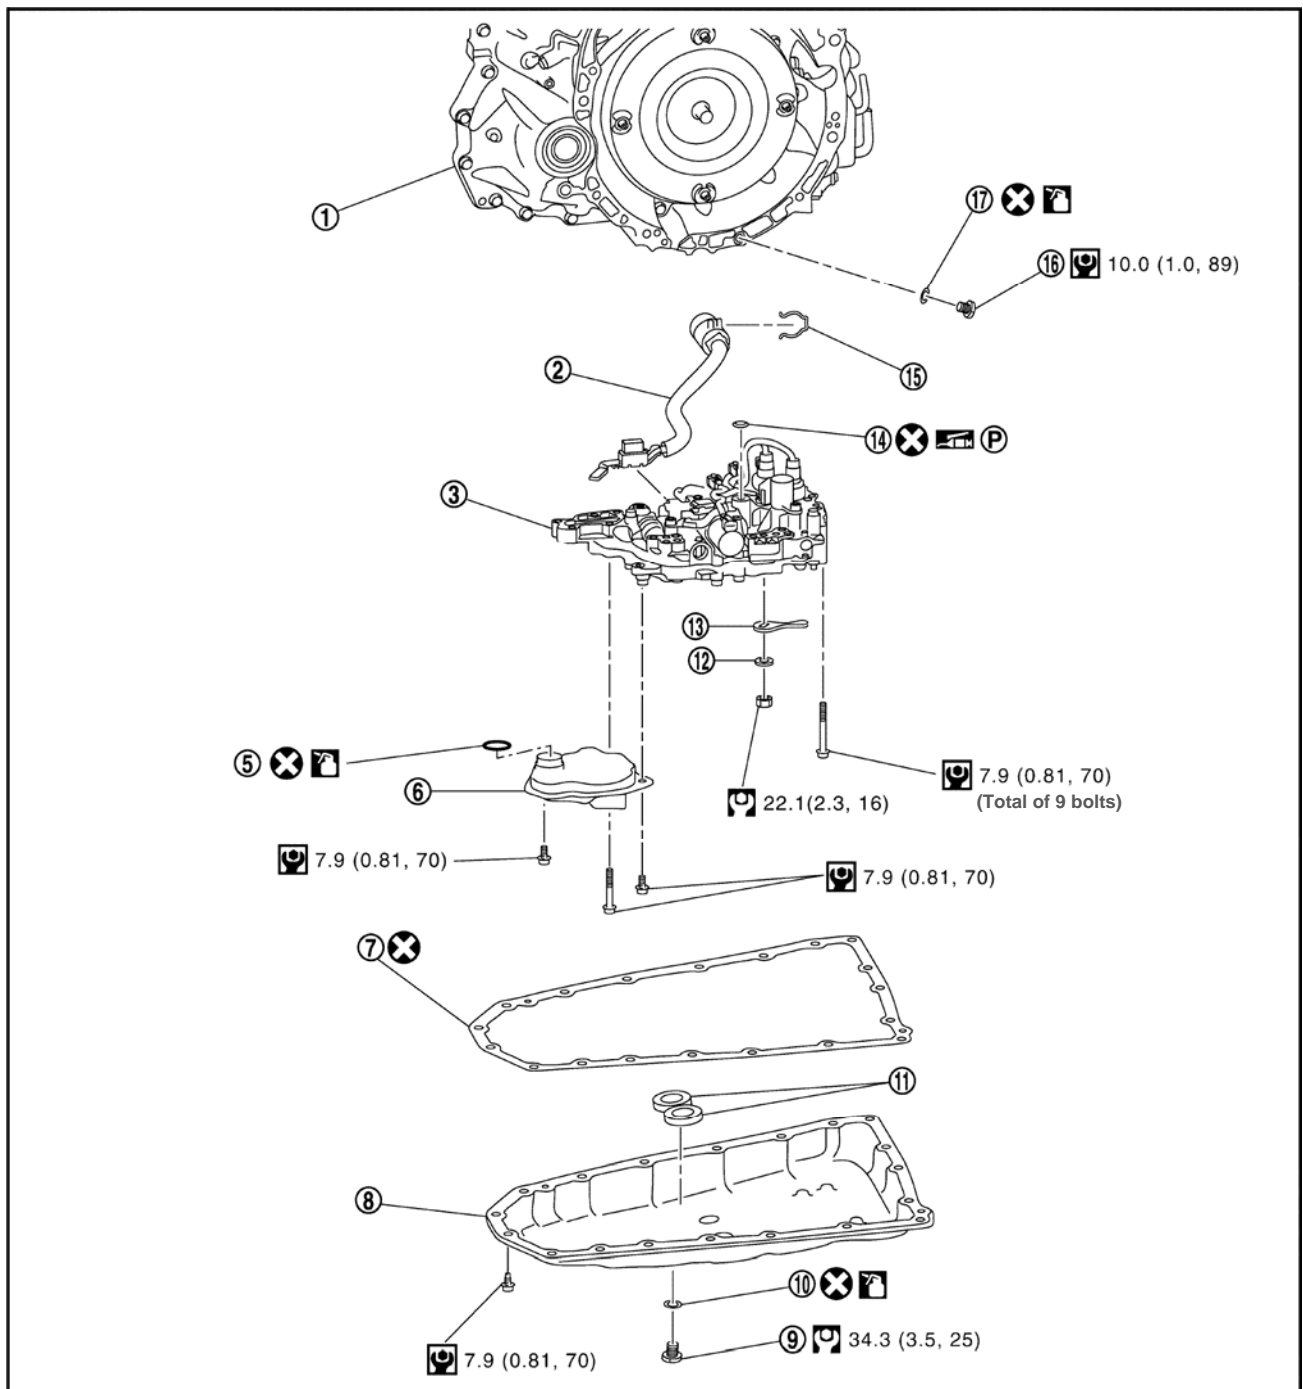
Figure 1

| ① | Transaxle (CVT) assembly | ② | Terminal cord assembly | ③ | Control valve (valve body) |
| ④ | Manual plate | ⑤ | O-ring | ⑥ | Oil strainer assembly |
| ⑦ | Oil pan gasket | ⑧ | Oil pan | ⑨ | Drain plug |
| ⑩ | Drain plug gasket | ⑪ | Two original magnets | ⑫ | Spring washer |
| ⑬ | Manual plate | ⑭ | Lip seal | ⑮ | Snap ring |
| ⑯ | Overflow plug | ⑰ | O-ring | | |

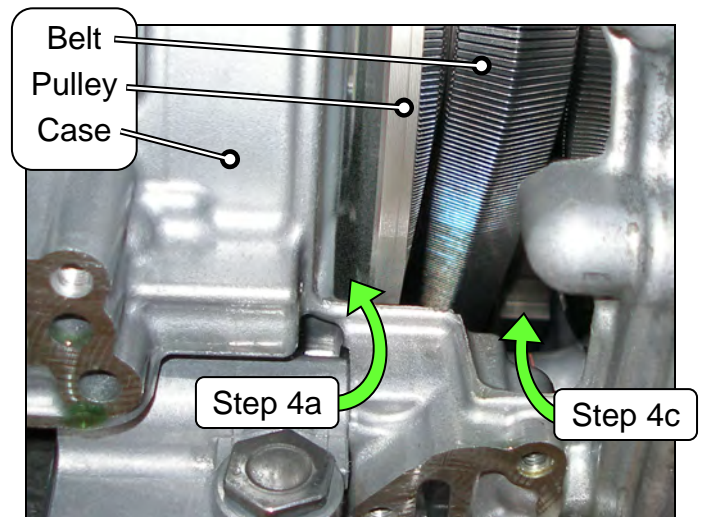
- a. Insert the camera lens between the CVT case and pulley where shown in Figures 3 and 4.
  - Insert the lens approximately seven (7) inches, and then view the side of the belt that contacts the pulley.

- c. If the inspection result is OK, inspect the other side of the belt.
- Insert the the camera lens in the second location where shown in Figure 3 and 6, and then perform step 4b again.
- d. If the inspection result is OK 360° on both sides of the belt, skip to step 5 on the next page.
- If any evidence of belt slippage is found, go to step 4e, and then step 6.
  - For additional information, see video # 544: “CVT Belt Inspection”. This video is located under the TECH TRAINING GARAGE VIDEOS tab in Virtual Academy.

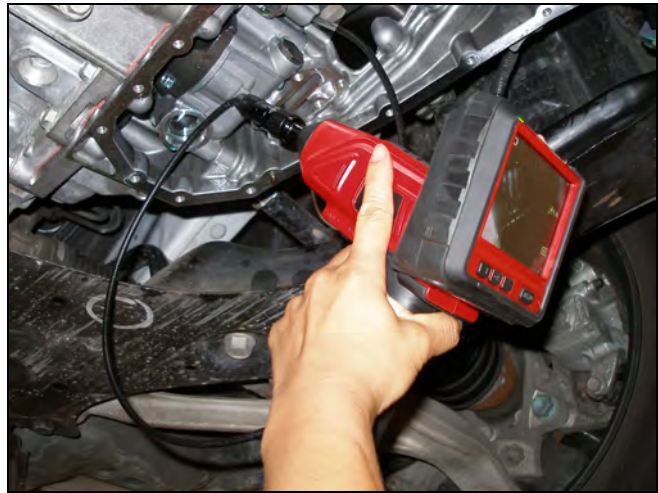
Figure 5

- b. Slowly and carefully turn the front left tire one full turn in the forward rotation to view all of the belt.

- Holding the borescope with one hand allows for turning the tire with the other hand (see Figure 5).

**CAUTION:** If the tire is rotated in the rearward rotation, the camera lens may get caught between the belt and pulley.

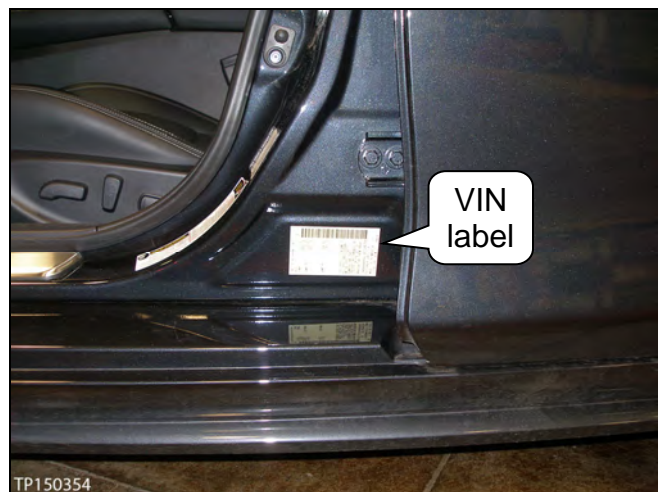
Figure 7

- e. Once CVT replacement is determined as required, use borescope J-51951 to record a 15 second or less continuous video of the most severe evidence of belt slip and the VIN on the F.M.V.S.S. certification label (VIN label). See Figure 7.

**NOTE:** This required video must be attached to the Powertrain Call Center CVT Preauthorization Form (in ASIST) prior to calling for authorization. Failure to submit a continuous video will cause immediate denial of request for replacement.

- Before starting to record, make sure the camera handle's AA batteries are fresh and the LCD monitor's battery is charged.
  - The whole video will show as backward, or reversed mirror image. This is okay.
  - The required video must show clear evidence of belt slippage and be 15 seconds or less.
5. If the belt inspection result is OK, replace the valve body.
    - There is no need for pictures or video showing "OK" belt surfaces.
    - For valve body replacement, go to page 12, **Control Valve (Valve Body) Installation**.
  6. If the belt inspection result is NG, replace the CVT assembly.
    - Get authorization to replace the CVT assembly (see page 19).
    - Make sure to perform step 4e on page 6.
    - For CVT assembly replacement, refer to the appropriate ESM, section **TM – Transaxle & Transmission / RE0F10D**.

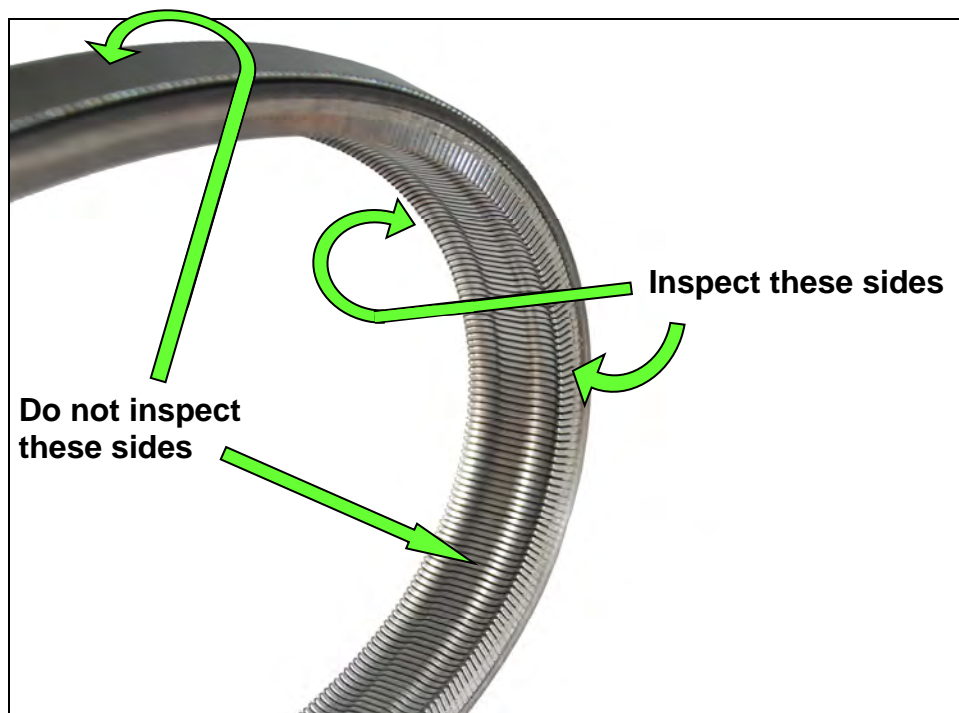
Figure 8

4. Using borescope J-51951 with mirror attachment, inspect the entirety of the two sides of the belt that come in contact with the pulleys (see page 7, Figure 8). Reference the pictures on pages 7 through 11 for comparison.

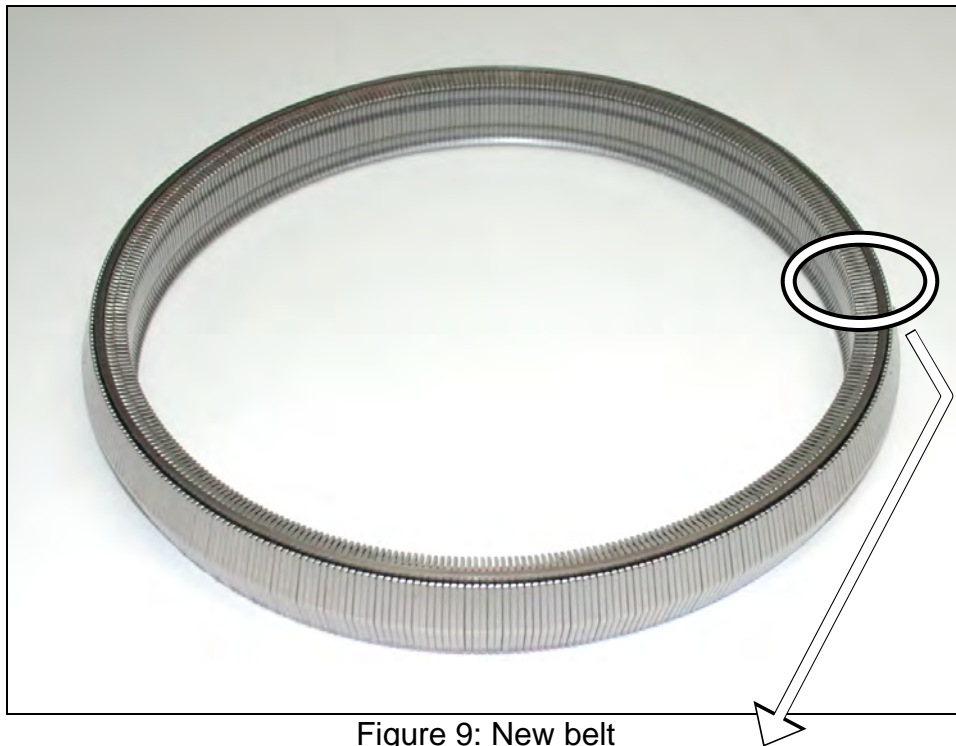
Figure 9: New belt

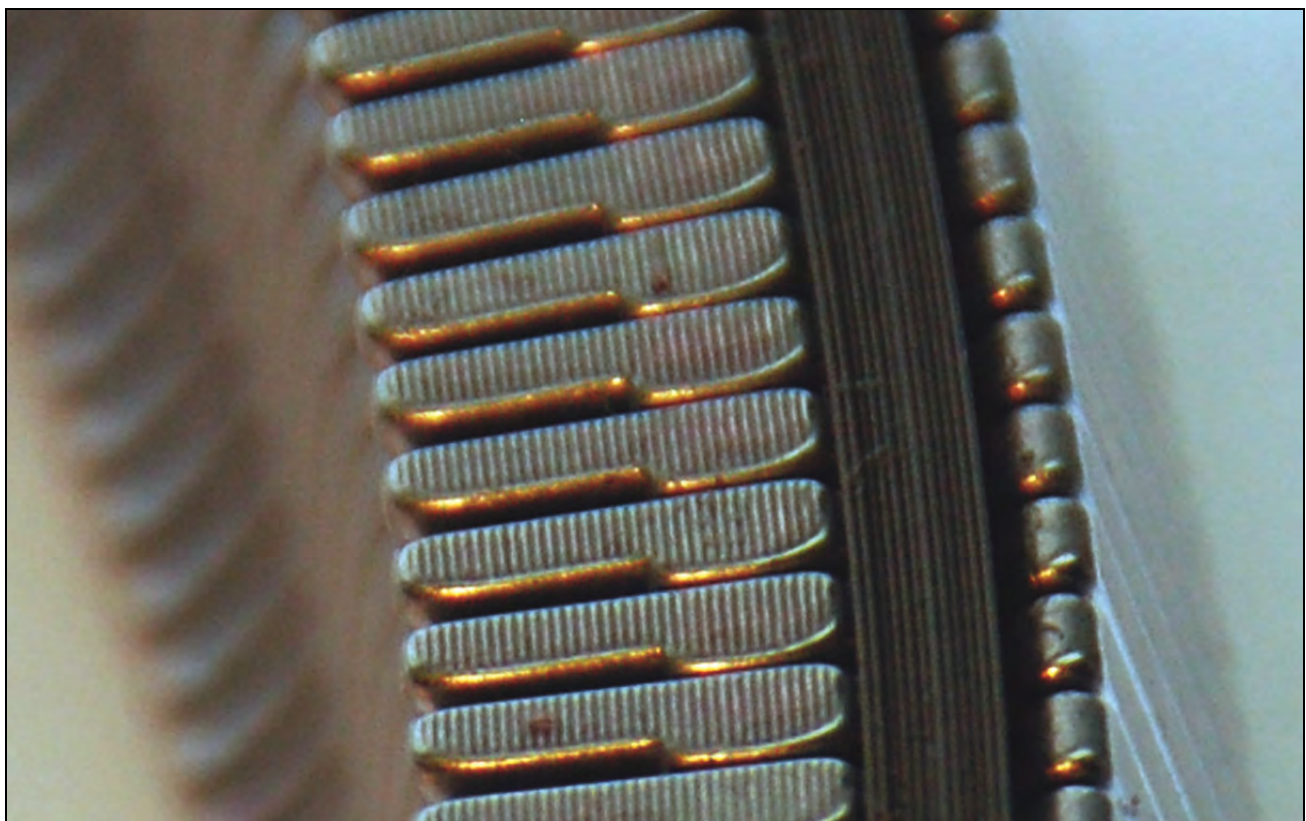
Figure 10: Close-up of section to be inspected

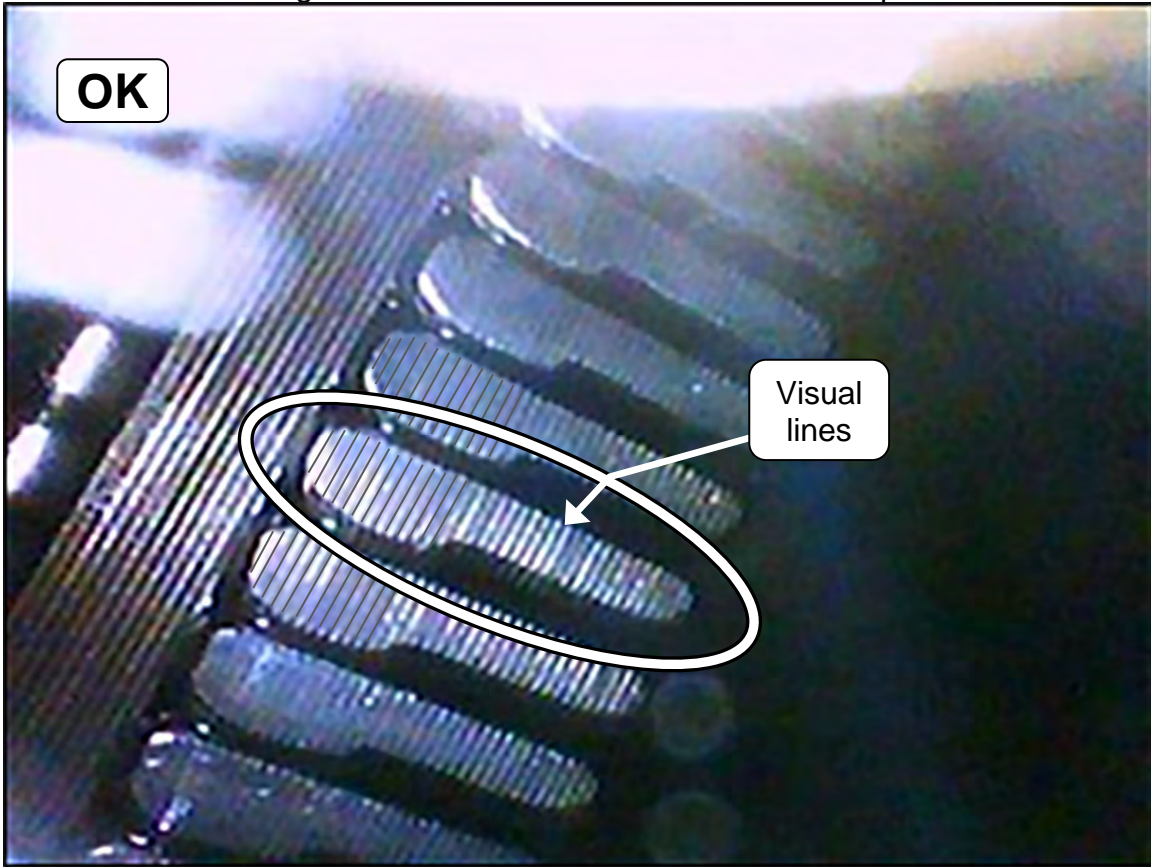
Pictures in Figures 11 and 12 were taken with borescope J-51951.

Figure 11: Belt is OK

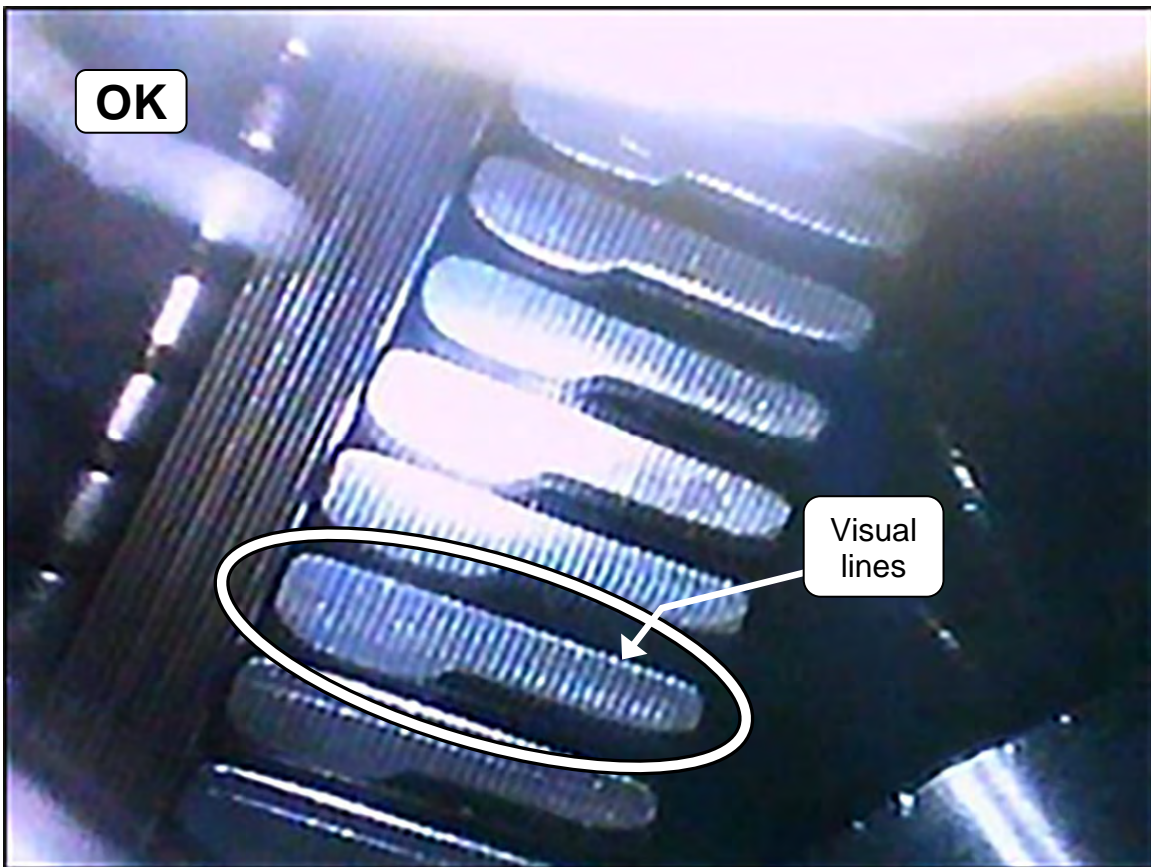
Figure 12: Belt is OK

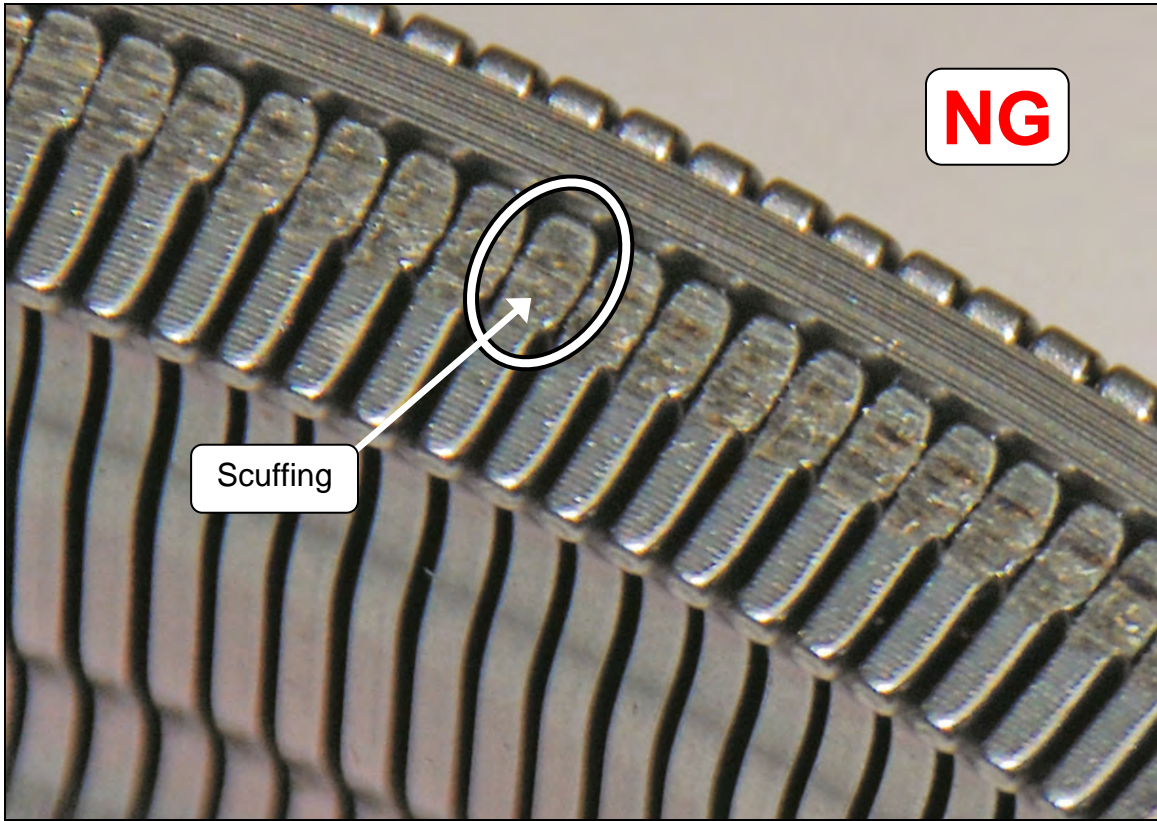
Figure 13: Example of NG belt

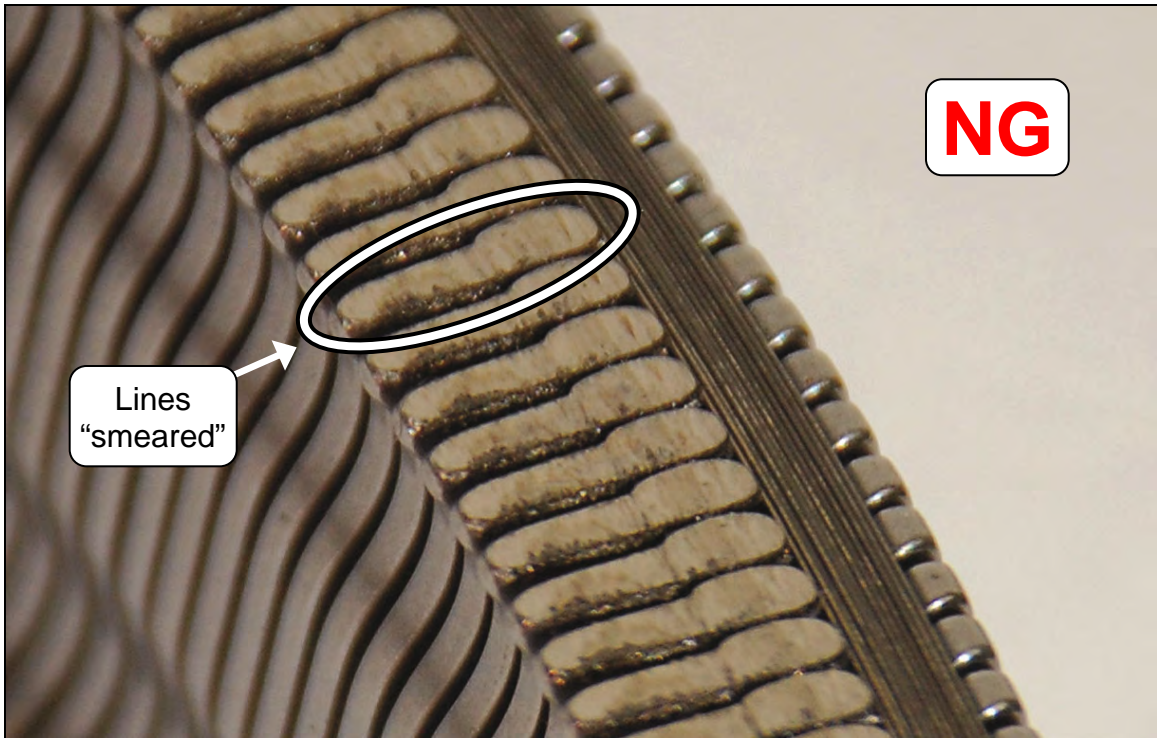
Figure 14: Example of NG belt

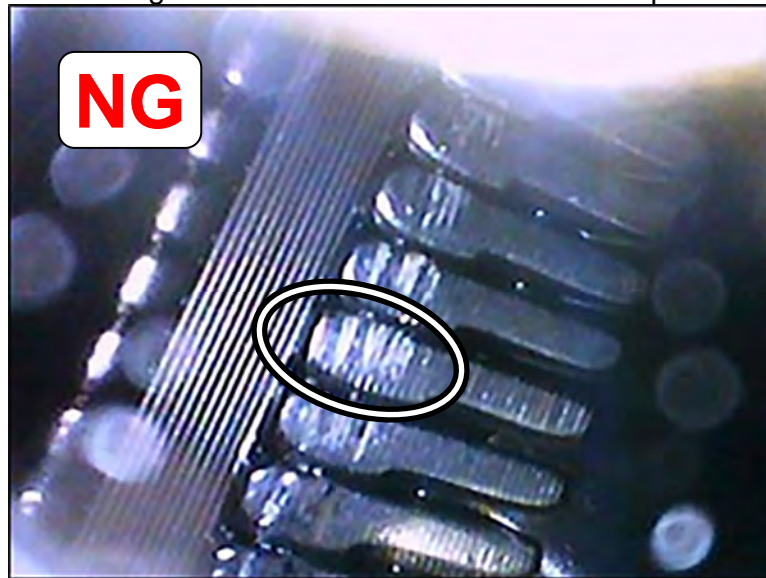
Pictures in Figures 15-17 were taken with borescope J-51951.

Figure 15: Example of NG belt

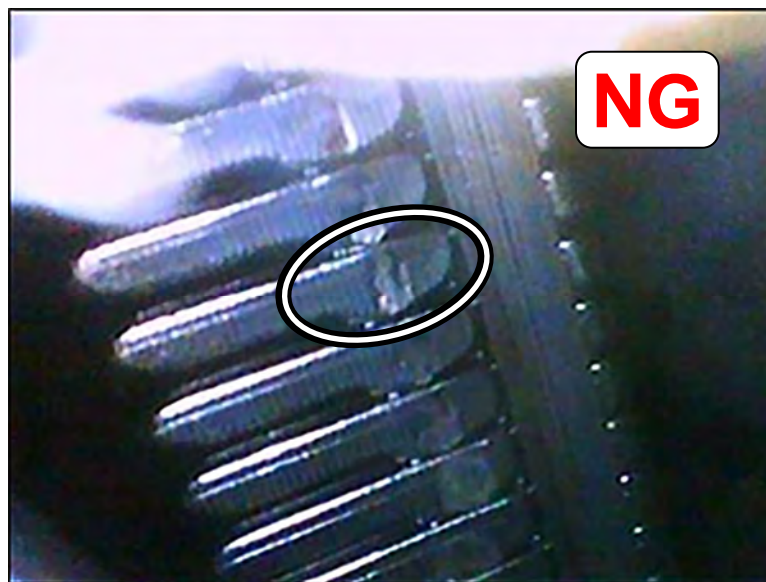
Figure 16: Example of NG belt

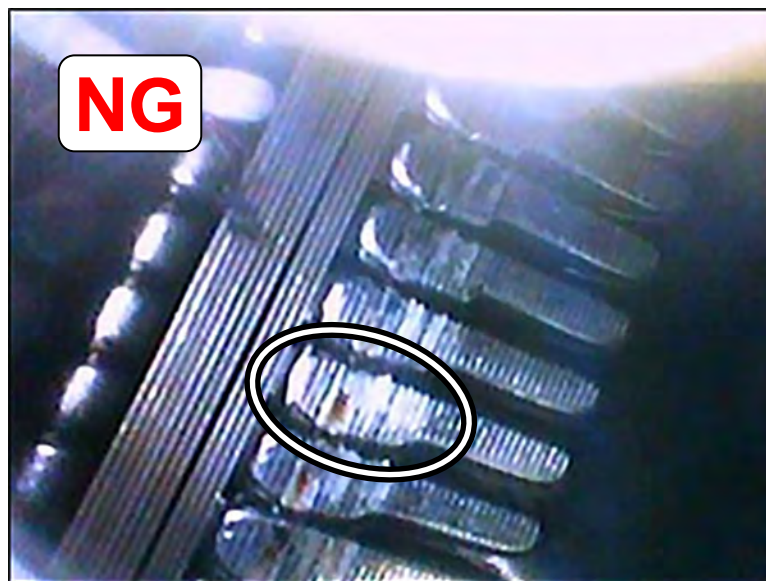
Figure 17: Example of NG belt

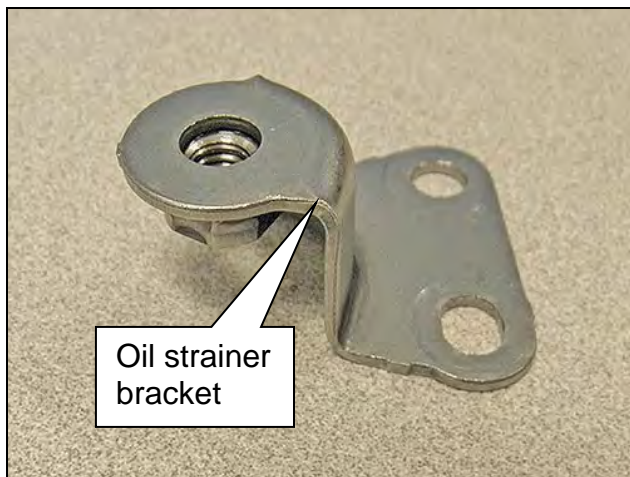
Figure 18

1. Discard the oil strainer bracket (Figure 18).
2. Install a new lip seal. Do NOT reuse the old lip seal (Figure 19).

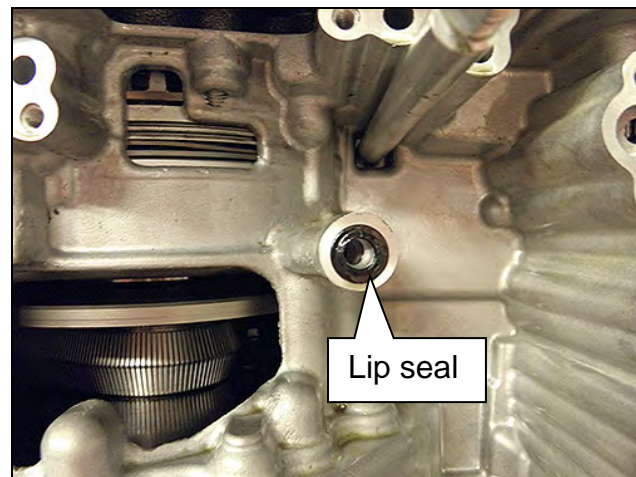
Figure 19

**NOTE:** Apply a small amount of petroleum jelly to the lip seal to keep it in place on the CVT.

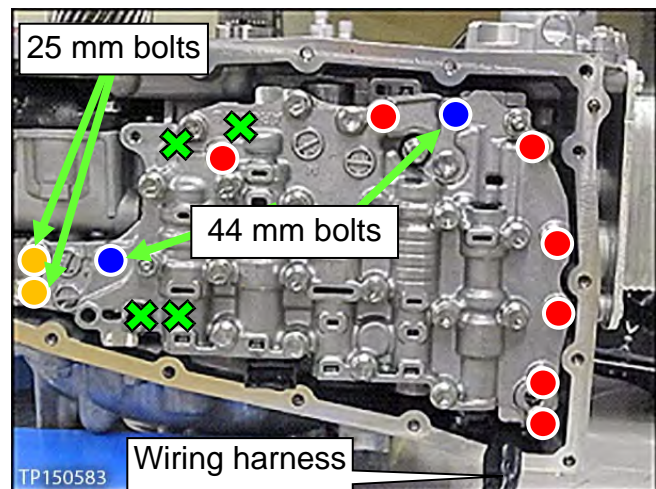
Figure 20

3. Install the Control Valve with nine (9) mounting bolts (Figure 20).

**IMPORTANT:** Leave Four (4)

bolt holes blank at this step.

- 54 mm long bolt   – 7 pieces
- 44 mm long bolt   – 2 piece
- 25 mm long bolt   – 2 piece

**CAUTION:** These two bolts are installed WITHOUT the strainer bracket.

- Bolt torque: 8.0 N•m (0.81 kg-m, **70.8 in-lb.**)

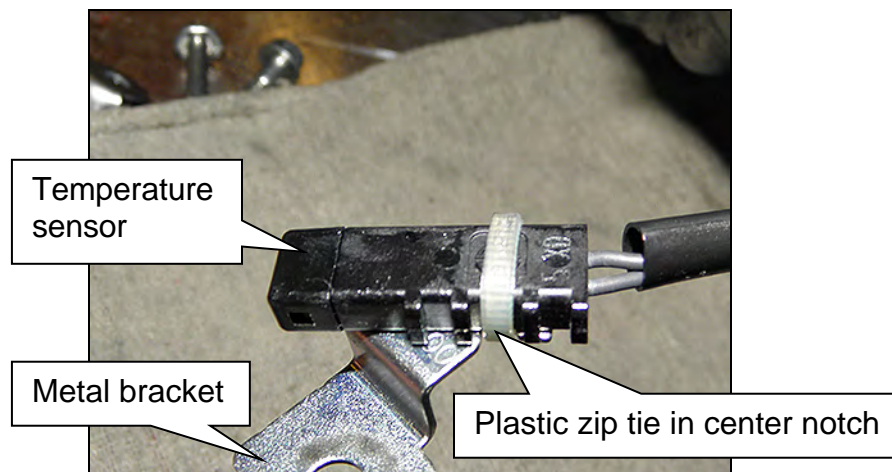
Figure 21

- a. Cut the plastic zip tie with an appropriate tool to remove the temperature sensor bracket from the terminal harness assembly. (Figure 21).

**CAUTION:** Cut the plastic zip tie over the metal bracket to avoid damage to the temperature sensor.

- b. Discard the removed bracket and plastic zip tie.
- c. Use the plastic zip tie from Parts Information to attach the new temperature sensor bracket to the temperature sensor of the terminal connector harness.

**IMPORTANT:** Locate the plastic zip tie at the **center notch** of three notches on the temperature sensor.

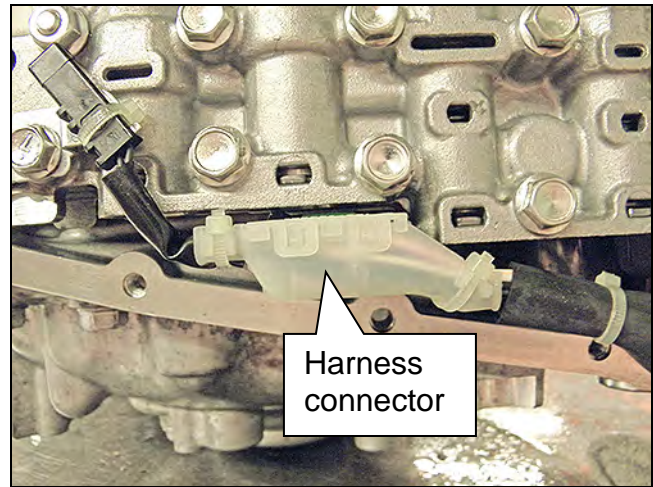
Figure 22

5. Connect the electrical harness connector (Figure 22).

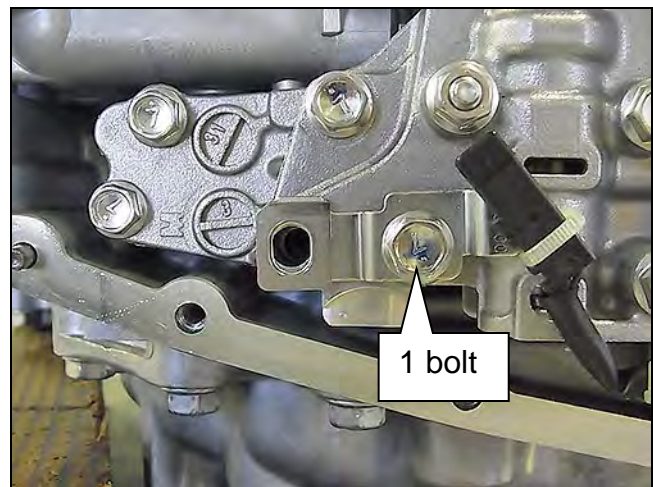
Figure 23

6. Install the CVT fluid temperature sensor bracket to the valve body with one (1) bolt (Figure 23).

**NOTE:** Leave one (1) bolt hole blank as it will be used to secure the oil strainer at a later step.

- Bolt torque: 8.0 N•m (0.81 kg-m, **70.8 in-lb.**)
- Bolt length: 54 mm

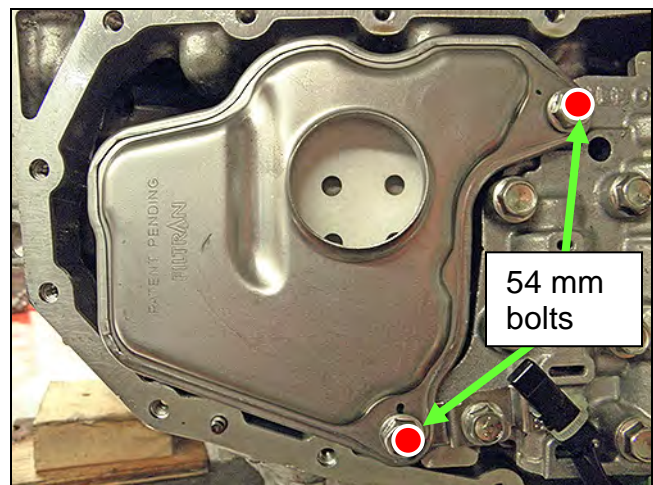
Figure 24

7. Install the new oil strainer with its new O-ring seal with two (2) bolts (Figure 24).

**NOTE:** replacement strainer maybe a different shape.

- Bolt torque: 8.0 N•m (0.81 kg-m, **70.8 in-lb.**)
- 54 mm long bolt

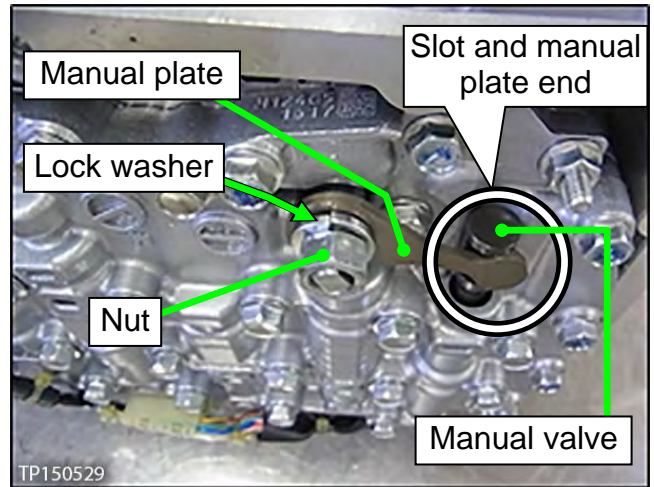
Figure 25

8. Install the manual plate, lock washer, and nut (Figure 25).

**NOTE:** Make sure the manual plate fits into the slot of the manual valve before applying torque to the nut.

- Reuse the existing manual plate, lock washer, and nut.
- Nut torque: 22.5 N•m (2.29 Kg-m, **16.6 ft-lb.**)

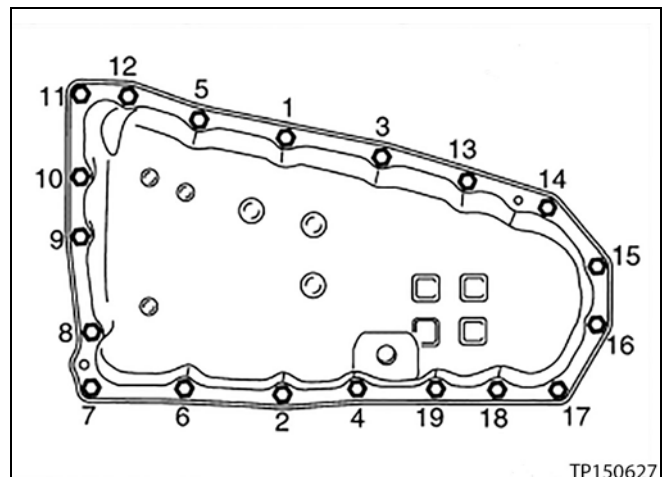
Figure 26

12. Install the oil pan bolts (see Figure 26).

- Reuse the existing pan bolts.
- Oil pan bolts torque: 8.0 N•m, (0.81 Kg-m, **70.8 in-lb.**)

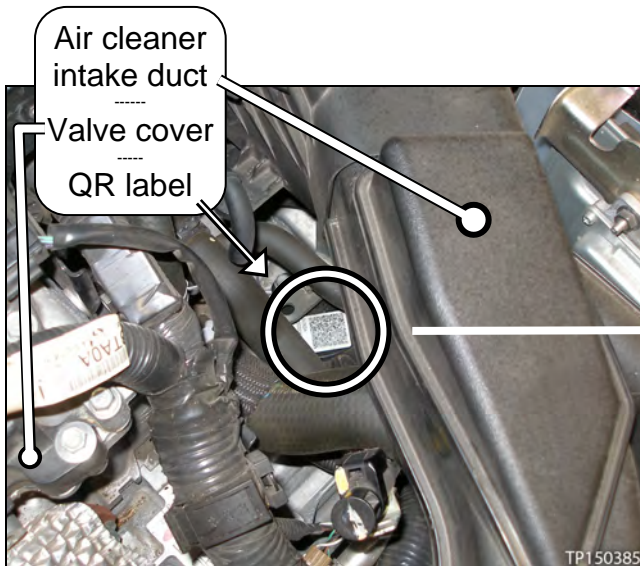
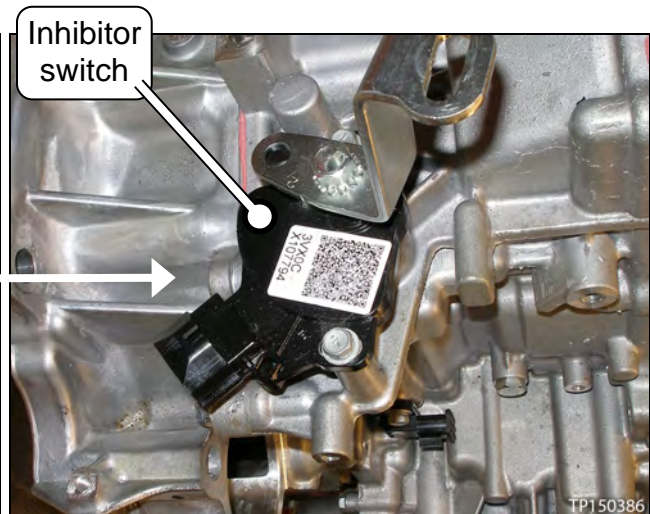
- Refer to **TM – Transaxle & Transmission / RE0F10D / BASIC INSPECTION**, and perform **ADDITIONAL SERVICE WHEN REPLACING TRANSAXLE ASSEMBLY**.
  - Check for fluid leakage.
  - Attach the QR label with the new calibration data onto the transmission range switch (inhibitor switch).
    - See Figure 27 and 28 below.
    - A QR Label and CD-R are included with the replacement valve body.
