SERVICE BULLETIN

Classification: ST15-008	Reference: NTB16-023	Date: March 8, 2016
------------------------------------	--------------------------------	-------------------------------

NISSAN; POWER STEERING NOISE HEARD INSIDE VEHICLE WITH WINDOWS CLOSED

APPLIED VEHICLES: 2013-2015 Altima (L33)
2013-2015 Pathfinder (L52)
2014 Pathfinder hybrid (L52)
2015 Murano (Z52)

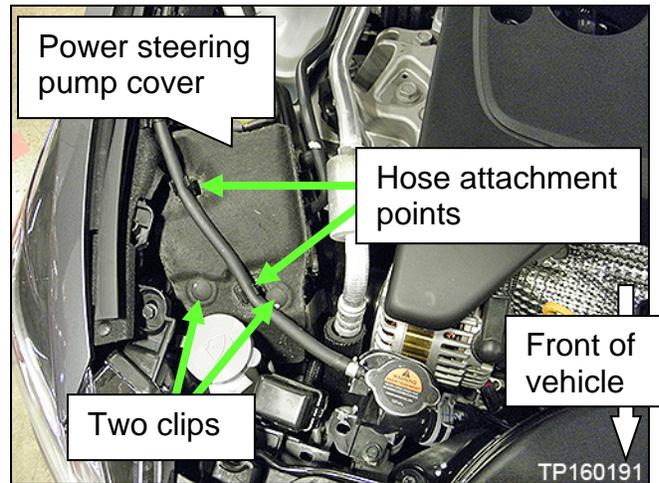
Figure 1

1. Remove the power steering pump cover (if equipped) to access the power steering pump motor housing.
 - Two hose attachment points and two clips.

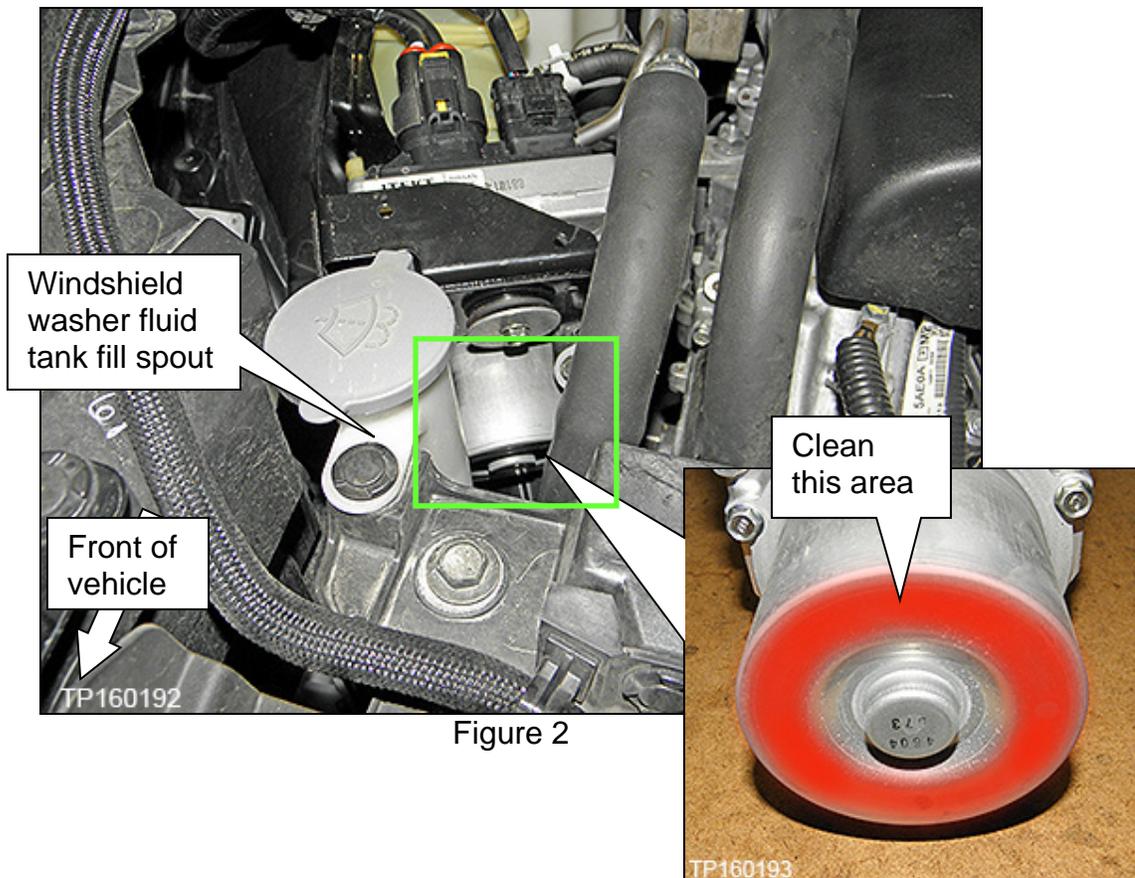
Figure 2

2. Clean the area where the adhesive will attach (Figure 2, and highlighted in red).
 - Use 50% isopropyl alcohol and water, and a clean cloth.

NOTE: Windshield washer fluid tank fill spout can be removed if additional access is necessary.

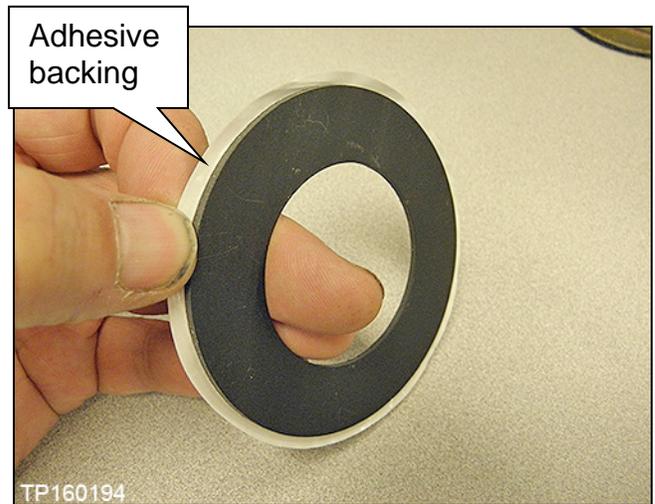
Figure 3

3. Remove the adhesive backing from the Insulator.

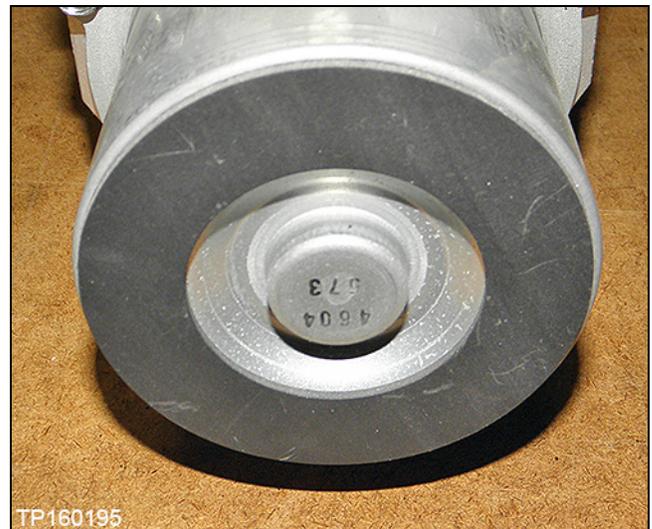
Figure 4

4. Attach the Insulator onto the end of the power steering pump motor housing (Figure 4).

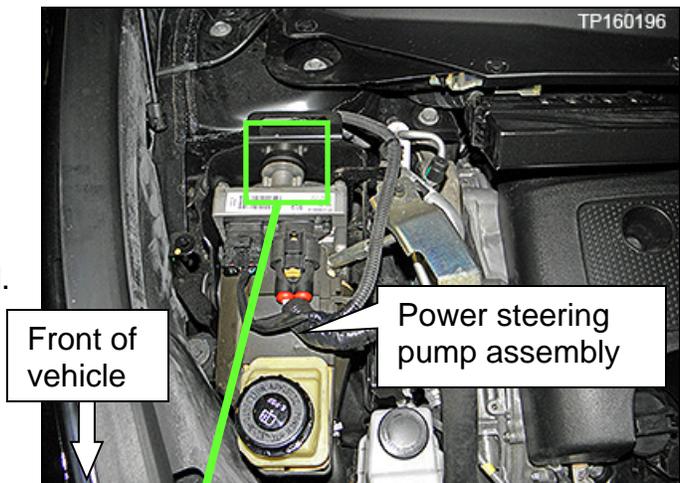
YES: Remove the cover over the power steering pump motor housing by lifting vertically to detach two integral clips.

NOTE: For hybrid only, Figure 5 shown with cover already removed.

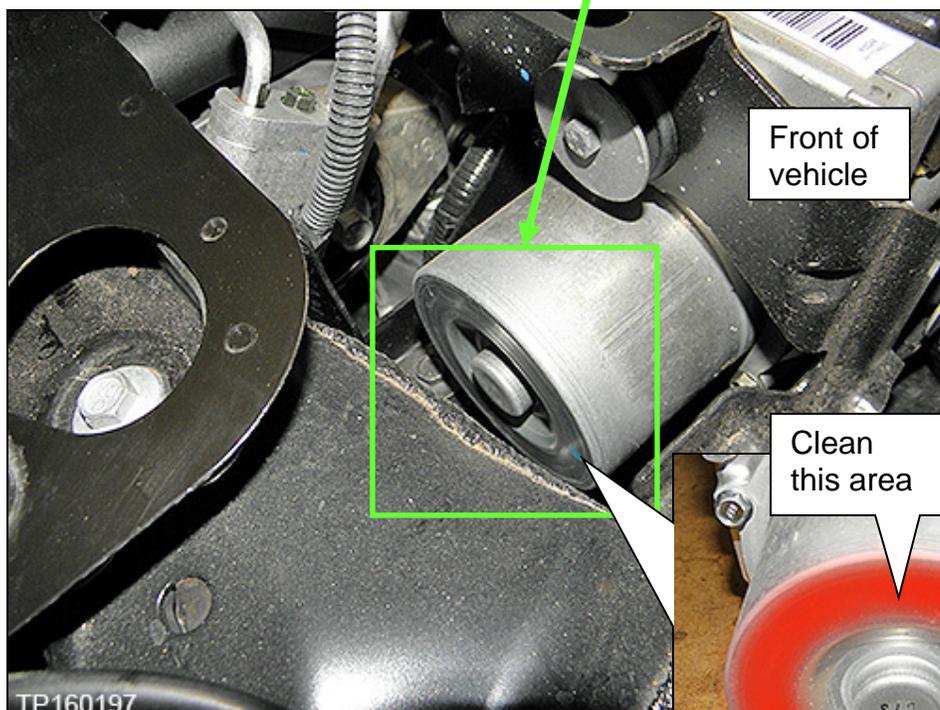
Figure 6

2. Clean the end of the power steering pump motor housing.

- Clean the area where the adhesive will attach (Figure 6, and highlighted in red).

NOTE: Use 50% isopropyl alcohol and water) and a clean cloth.

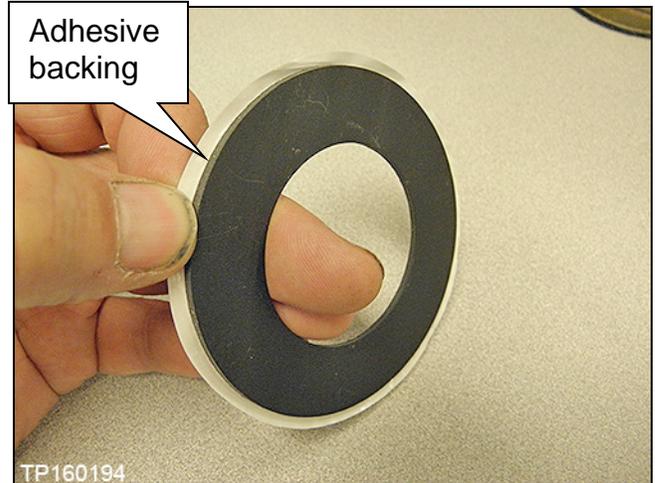
Figure 7

3. Remove the adhesive backing from the Insulator.

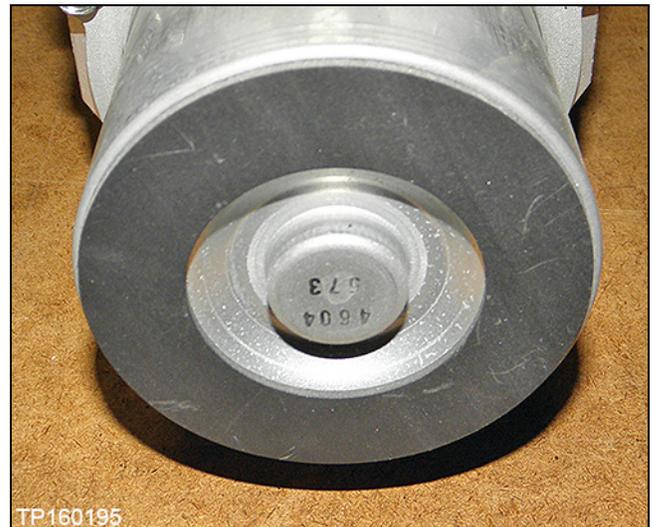
Figure 8

4. Attach the Insulator onto the end of the power steering pump motor housing (Figure 8).
