This article supersedes TSB **15-0079** to update the Part List.

ISSUE

Some 2009-2014 Escape, 2009-2011 Mariner, 2010-2014 Fusion, 2010-2011 Milan, 2012-2014 Edge/Explorer, and 2013-2014 Taurus/MKT/MKZ vehicles built on or before 10/14/2013 and equipped with a 6F35 automatic transmission may exhibit a fluid leak from the left hand (LH) transmission halfshaft seal due to wear on the transmission case bushing.

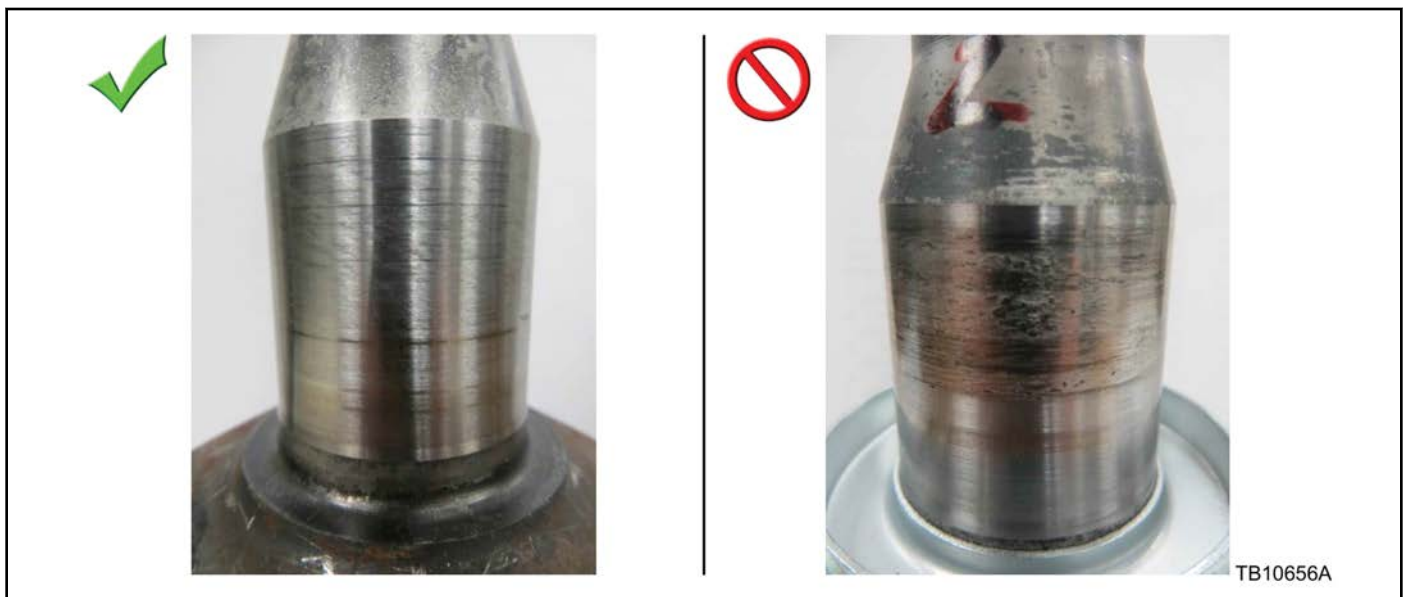
Figure 1 - Article 16-0043

1. Remove the LH halfshaft. Refer to Workshop Manual (WSM), Section 307-01.
2. Inspect the halfshaft journal surface finish. (Figure 1)

- a. If the journal does not have any metal transfer from the bushing, the halfshaft can be reused. Use the service kit that contains only the bushing and seal.
- b. If the journal surface finish has metal transfer from the bushing, replace the front halfshaft. Refer to WSM, Section 205-04.
 - (1) The replacement bushing with the red Teflon® coating on the inside diameter of the bushing allows for the reuse of the original halfshaft if the halfshaft journal does not have any metal transfer from the original bushing.

3. Replace the transmission case bushing. Refer to WSM, Section 307-01.

- 1. Remove the LH halfshaft. Refer to WSM, Section 307-01.
- 2. Inspect the halfshaft journal surface finish. (Figure 1)
 - a. If the journal surface does not have any metal transfer from the bushing, the constant velocity (CV) joint can be reused. Use the service kit that contains only the bushing and seal.
 - b. If journal surface finish has metal transfer from the bushing, replace the inner CV joint housing. Refer to WSM, Section 205-04.
- 3. Replace the transmission case bushing. Refer to WSM, Section 307-01.
