## Pushout Window Latch Switch Screw Adjustment

# UPDATE

**Models Affected:** All 2015 Model Year and Newer Buses with Pushout Sash Windows.

S U 1 6 0 2

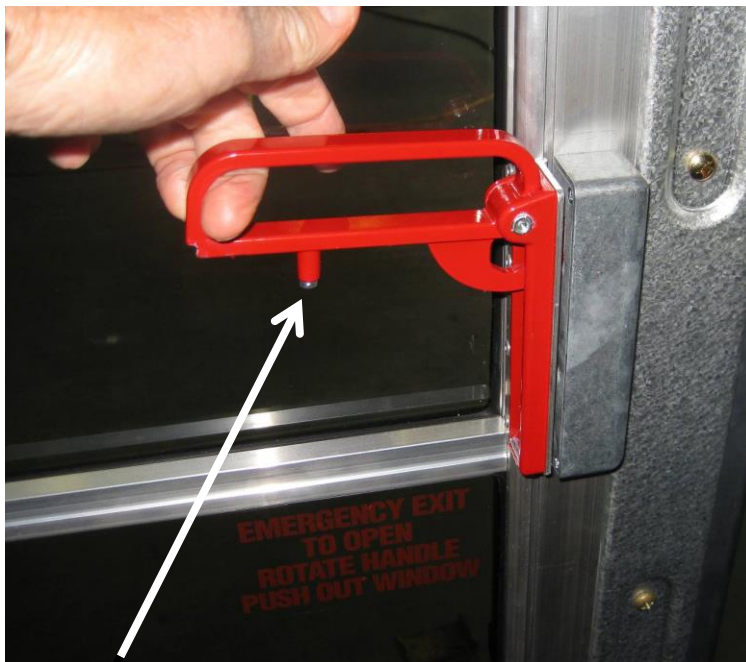
Adjustment is in the handle, see adjustment procedure on attached page

The Lippert Push-Out Window was designed with an adjustment feature in the latch to overcome any slight variations that may occur during window installation or settling. Every Push-Out window is tested for continuity at the factory prior to shipment.

If the variation is enough to cause the latch not to engage the alarm switch a simple adjustment of the screw can correct the issue.

Lift the Push-Out Latch Handle to reveal the Hex. Head Adjustment Screw.

With a wrench turn the screw counter-clockwise to adjust the screw out until it properly engages the alarm switch when the handle is closed. Adjust in one-half turn increments, closing the latch handle to check continuity. Note that the screw has a lock patch to keep it in position after adjustment.

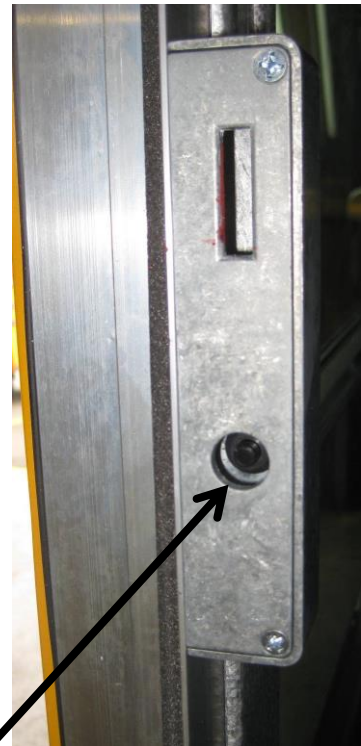
Switch is not adjustable
