Technical Service Bulletin

SUBJECT:		No: TSB-16-52A-001	
FRONT SEAT SLIDE RAILS – LOCK POSITION TIMING NOT SYNCHRONIZED		DATE: February, 2016	
		MODEL: 2014–15 Mirage	
CIRCULATE TO:	<input type="checkbox"/> GENERAL MANAGER	<input checked="" type="checkbox"/> PARTS MANAGER	<input checked="" type="checkbox"/> TECHNICIAN
<input checked="" type="checkbox"/> SERVICE ADVISOR	<input checked="" type="checkbox"/> SERVICE MANAGER	<input checked="" type="checkbox"/> WARRANTY PROCESSOR	<input type="checkbox"/> SALES MANAGER

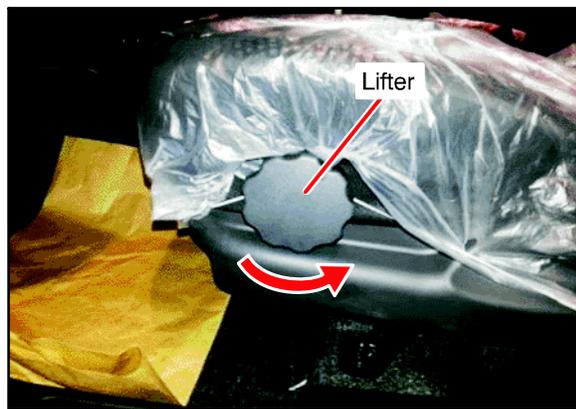
1. With height adjuster:
Adjust the height of the seat cushion to the highest position by turning the lifter counterclockwise.

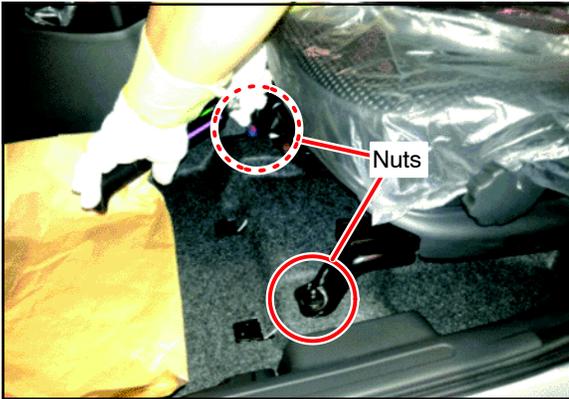
2. Slide the seat to its rearmost position.
3. Loosen the inner and outer nuts at the front of both seat rails.

NOTE: Do not completely remove the nuts. Keep 2–3 threads engaged to prevent the seat from rocking backward.

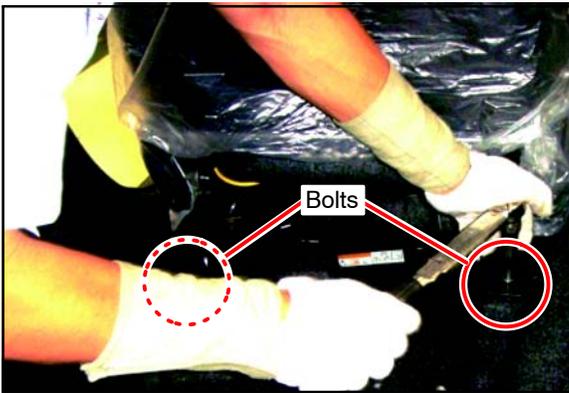
4. Slide the seat to its forwardmost position.
5. Loosen the inner and outer bolts at the rear of both seat rails.

NOTE: Do not completely remove the bolts. Keep 2–3 threads engaged to prevent the seat from rocking backward.

6. Slide the seat forward and backward by hand to confirm that the seat rails operate smoothly.

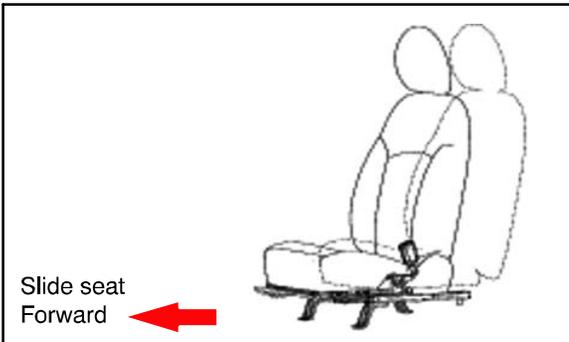
7. Slide the seat forward to its forwardmost position.
8. Securely lock the inner and outer rails into position, then securely tighten the bolts to the proper torque listed below.

Torque: 43 ± 8 N-m (32 ± 5 ft-lb)

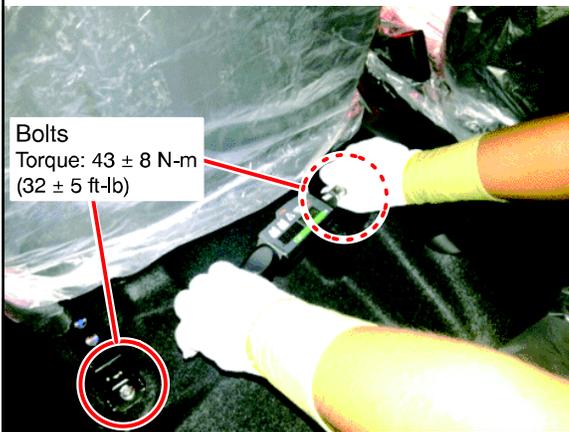
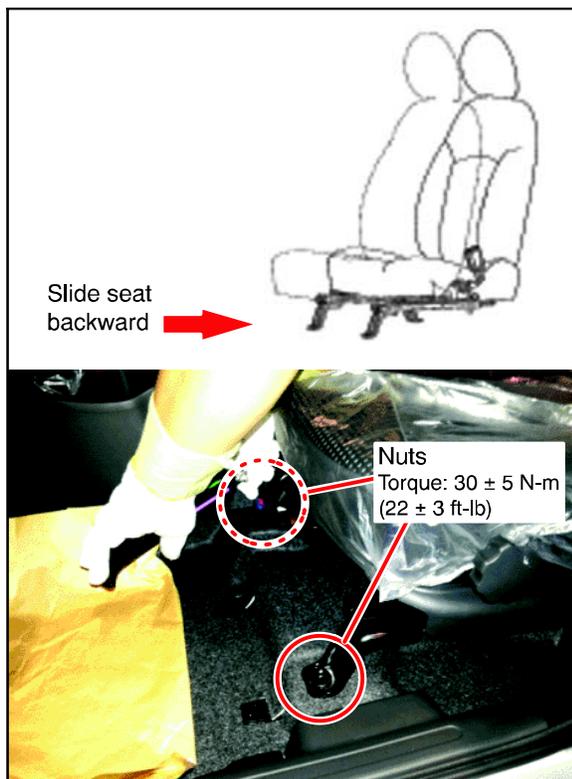
9. Slide the seat backward to its rearmost position.
10. Securely lock the inner and outer rails into position, then securely tighten the nuts to the proper torque listed below.

Torque: 30 ± 5 N-m (22 ± 3 ft-lb)

Verify that the bolts and nuts are tightened securely to the correct tightening torque.

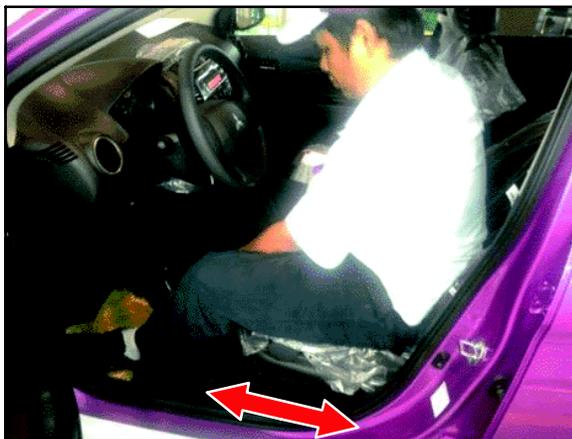
11. Check the electrical connectors under the seat bottom assembly to ensure that none of the connectors became dislocated or disconnected during the previous steps.

Make sure that all connectors under the seat are NOT damaged, and are connected securely if they were accidentally disconnected.

12. Confirm that the slide adjuster operates smoothly and verify the lock position timing is synchronized.
13. Start the engine and confirm NO airbag or other warning lights are illuminated.
