Service Bulletin

Bulletin No.: 16-NA-049

Subject: Clicking Noise Near Brake Pedal, Hard Brake Pedal, White Tie Strap on Brake Pedal Assembly and/or Possible DTCs C058A, P2299 or P05E0 Set

| Brand: | Model: | Model Year: | | VIN: | | Engine: | Transmission: |
|---|---|---|---|---|---|---|---|
| Chevrolet | Volt | 2016 | 2017 | | | All | All |

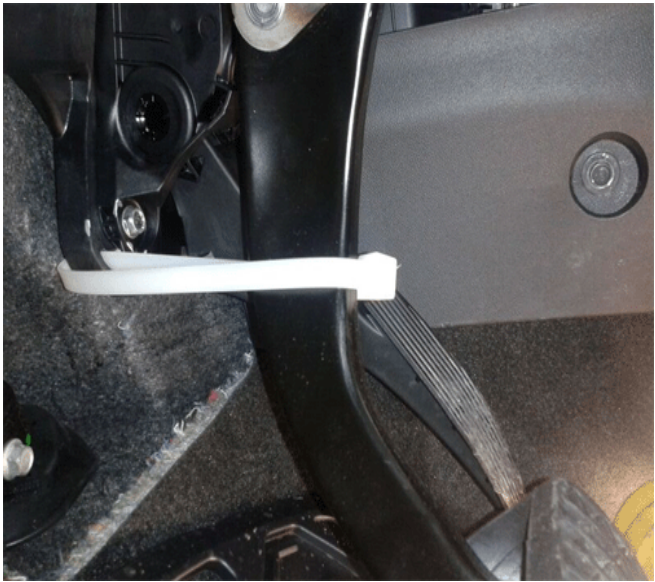
| | <p style="font-size: small;">4418521</p> <p>Some customers may comment on a white tie strap around the brake pedal assembly, clicking noise near the brake pedal, hard brake pedal or brake light on. During diagnosis a technician may find DTCs C058A, P2299 or P05E0 set.</p> |
| Cause | The assembly plant may have left a temporary tie strap on the brake pedal assembly during the assembly process. |

If you encounter a vehicle with the above concern, check to see if the temporary tie strap was left on the brake pedal assembly, if so cut and discard the tie strap.

If there is a code set, be sure the code is not current and refer to SI for further diagnosis.
