Campaign Service

BULLETIN NUMBER:
CB16-E-001

CUSTOMER SATISFACTION CAMPAIGN

FRONT WHEEL BEARING MAINTENANCE

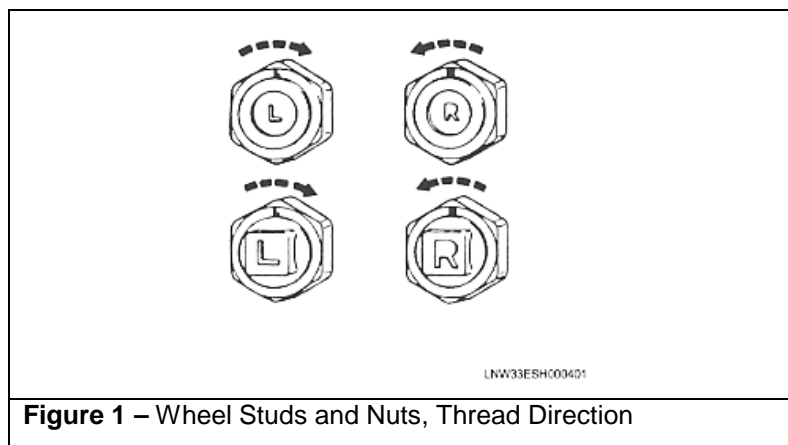
NOTE: The wheel studs and nuts on right side have right-hand threads, while wheel nuts on the left side have left-hand threads. See Figure 1.

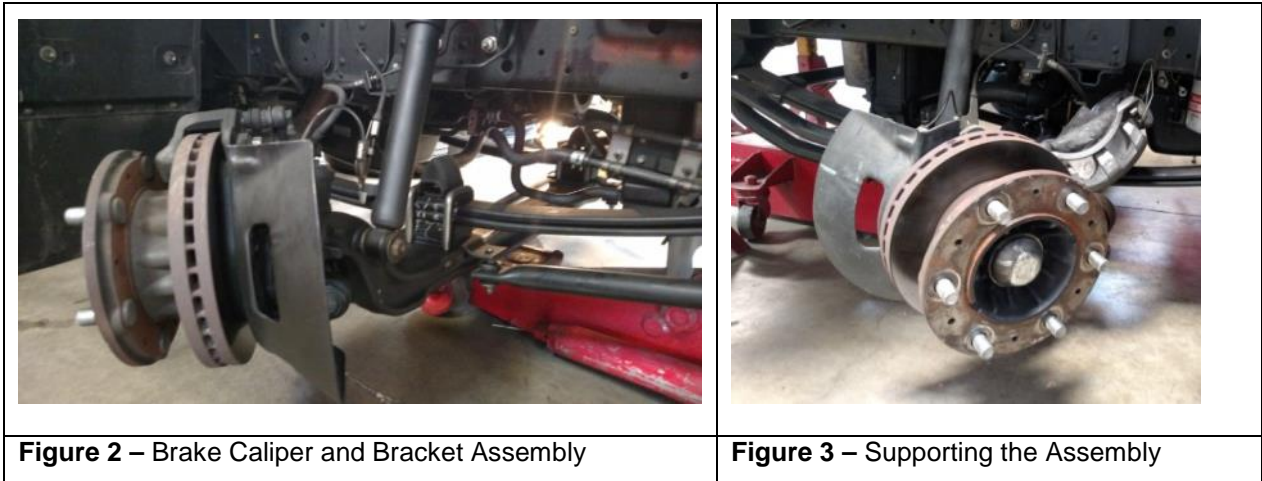
5. Remove the wheel and tire assembly.
6. Tilt up the cab.
7. Remove the brake caliper and dust cover as an assembly by unbolting the caliper mounting dust cover. Hang the brake assembly with heavy gauge wire to support the assembly. See Figures 2 and 3.

IMPORTANT: Be careful not to place tension or weight on the brake lines. This can cause damage to the brake system's soft and/or hard lines leading to brake system failure.

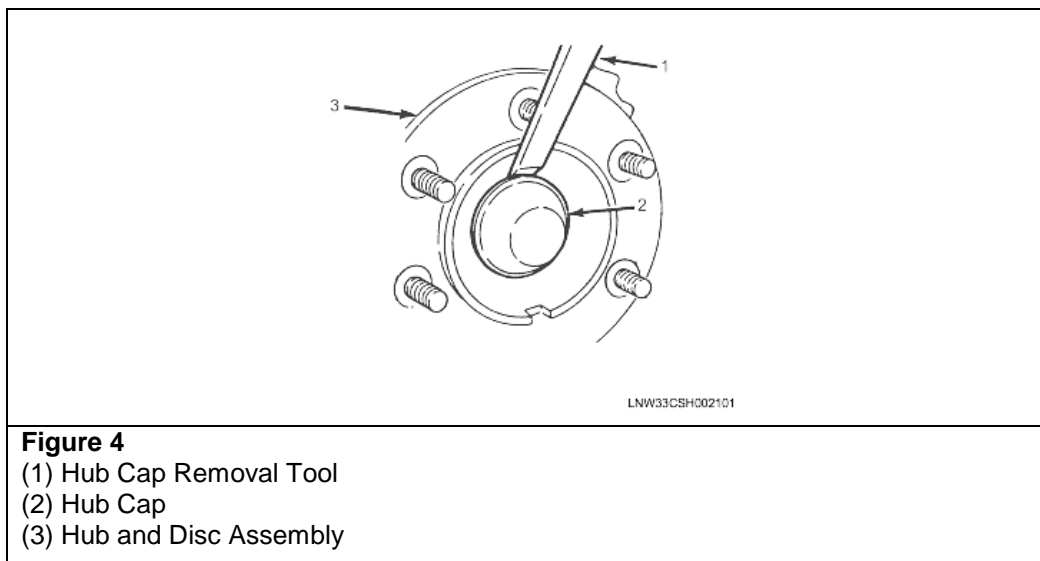
8. Remove the hub cap as shown in Figure 4.

IMPORTANT: Be careful not to scratch or distort the cap sealing face when removing the hub cap.

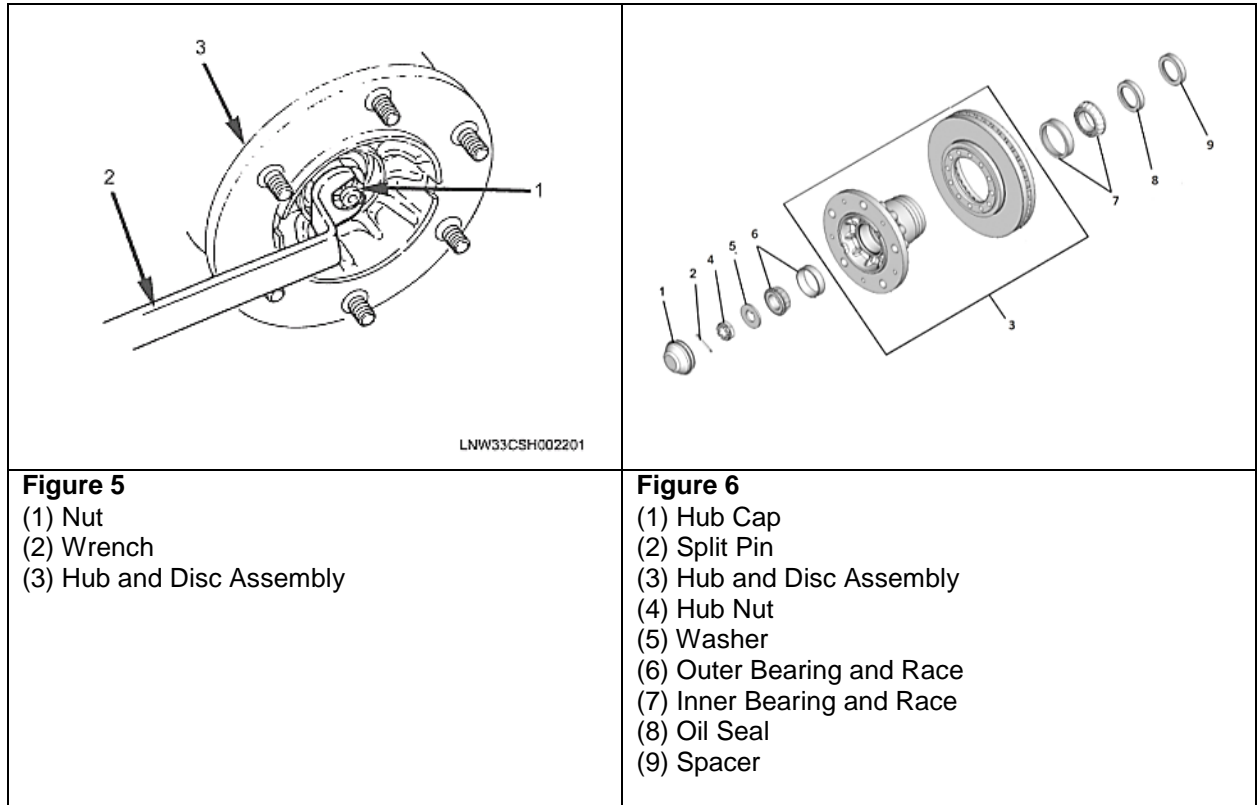
10. Remove the nut and washer from the knuckle. See Figures 5 and 6.

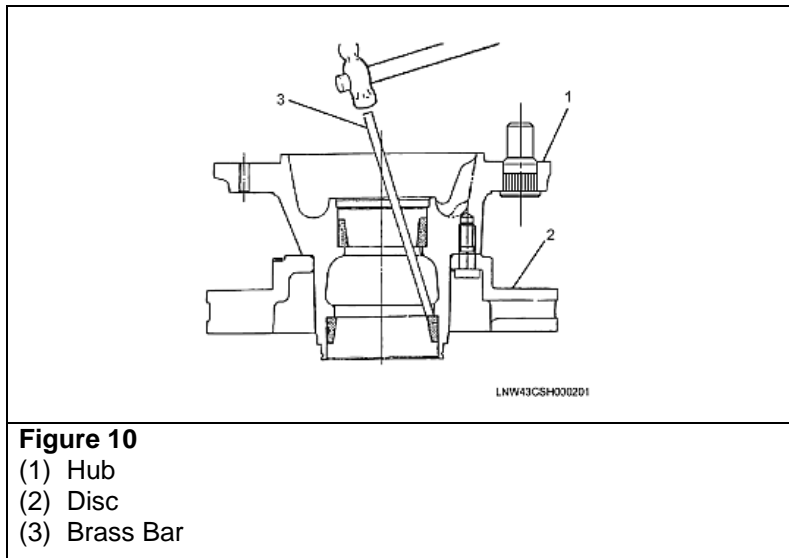
1. Remove the damaged bearing to be replaced, by driving the inner and outer bearing races out of the hub.
2. Drive the outer race out from the opposite side. See Figure 10.

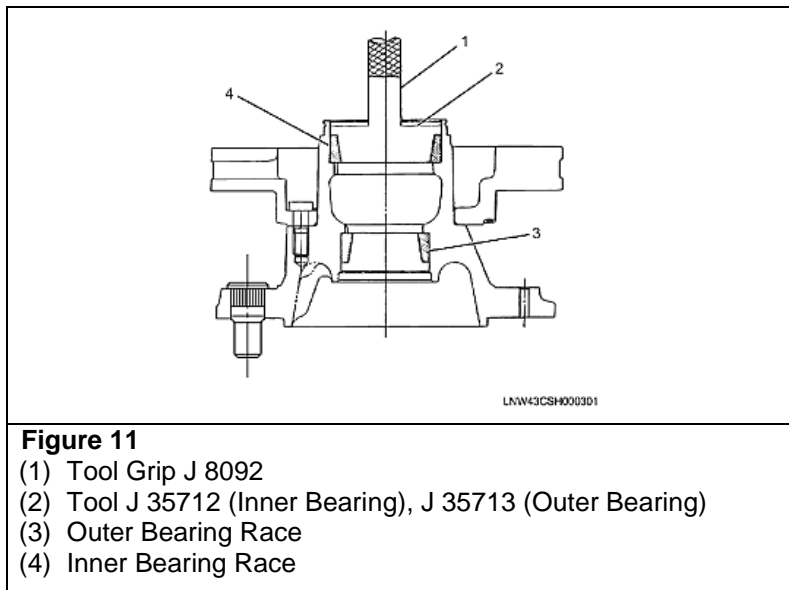
3. Lightly grease the new bearing races, using Special Tools: J 8092 (Tool Grip), J 35712 (for inner bearing) and J 35713 (for outer bearing); seating them completely into the hub. See Figure 11.

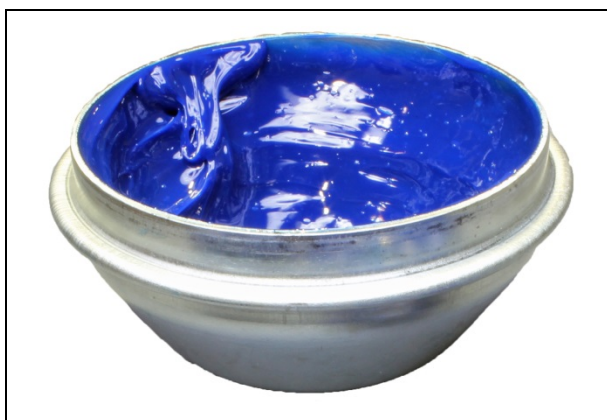
1. Apply a 5mm layer of grease across the top of the bearing races and completely fill the hub cavity, and completely grease the inner race of the inner bearing (See Figure 15). Fill the hub cap half way with grease and taper to the edge of cap. Overfilling cap will create a hydraulic condition not allowing the hub cap to fully seat. See Figures 12 and 13.

Figure 12 – Grease Hub Cap

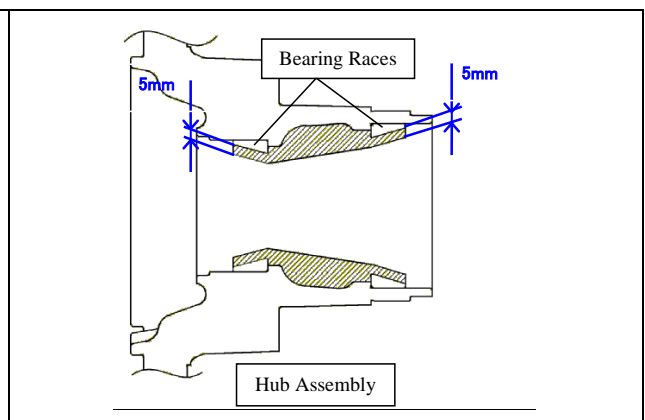
Figure 13 – Grease in the hub must make contact with the inner and outer races and create a 5mm wall thickness.

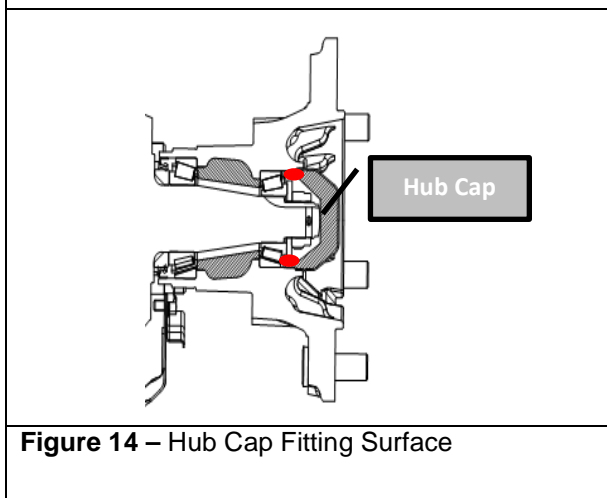
CAUTION: Do not apply grease on fitting surface between the hub cap and hub assembly. See Figure 14.

Figure 14 – Hub Cap Fitting Surface

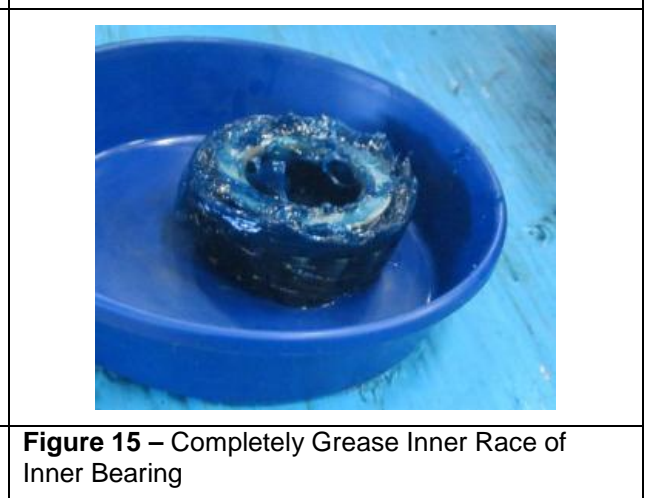
Figure 15 – Completely Grease Inner Race of Inner Bearing

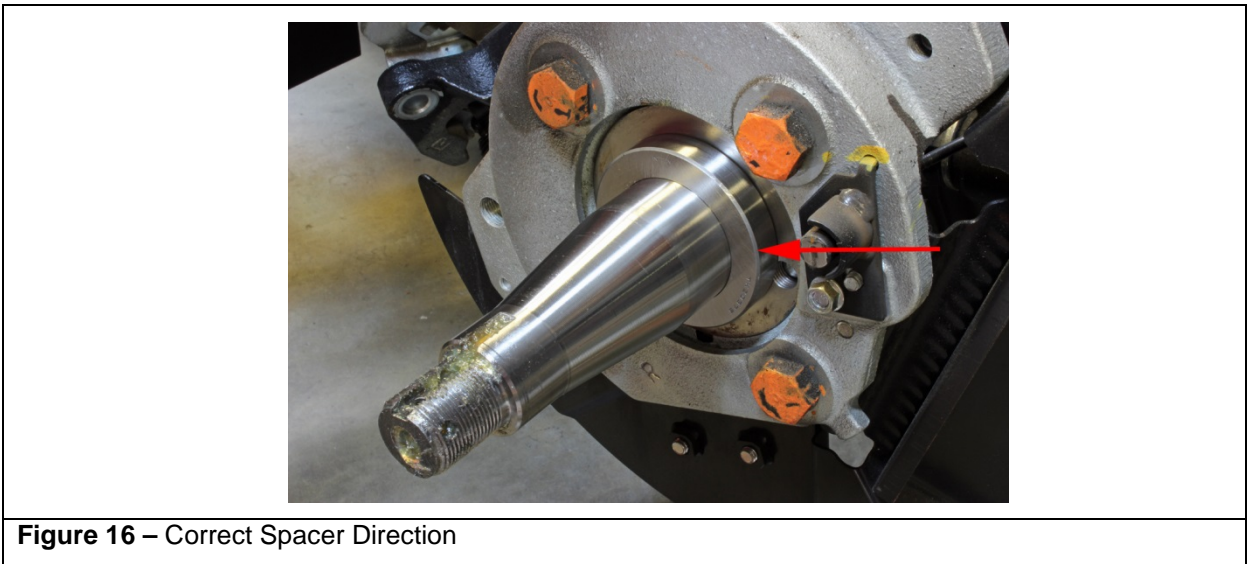
3. Install the inner bearing with a new oil seal with the hollow side of the oil seal facing the bearing.

4. Install the spacer onto the knuckle; the concave side of the spacer faces the knuckle.

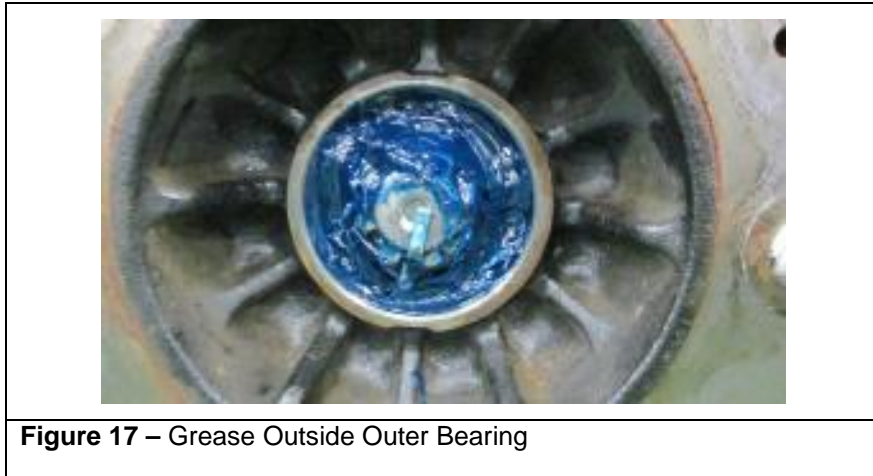
14. Apply grease on the outside of the outer bearing (See Figure 17).

IMPORTANT: Be sure the grease inside the hub cap directly contacts the grease on the outer bearing.

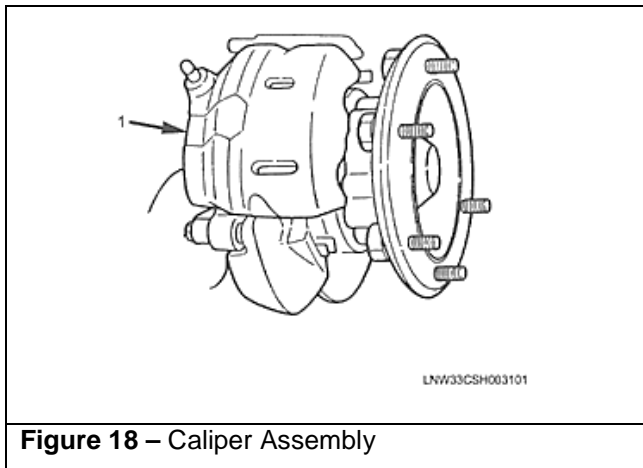
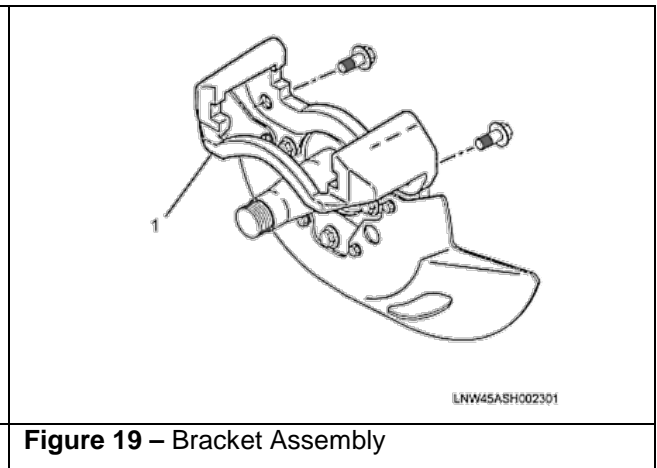
17. Return the brake caliper and bracket assembly to its original position (see Figures 18 and 19). Tighten the caliper mounting bracket bolts to the specified torque.

Tightening Torque: 221 Nm (163 lb ft)

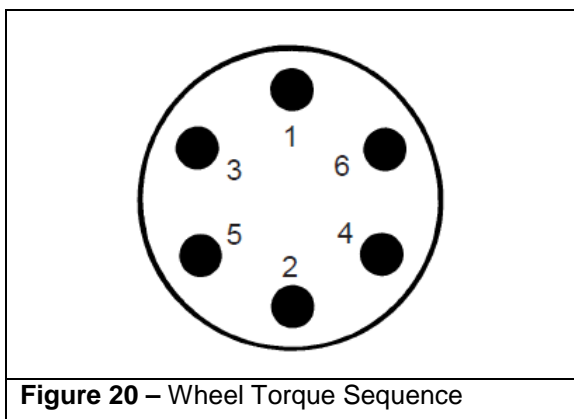
21. Torque wheel nuts in the sequence shown. See Figure 20.

Tightening Torque: 500 Nm (369 lb ft).
