**Freightliner
Service Bulletin**

On some Cascadia vehicles, water may intrude into the cab through the marker light seals. If a leak is detected at a marker light, use the procedure in this bulletin to repair the leak.

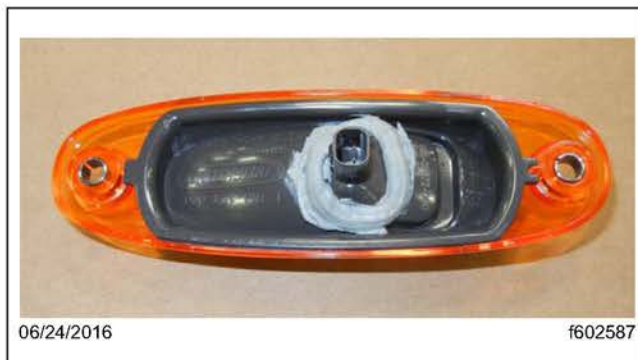
Fig. 1, Applying Sealant to Marker Light

4. Using soapy water, clean the surfaces the sealant will contact.
5. Make sure the cleaned surfaces are dry, then apply Sikaflex-221 sealant to the marker light as shown in [Fig. 1](#).
6. Install the gasket on the marker light.
7. Apply Sikaflex-221 sealant to the gasket as shown in [Fig. 2](#).
8. Install the marker light.

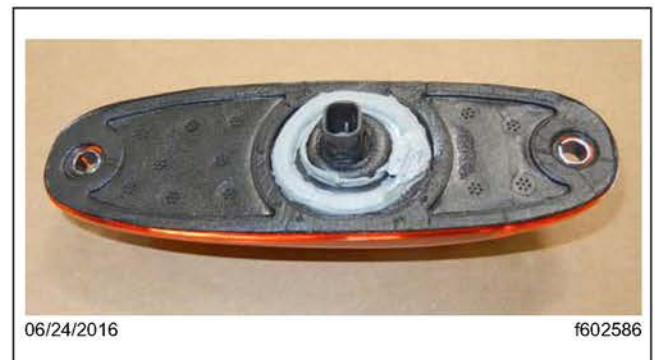
Fig. 2, Applying Sealant to Gasket
