HYUNDAI NEW THINKING. NEW POSSIBILITIES.	GROUP CAMPAIGN	NUMBER 16-01-034-2
	DATE AUGUST 2016	MODEL ELANTRA (AD/ADa)
Technical Service Bulletin		
SUBJECT:	ENGINE THERMOSTAT REPLACEMENT P0128 (SERVICE CAMPAIGN TLL)

Description: This bulletin provides a procedure for replacing the thermostat on certain 2017 Elantra vehicles. The thermostat may function improperly and may result in Diagnostic Trouble Code P0128. Replacement of thermostat is required even without a P0128 code.

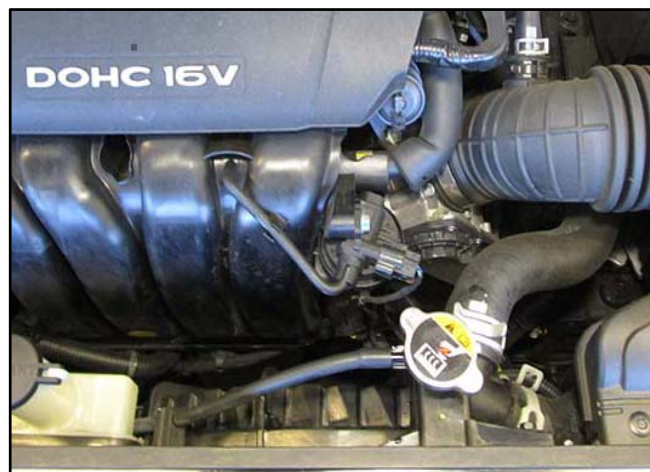
1. Open the hood and loosen the radiator cap.

**CAUTION**

DO NOT open the cap when the engine is hot.

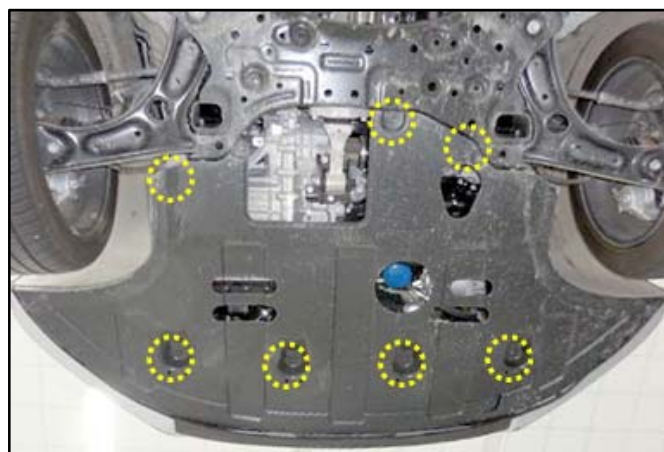
2. Lift the vehicle on a hoist.

Use a 10mm socket and ratchet to remove 7 bolts as shown.

Use a trim tab or similar tool to remove 12 plastic fittings and remove the undercover.

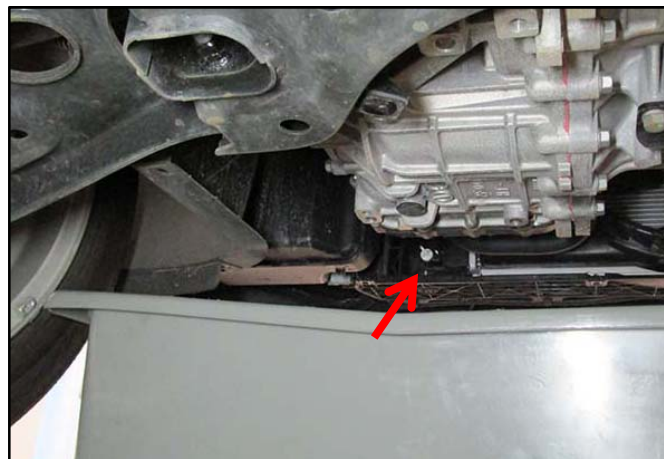
3. Place a **clean container** under the radiator.

Use pliers to loosen the plastic drain plug for the radiator and drain approximately 1/2 gallon of coolant.

Tighten the plug.

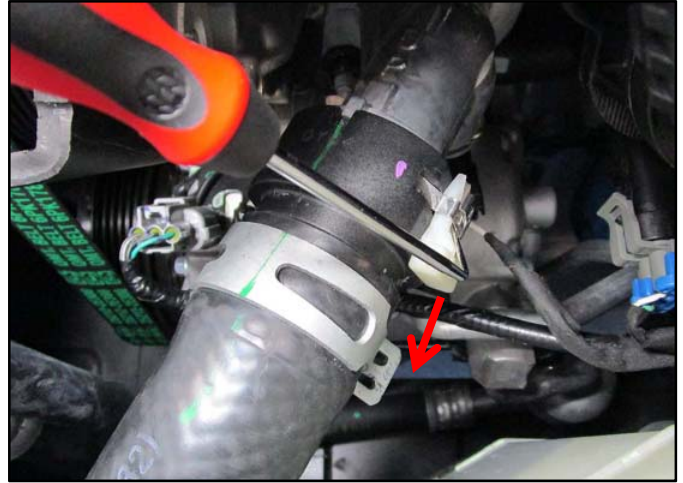
5. Locate the lower radiator hose with integral quick disconnect under the alternator.

For vehicles with a white retainer:

Insert a 90° pick or similar tool under the silver tab. Gently rotate the pick clockwise and lift the silver tab up. Pull the white retainer out of the tab.

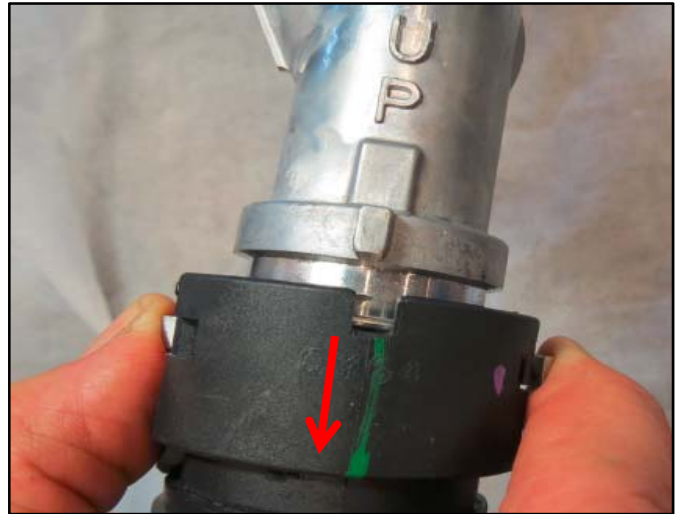
6. Press the tabs on the left and right sides of the quick disconnect and pull the radiator hose from the thermostat.

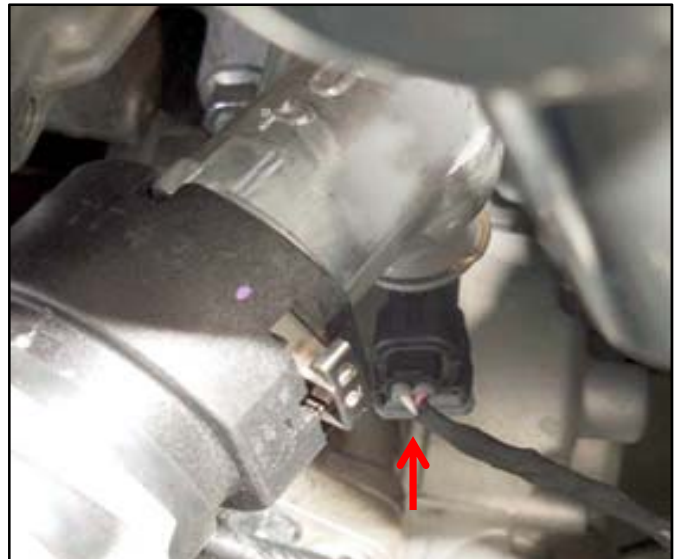
7. Press the tab on the bottom side of the coolant temperature sensor connector and disconnect the connector.

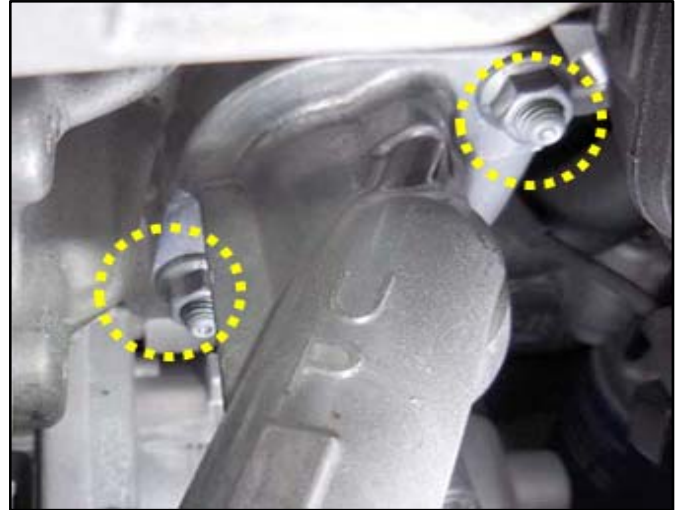
8. Use a 12mm socket and ratchet to remove the nuts for the thermostat and remove the thermostat.

Install the new thermostat and tighten the nuts to the specified torque.

Tightening torque:

15~18 lb-ft (2.0~2.5 kgf.m, 2.0~24 Nm)

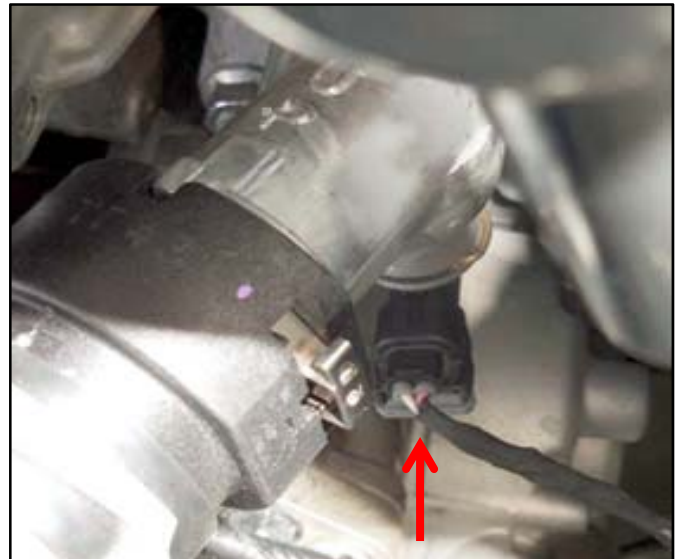
9. Reconnect the coolant temperature sensor connector.

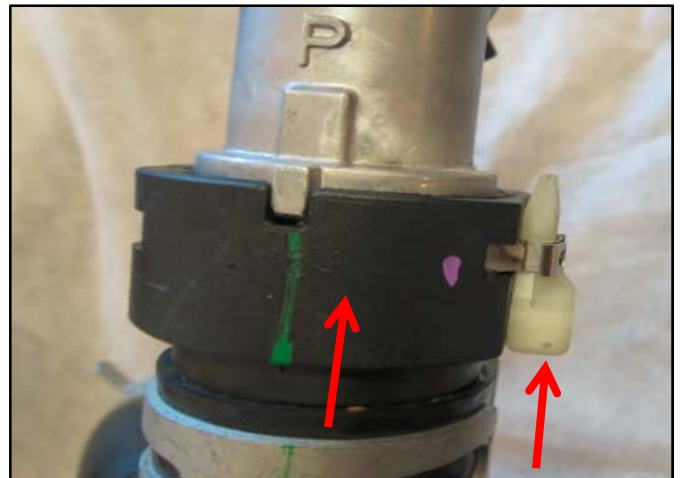
10. Reinstall the radiator hose to the thermostat. Push firmly until a click is heard from the quick disconnect.

Insert the white retainer into the tab.

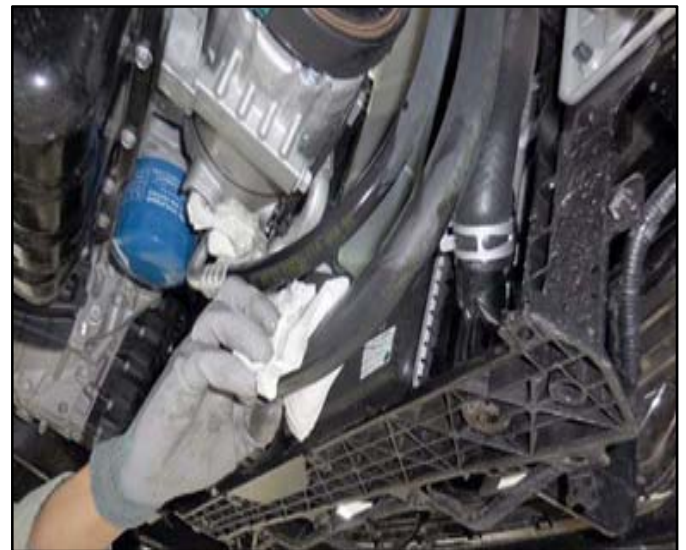
14. Clean any coolant residue under the engine.

Check for leaks from the thermostat.

Reinstall the undercover.

Tightening torque:

3~4 lb-ft, 0.4~0.6 kgf.m, 4~6 N.m
