# Technical Service Bulletin

## 10 Oil leak between engine and gearbox

10 16 13 2044546/1 June 14, 2016.

Model(s)	Year	VIN Range	Vehicle-Specific Equipment
A6, A7, A8, Q5, Q7	2013 - 2016	All	TDI engine

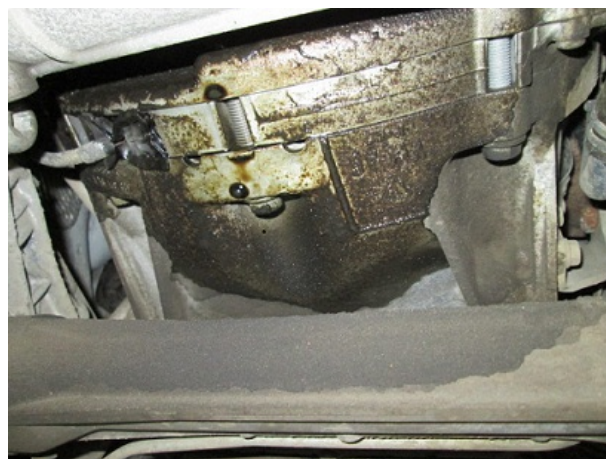
Evidence of oil loss, leaks, or drips on underbody (Figure 1). Evidence of oil loss may appear in any of the following areas:

- Side on upper oil sump in area of long bolts.
- Sealing flange securing bolts to upper oil sump.
- Thread in crankshaft to attachment of drive plate/flywheel.
- Oil seal of crankshaft (gearbox side) leaks.

*Figure 1. Underbody without undertray showing evidence of oil loss.*

The evidence of oil loss is due to engine oil leaks between engine and gearbox.

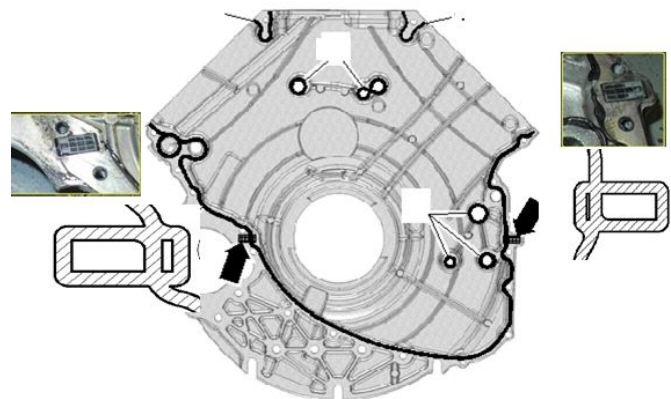
**Figure 4.** Rubber seals (black outlines). New sealant track (hatched area).

- If oil loss marks are visible on the lateral long bolts and between the sealing surface of the upper oil sump to the cylinder block (Figure 2, B):
  - The upper oil sump must be sealed again.
- If oil loss marks are visible only on the sealing flange (Figure 2, A and C) (Figure 3, D):
  - The sealing flange must be sealed.
  - This leak is caused when oil leaks from the illustrated areas (Figure 2, A and C) (Figure 3, D) over the rubber seals (Figure 4). The oil seeps from position C, over the parting line to position A and D.
  - Note that there is an optimized sealant track in the area of the rubber seals (Figure 4, hatched area).

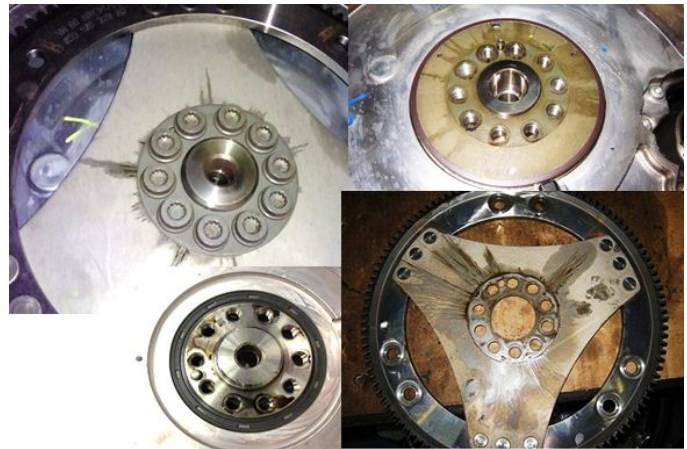
**Figure 5.** Fix the new securing bolts as shown.

- If oil loss marks are visible in the area of the securing bolts when the drive plate/flywheel is removed:
  - Install new securing bolts as shown (Figure 5). Note that replacing the oil seal will not fix this problem.
  - Clean the threads in the crankshaft flange so that they are completely free of grease. Loctite 7061 (which is commercially available) can be used to clean the threads.
  - Seal the new securing bolts for the drive plate/two-mass flywheel (Figure 6), on the crankshaft flange with Loctite 648 (part number D 154100A1, or commercially available). The area marked in red (Figure 6) must be cleaned and be completely free of grease. Apply the Loctite 648 completely around on approximately five thread turns behind the existing solid sealer on the new securing bolts for the drive plate/flywheel.

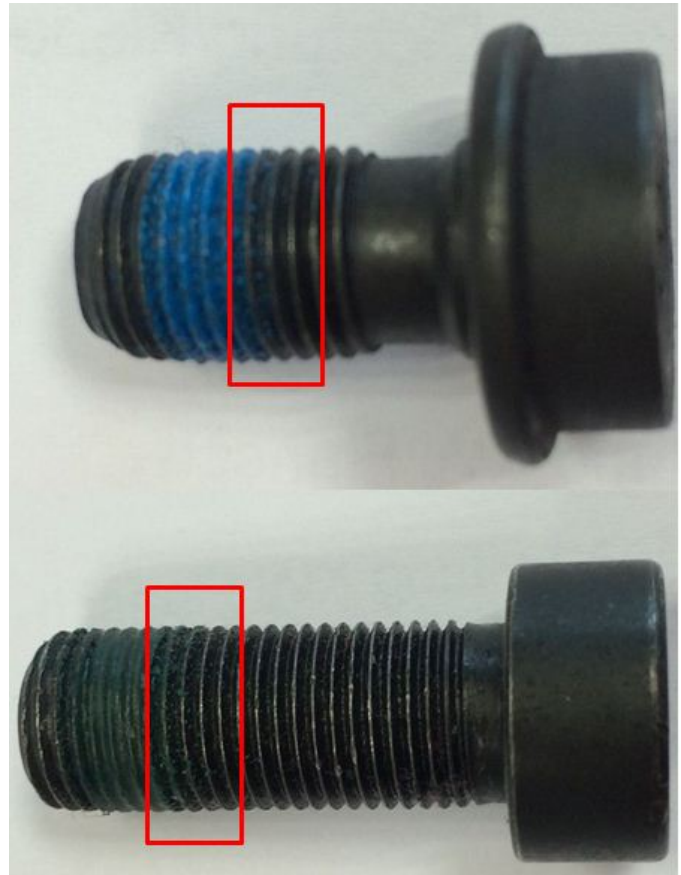
**Figure 6.** New securing bolts for the drive plate/two-mass flywheel (short bolt part number: N 90539801, long bolt part number: N 90929401 (M10x1x27))

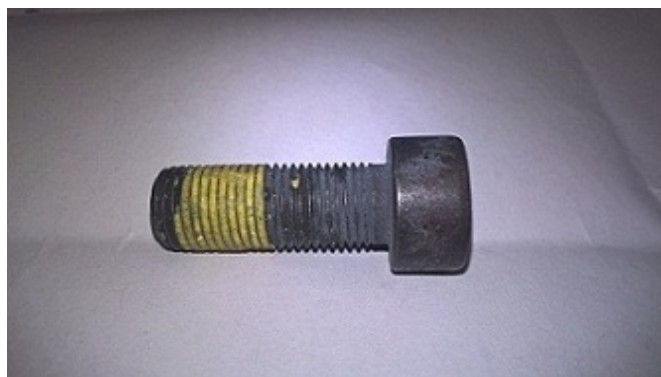
**Figure 7.** New generation bolt (part number WHT007991 (M10x1x27))

- For new generation bolts with microencapsulation (from December 2015), proceed according to the repair manual when removing/replacing this bolt. Observe the cleaning guidelines for the threaded hole in the crankshaft.
- The bolts must be tightened with a hand ratchet wrench, as the speed of a pneumatic impact wrench is too high and the sealant will not correctly cover the threads. Torque the bolts down to specification according to repair manual.
- If the oil loss marks clearly show that the oil passes over the sealing lips:
  - Replace the oil seal.
