## Third Row Seat Installation

<b>Classification</b>	Parts and Accessories Bulletin	<b>Section/Group</b>	13 - Seats	<b>Country/Region</b>	North America, Europe, Japan
<b>Year</b>	All	<b>Model</b>	Model S	<b>Version</b>	All

This Service Bulletin contains installation instructions for the optional third row seat. Included in this procedure are steps to add the rear crossmember (if needed), remove and modify existing trim panels, install hardware, add the 2<sup>nd</sup> row seatback bezel, and adjust the latch assembly.

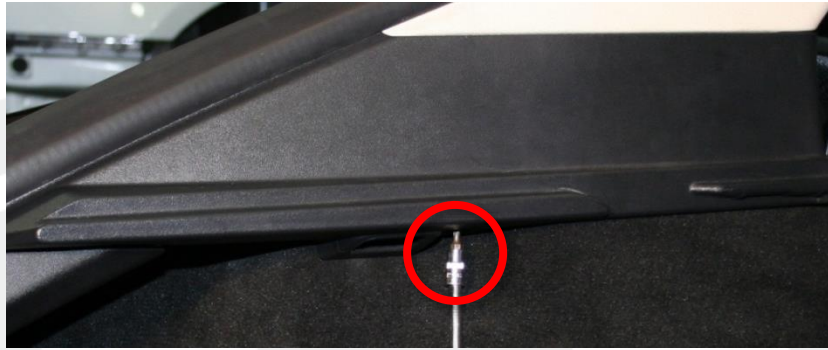
Figure 1

1. Remove the rear trunk load floor.
2. Remove the screw that secures the RH C-pillar rear trim panel. Unfasten the trim clips and remove the panel.
3. Remove the screw that secures the LH C-pillar rear trim panel (Figure 1). Carefully unclip and remove the panel enough to see the liftgate switch wiring harness connector. Release the connector by hand.

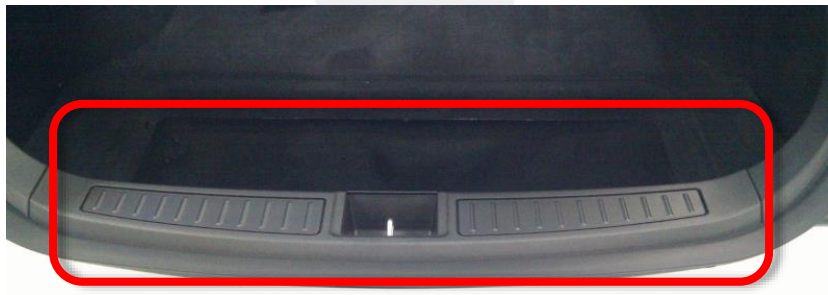
Figure 2

4. Disengage the four trim clips that secure the trunk sill panel and remove it (Figure 2).

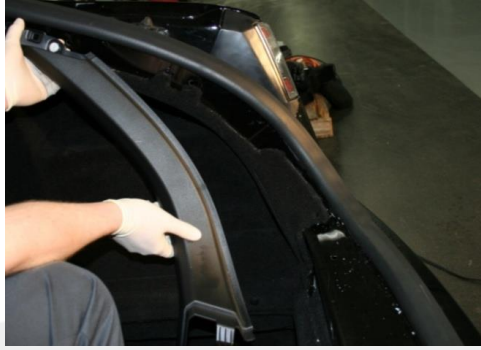
Figure 3 (RH shown, LH similar)

5. Remove the LH and RH trunk side trim panel covers (Figure 3).

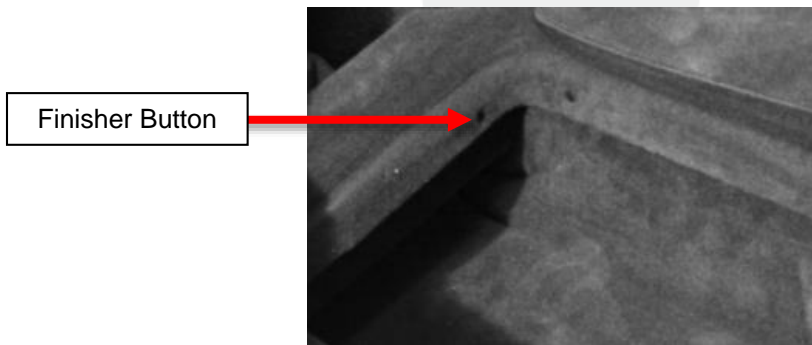
Figure 4

1. Remove the retaining finisher buttons and fir tree clips around the top of the footwell (Figure 4).

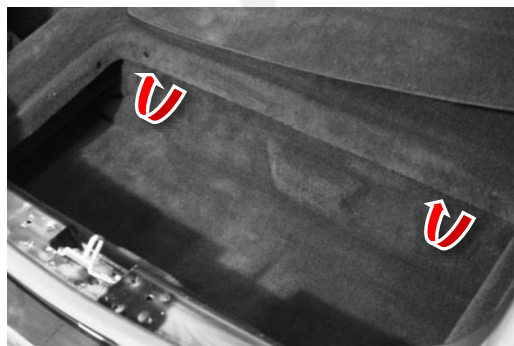
Figure 5

2. Remove the clips on the outboard edge of the lower carpet to release it from the trunk floor trim carpet.
3. Remove the 3 fir tree clips that secure the back edge of the trunk floor trim carpet along the seats: one at each corner and one at the 60/40 seat split.
4. Pull upward on the trunk floor trim carpet to remove it (Figure 5) and set it aside on a protective surface.

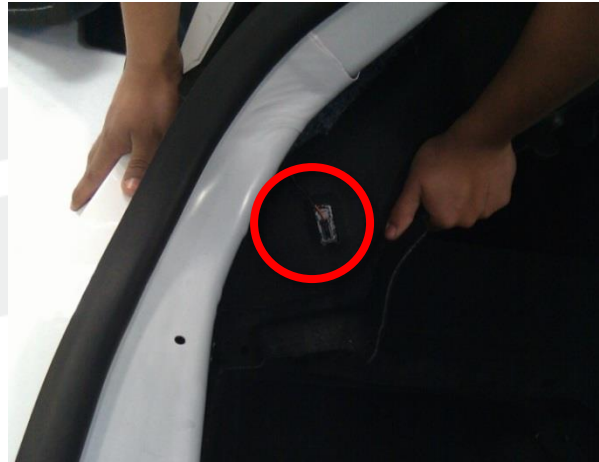
**Figure 6**

5. Remove the trunk footwell carpet and set it aside on a protective surface.
6. Remove the LH and RH strut cover (side rail cover) rear carpets and set them aside on a protective surface.
7. Remove the 2 fir tree clips at the front and back corners of the LH trunk side trim panel.
8. Carefully pull back the liftgate edge of the panel. If the trim has trunk lights, disconnect the trunk light wiring harness by pressing the tab (Figure 6).

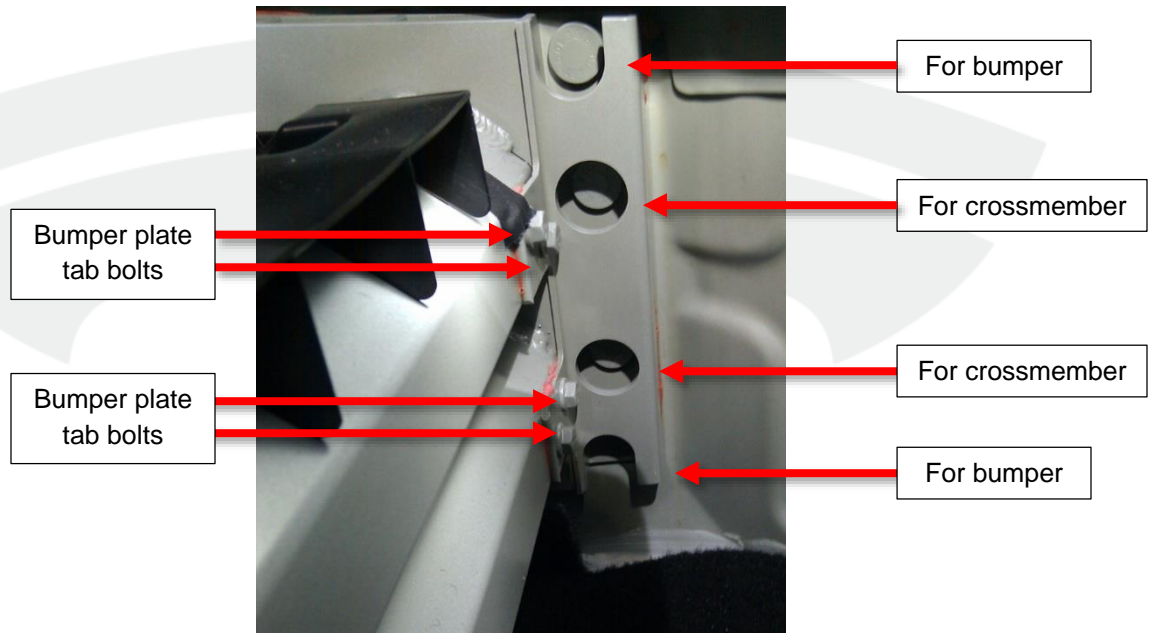
1. Hold the trunk floor insulation away from the rear body panel.
2. Look down the outboard side of the side rails where they meet the rear bumper plate. Verify that:
  - 4 bolts connect the tabs of the rear bumper plate to the side rail (Figure 7).
  - 4 visible studs run through the rear panel to protrude under the fascia. The stud heads are visible through the bumper plate. The top and bottom are for the rear bumper, and the middle two are for the rear crossmember.

Figure 7 (LH pictured, RH similar)

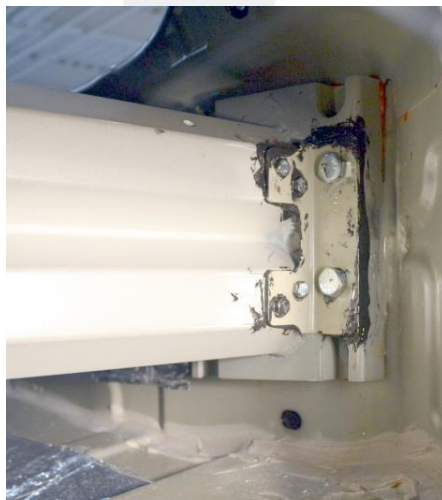
Figure 8

Some early cars might have an L-bracket with tabs installed, which is also acceptable (Figure 8).

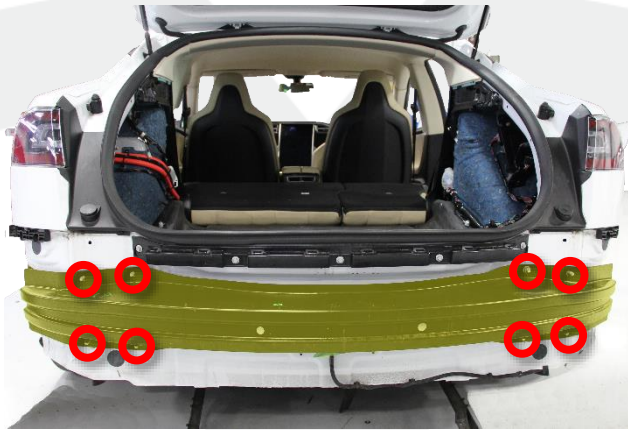
1. Remove the rear fascia assembly (refer to Service Manual procedure 10013001).
2. Remove the 8 flange nuts that secure the rear bumper (Figure 9). Remove the bumper from the vehicle.

**Figure 9 (Rear bumper highlighted)**

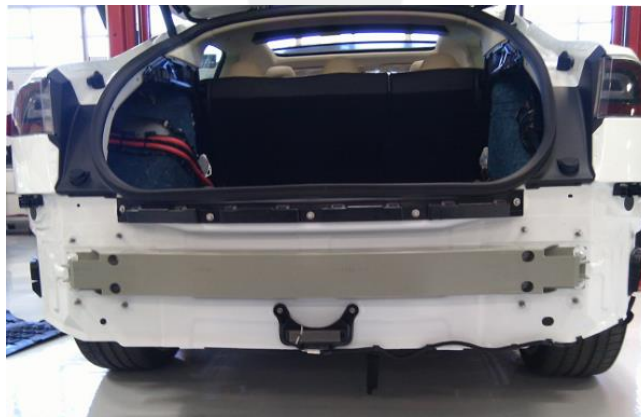
3. Check whether a rear crossmember is already installed (Figure 10). If a rear crossmember is already installed on its 8 studs, reinstall the bumper (torque 52 Nm) and rear fascia and skip directly to the “Template Preparation” section.

**Figure 10 (Rear crossmember installed)**

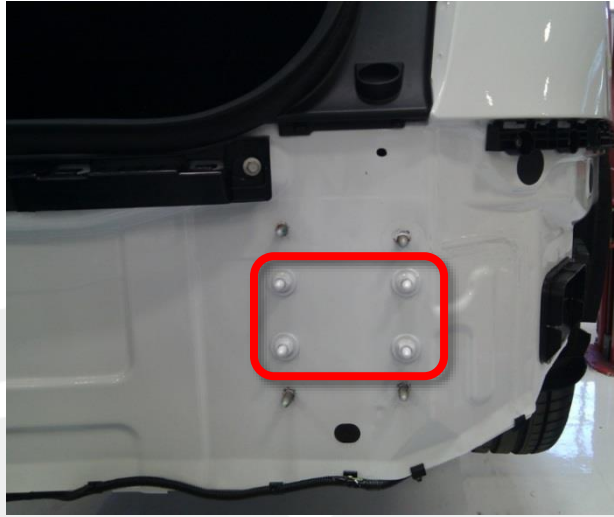
4. If a rear crossmember is not yet installed, but 8 studs exist on the rear panel next to the bumper studs (Figure 11), remove the flange nuts and any washers from the studs. Discard any washers that were installed on the vehicle.

**Figure 11 (Rear crossmember studs)**

5. Install the rear crossmember onto the vehicle using 4 M10 flange nuts on each end (torque 50 Nm).
6. Reinstall the rear bumper on the vehicle using the original flange nuts (torque 52 Nm).
7. Reinstall the rear fascia assembly.

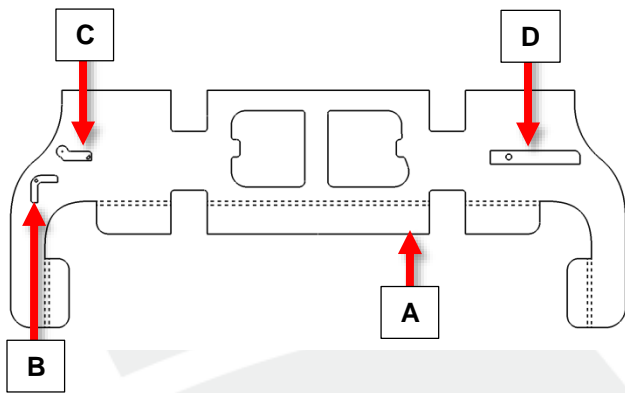
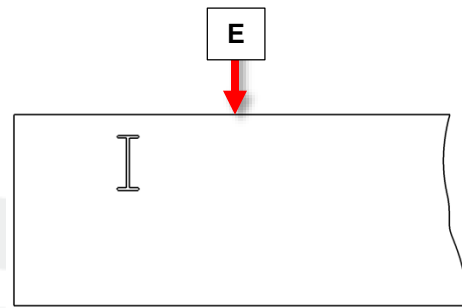
This template consists of a kit that has total of 5 templates and is available to modify carpet and plastic trim if the trim pieces are not already perforated (Figures 12 and 13):

Description	Application
Template A	Main template for cutting the trunk floorboard and footwell carpet
Template B	Properly bending template A along the perforated lines
Template C	Drilling a hole in the LH and RH side plastic strut covers
Template D	Cutting the strut cover carpet (side rail cover)
Template E	Cutting the LH and RH side carpet trim panels

1. Inspect template sections (Figures 12 and 13).
2. Place the main template A on the edge of a workbench.

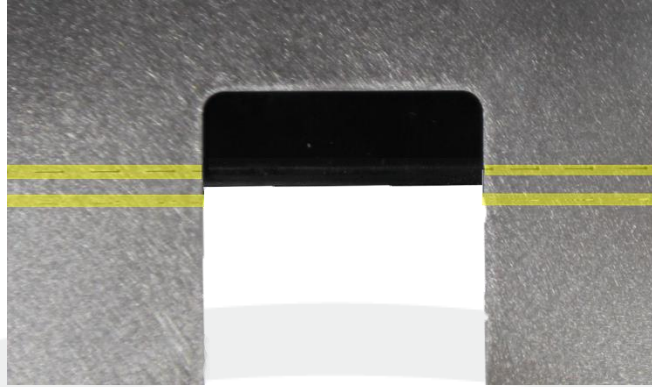
- Align the edge of the workbench between the template marking lines (Figure 14).

**Figure 14 (Template marking lines highlighted)**

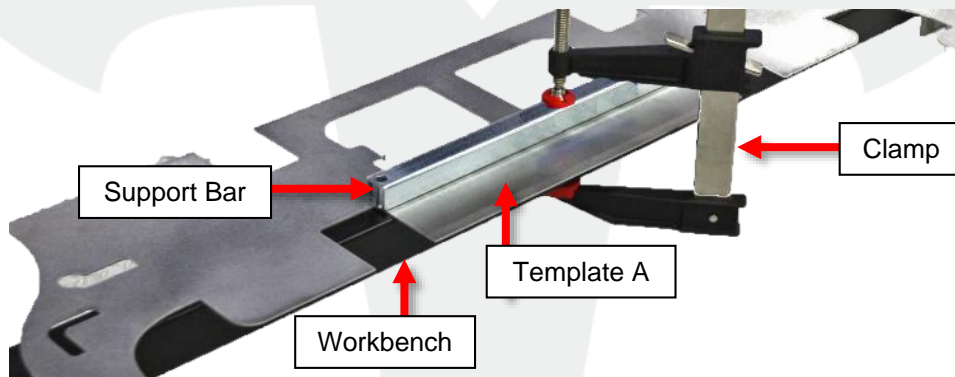
**Figure 15**

- Put a support bar on top of the template, then secure the template with a clamp (Figure 15).

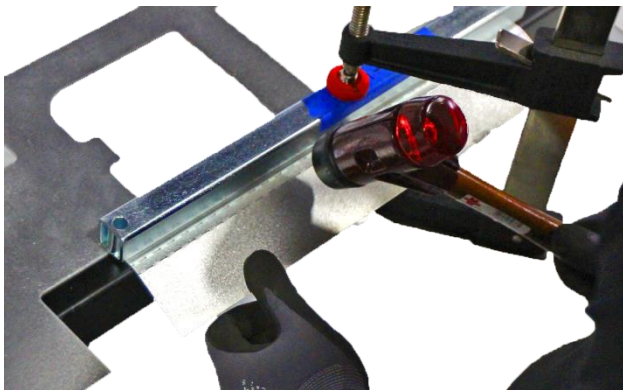
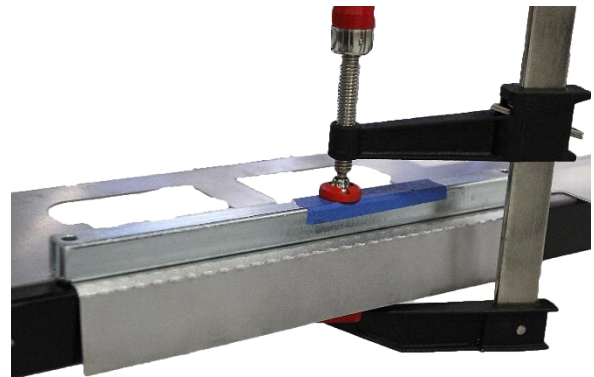
- On template A, use a deadblow hammer to bend the tabs at the perforated lines (Figure 16) from straight to approximately a 90 degree angle (Figure 17).

**⚠ CAUTION:** Do not bend the template past 90 degrees to avoid breaking the template.

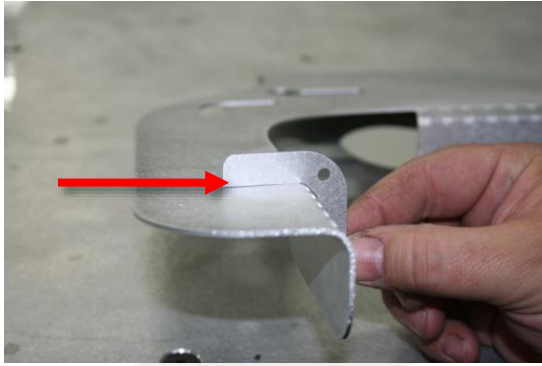
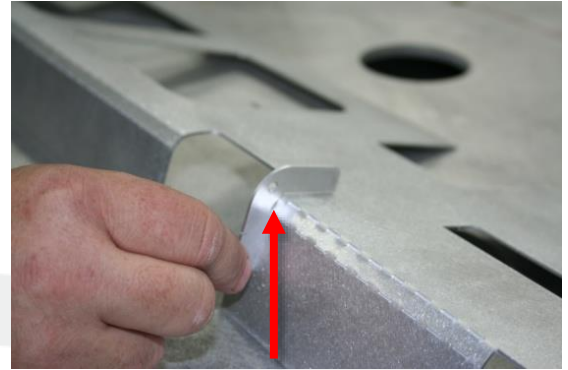
- Verify the bent angles on template A with template B (Figures 18 and 19). Move template B along the bent tabs on template A, adjusting the tabs as needed to close any gaps between the two templates.

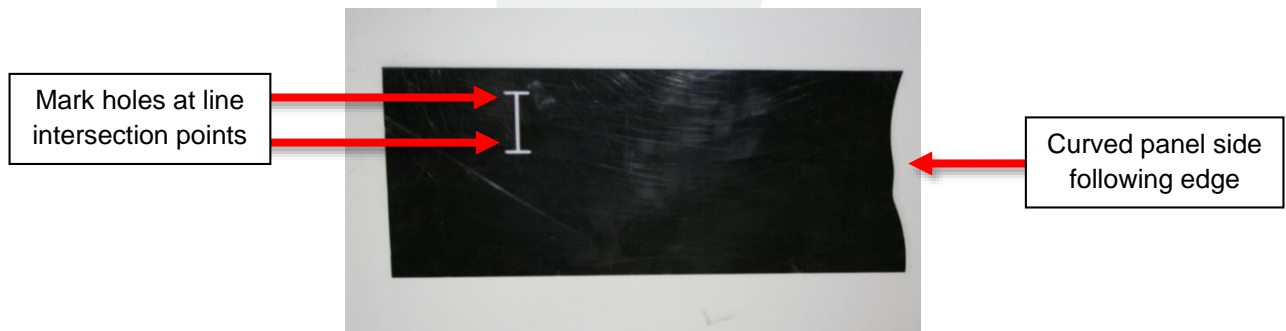
Figure 20

**NOTE:** Some vehicles already have perforations in the side carpet trim panels. Check for perforations in the panels, using template E as a guide. If perforations already exist, proceed to step 3. Template E is used for both the LH and RH side carpet trim panels. Invert the template for each side (Figure 20).

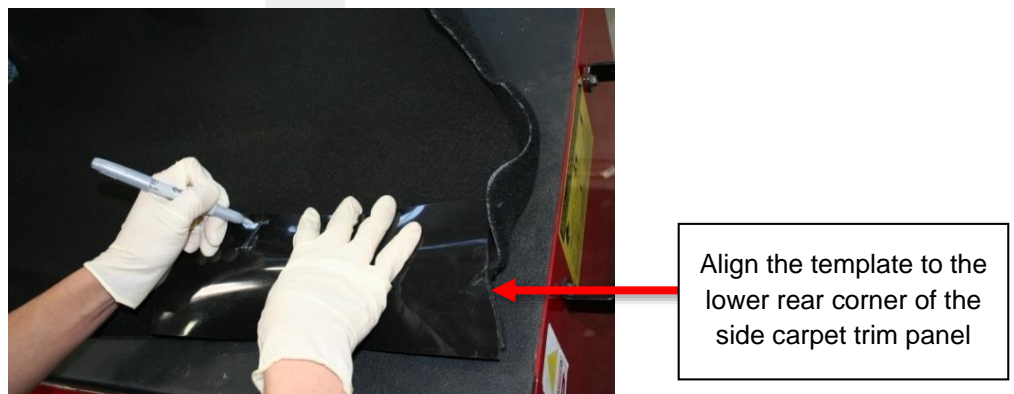
Figure 21

- Align the template E along the backside lower rear corner of the side carpet trim panel. Align the curved side of template with the rear edge of the trim panel. Trace the slot opening with a marker pen (Figure 21).

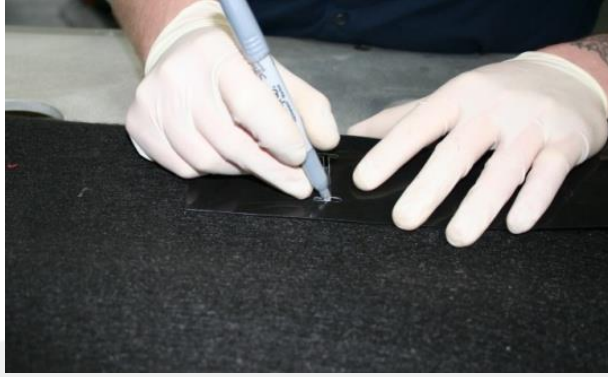
Figure 22

2. Mark a center hole for the drill bit at the two line intersections, and then connect the dots (Figure 22).

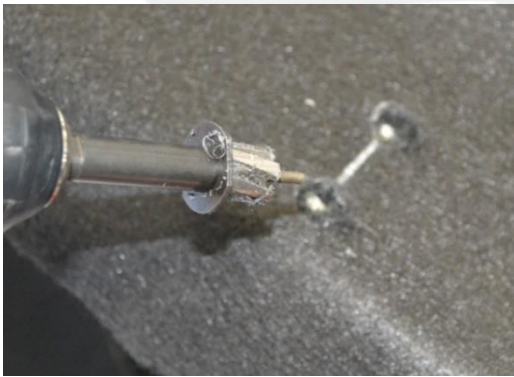
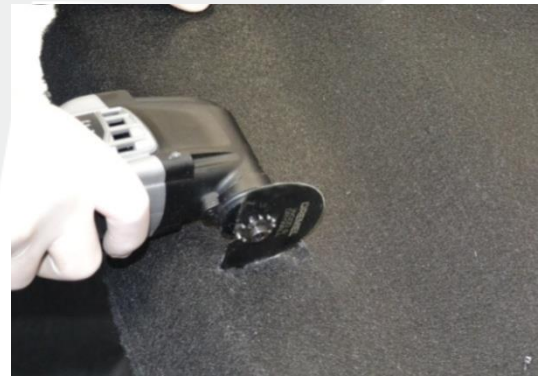
3. Drill a 13 mm diameter hole at each of the two marked center intersection dots, and then cut a slit connecting the two holes (Figures 23 and 24).

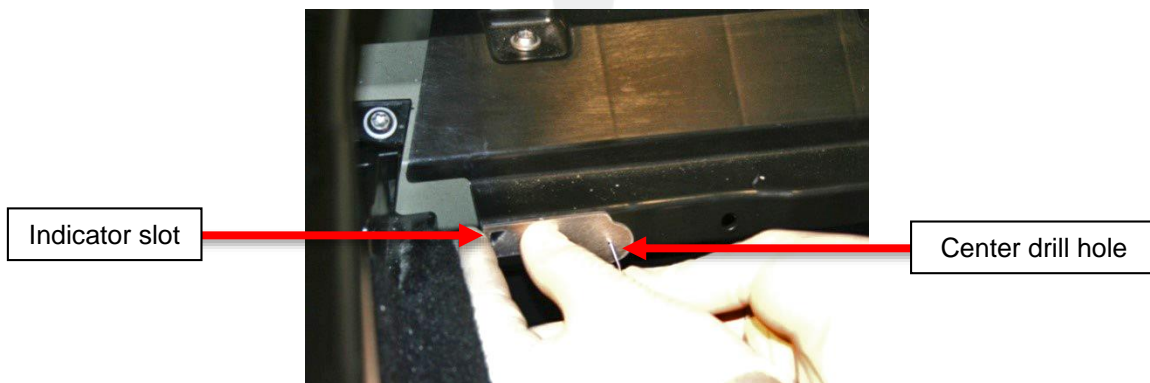
Figure 25 (LH shown, RH similar)

1. Place template C on the inboard edge of the LH plastic strut cover. The flat edge of the template with the indicator slot faces toward the back of the vehicle. The round edge of the template faces toward the front of the vehicle.
2. Mark a drill hole with a center punch as indicated by template C (Figure 25).

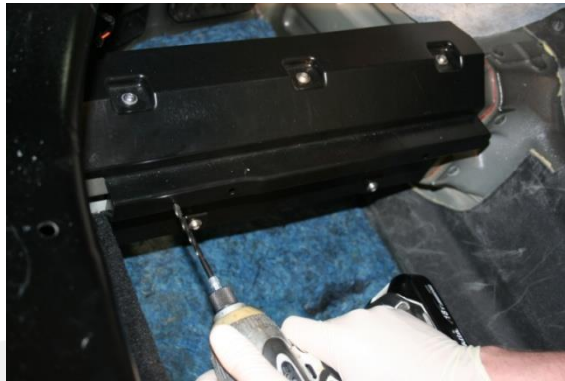
**Figure 26 (LH shown, RH similar)**

3. At the hole mark, drill a 5 mm diameter hole in the LH plastic strut cover (Figure 26).

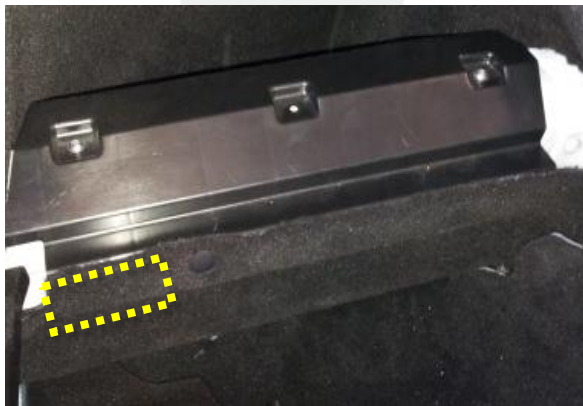
**Figure 27**

**NOTE:** Identify the part of the strut cover carpet that needs to be removed. This step adds extra clearance for the third row seat assembly as it folds into and exits the footwell (Figure 27).

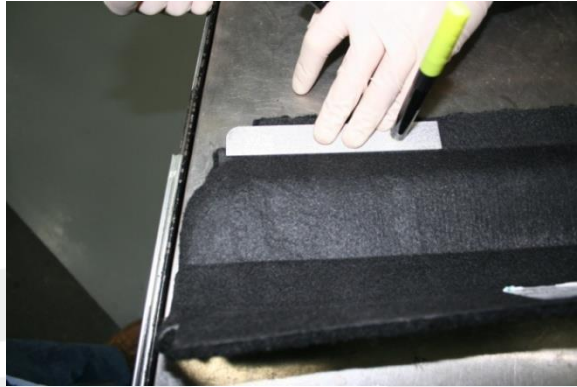
**Figure 28**

1. Place template D on the back side of the footwell carpet (Figure 28). The round hole in template D aligns with the hole in the carpet. Place a pen or similar object in the template alignment hole to hold it place.

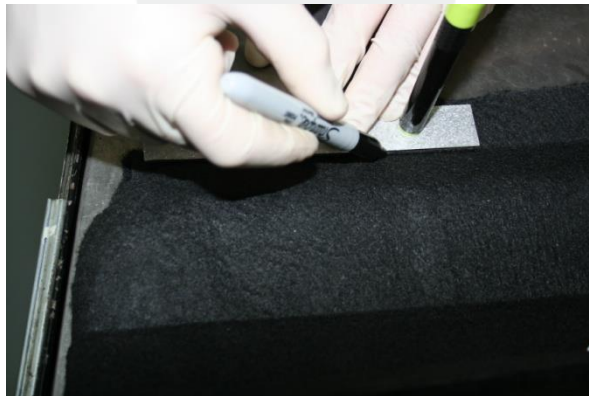
**Figure 29**

2. Trace along the outside perimeter of template D with a paint pen or marker (Figure 29).

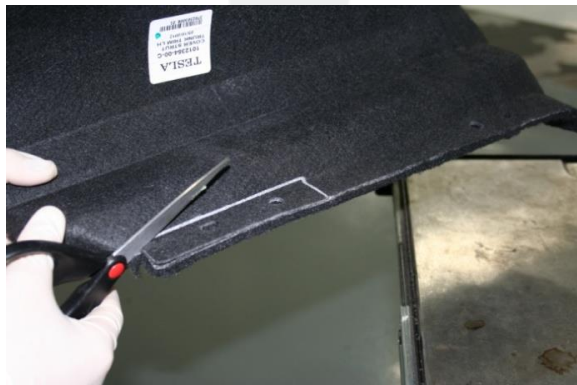
**Figure 30**

3. Cut the carpet section around the marked outline (Figure 30).

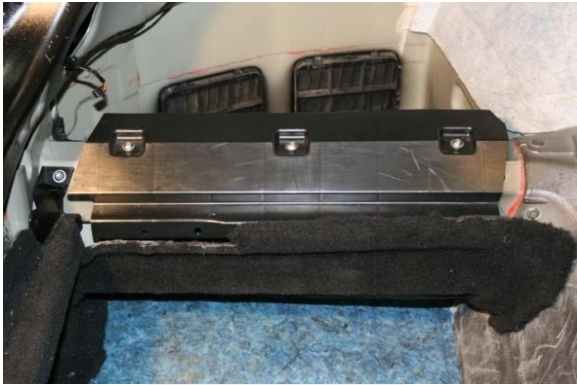
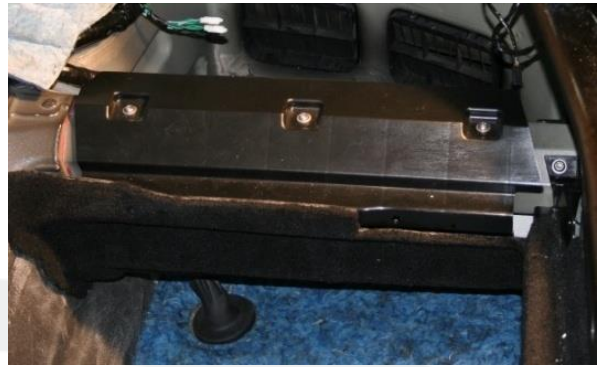
- Place the LH and RH carpeted strut covers in position (Figures 31 and 32).

- Install fir tree push pins to secure the carpet on the LH and RH sides.
- On each side of the vehicle, install a fir tree push pin to fasten the carpeted strut cover to the hole that was drilled in the "Plastic Strut Cover Modification" section.

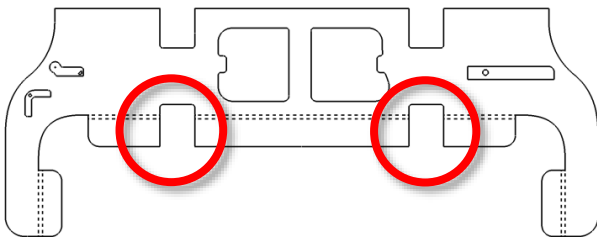
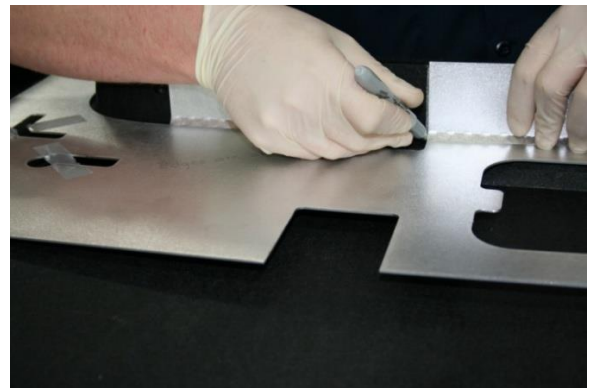
- Align template A against the back of the trunk floorboard carpet. Use a marker pen to mark the outline of the LH and RH trunk floorboard carpet third row seat mounting access holes (Figures 33 and 34).

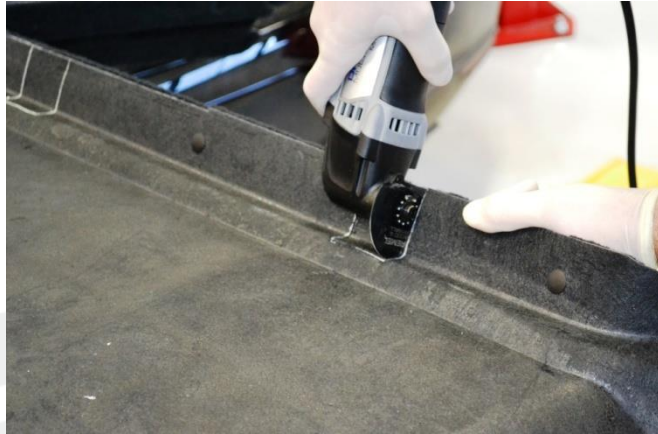
**Figure 35**

2. Remove the carpet sections with a cutting tool along the marked lines (Figure 35).

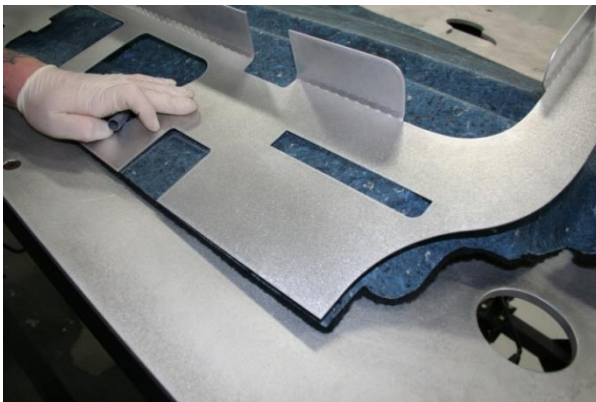
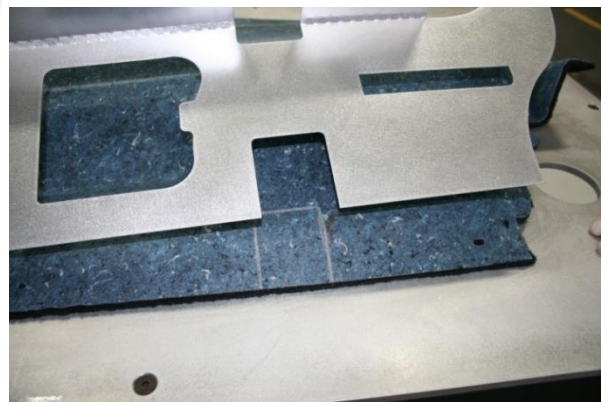
1. Align template A against flat edge of the footwell carpet to locate the third row seat mounting bracket access holes. Mark the holes with a paint pen or marker (Figures 36 and 37).

2. Remove the carpet sections for the LH and RH mounting bracket holes with a cutting tool.

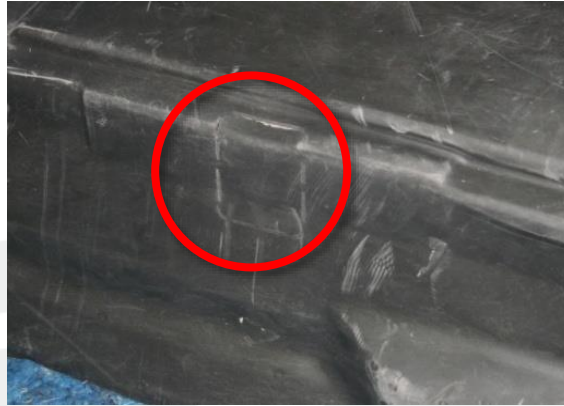
**Figure 38**

1. Inspect the insulation pad for pre-existing perforations (Figure 38). If perforations are visible, proceed to step 5.

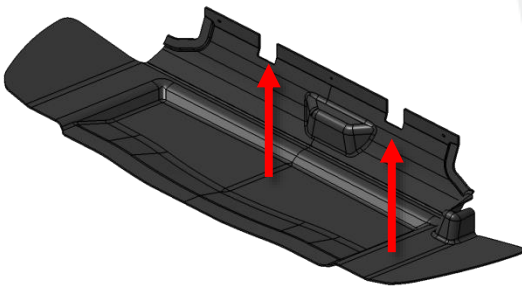
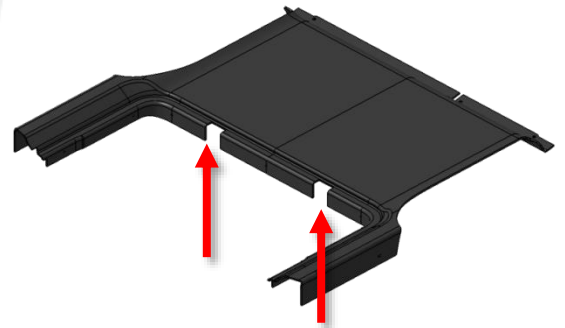
2. If perforations are not visible, temporarily install the footwell and trunk floor carpet sections to use as a template (Figures 39 and 40).

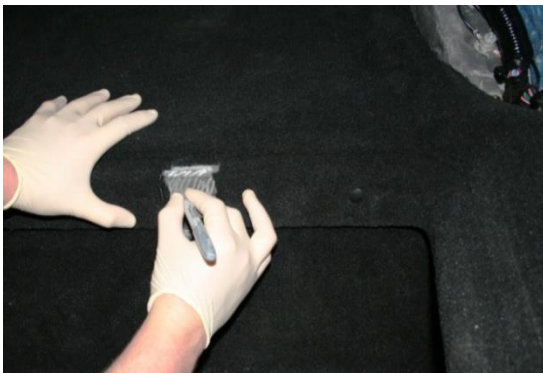
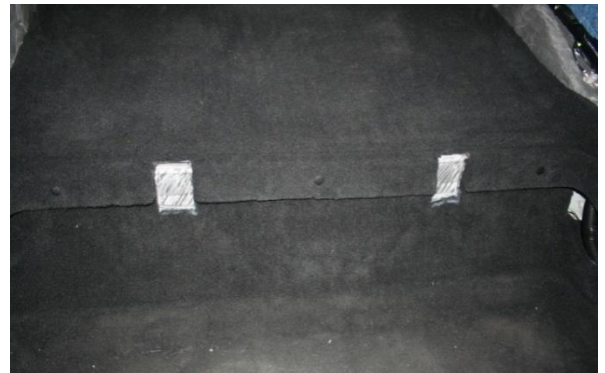
3. Using the cutouts in the carpet as a template, mark the location of the knee pivot third row seat mounting bracket openings with a paint marker (Figures 41 and 42).

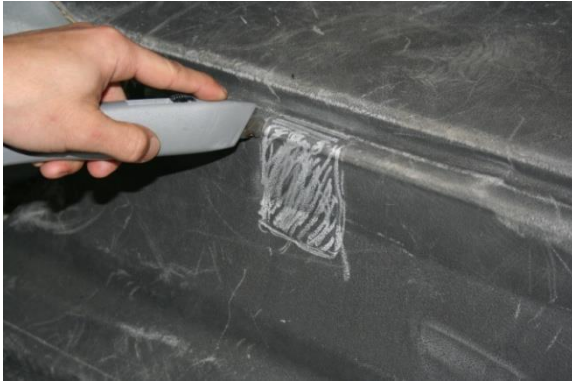
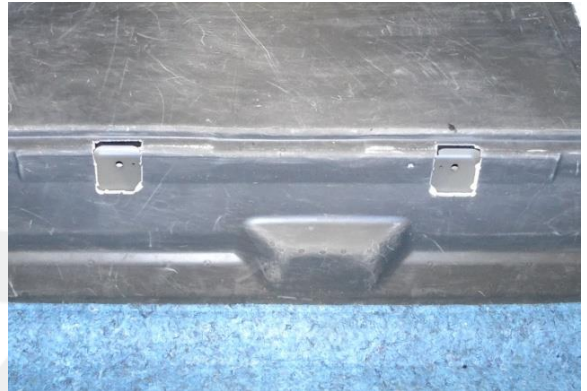
4. Remove the footwell carpet and trunk floor carpet.
5. Cut the insulation pad along the existing perforations or along the perimeter of the marked area (Figures 43 and 44).

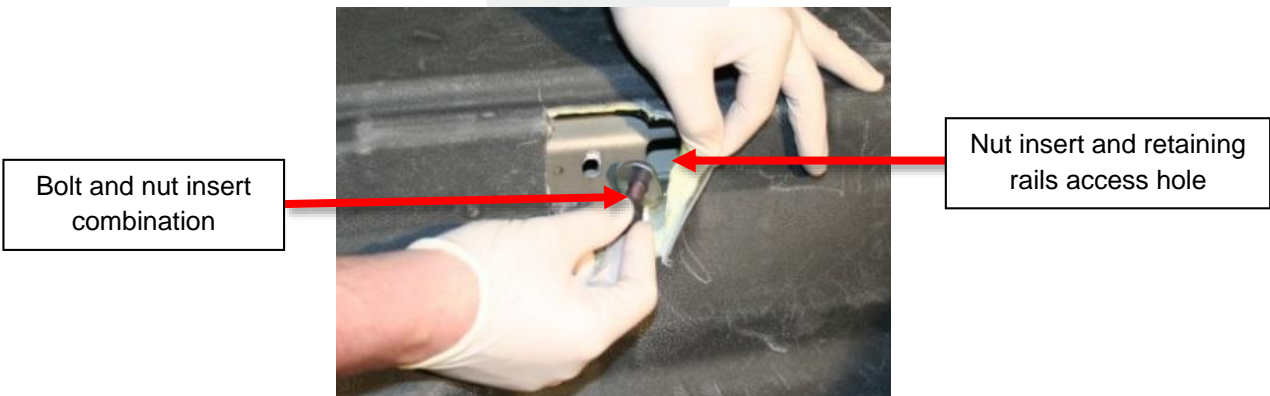
Figure 45 (RH shown, LH similar)

1. Screw a few threads of the mounting bracket bolt into the nut insert with the flat side facing out.
2. Place the nut insert in the back of the body panel into the retaining rails (Figure 45).

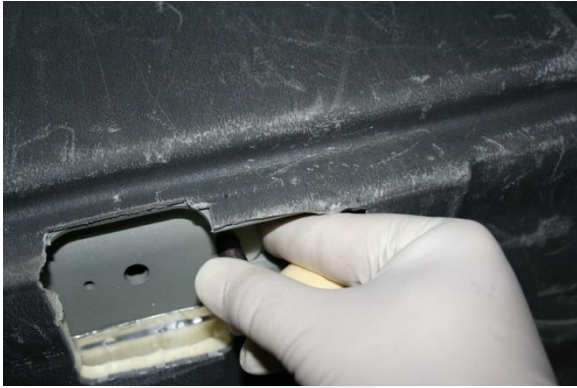
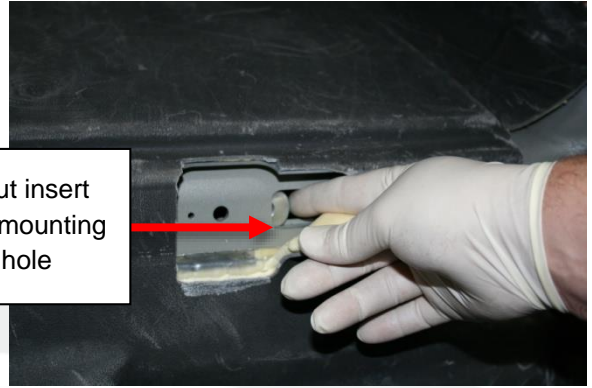
3. Unscrew the bolt and slide the nut insert within the holding rail towards the mounting bracket hole until the threads are visible (Figures 46 and 47).

Slide nut insert  
towards mounting  
bolt hole

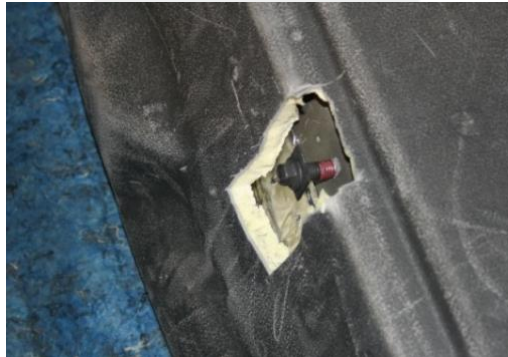
**Figure 48**

4. Hold the nut insert in place and start threading the bolt for a few threads to retain (Figure 48).

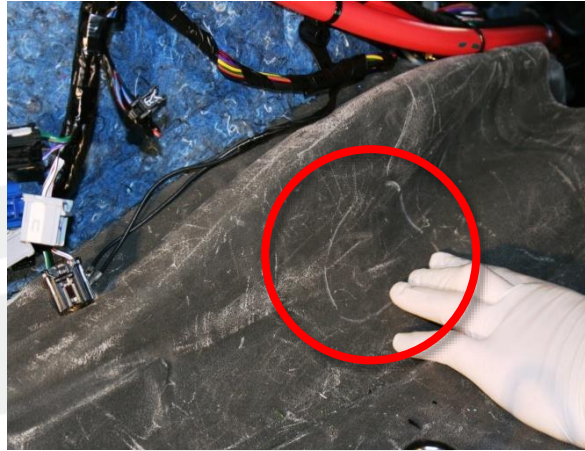
**Figure 49**

1. Inspect the LH and RH striker insulation pad for pre-existing perforations (Figure 49). If perforations are visible, proceed to step 4.

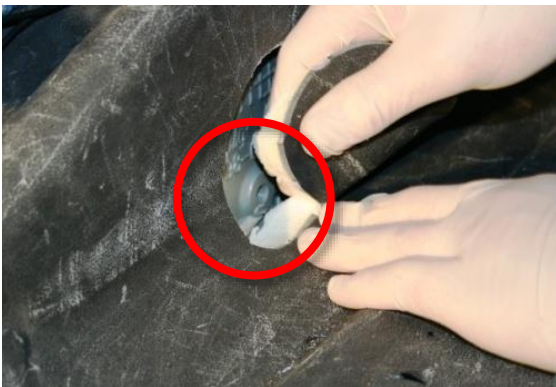
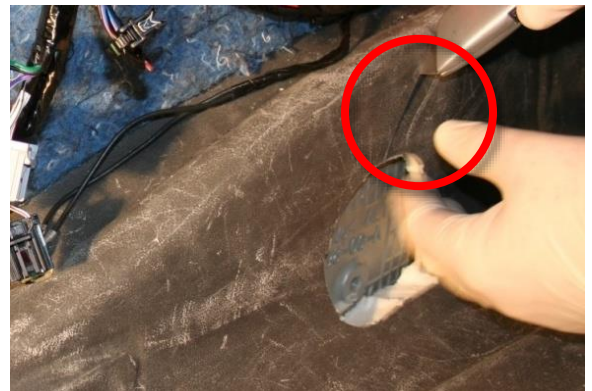
2. If perforations are not visible, locate the top and bottom striker mounting bolt holes with your hand. Press the area under the insulation pad, feeling for the raised threaded mounting boss. Cut out the insulation section around this area.
3. Remove this insulation section to expose the lower mounting bolt threads (Figures 50 and 51). Temporarily place the striker with the long end up to locate the upper mounting bolt boss. Mark and cut the insulation pad to expose the top threaded boss.

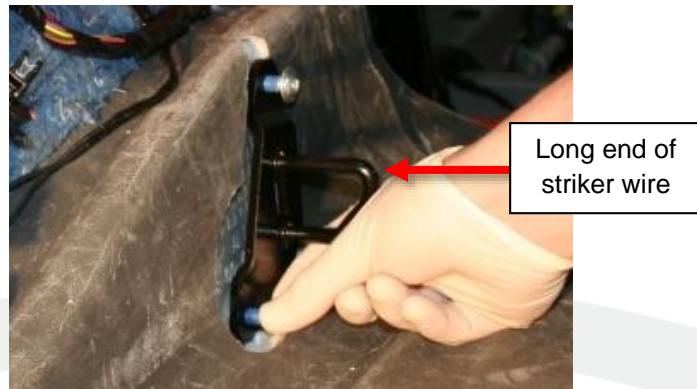
**Figure 52**

4. Ensure the long end of the striker wire faces upward. Mount the striker flush with the body panel and evenly hand tighten the upper and lower striker mounting bolts (Figure 52).

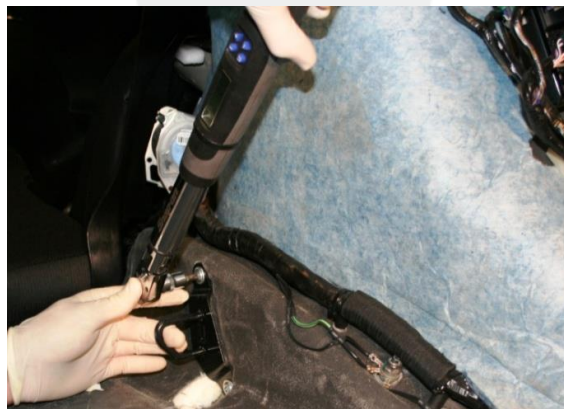
**Figure 53**

5. Repeat steps 1–4 for the RH striker installation.
6. Torque the LH and RH striker bolts to 16.5 Nm (Figure 53).

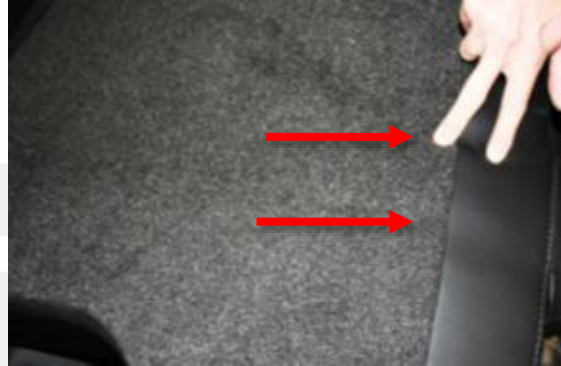
**Figure 54**

1. Press down on the center of the 2<sup>nd</sup> row seat back along the carpet and upholstery seam to locate the hidden seat latch. (Figure 54). The latch can be felt as two cavities under the carpet and upholstery.

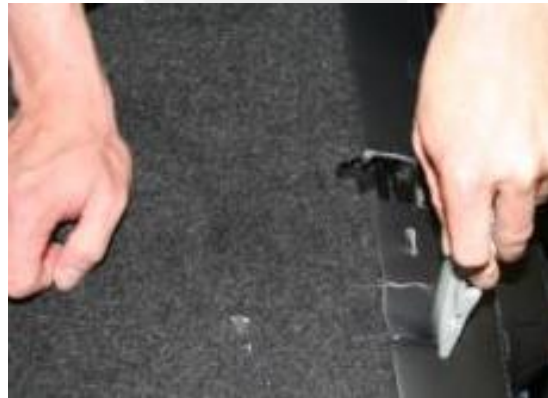
**Figure 55**

2. Trace the latch cavities with chalk as a guideline if needed.
3. Cut the carpet and upholstery around the two indentations to expose the latch components (Figure 55).

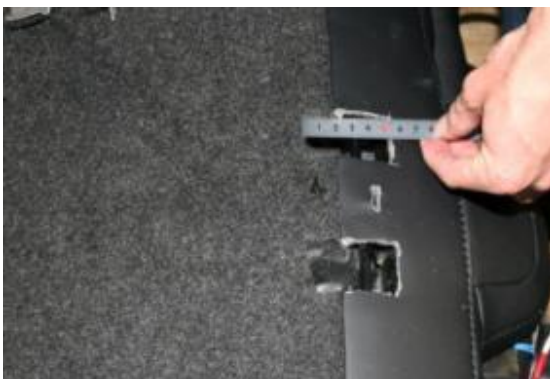
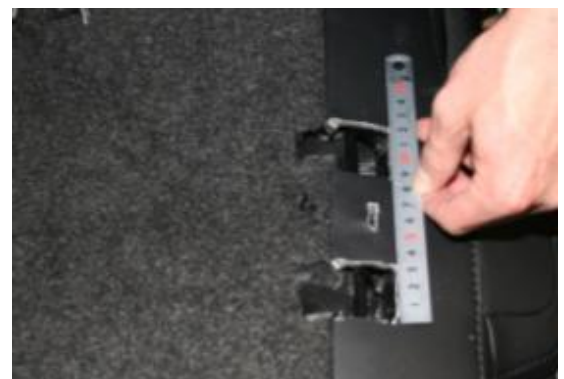
4. The vertical length is approximately 55 mm and the horizontal total length is about 120 mm (Figures 56 and 57).

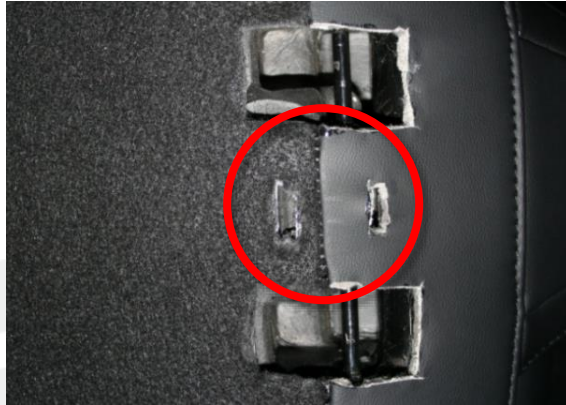
**Figure 58**

5. Press down and feel for two horizontal cavities approximately 20 mm in length at the center of the seat back.
6. Cut out the 20 mm cavities, one in the carpet section and one in the upholstery (Figure 58).

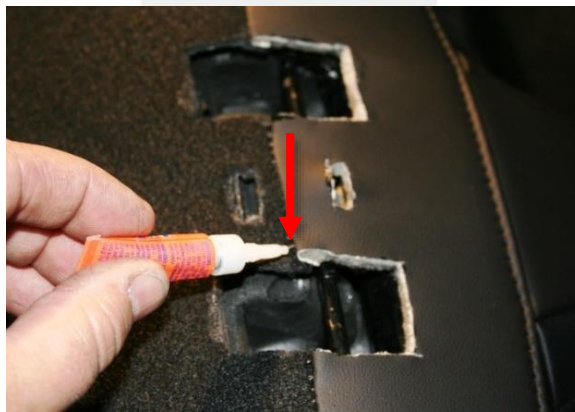
**Figure 59**

7. To ensure fabric integrity and prevent fraying, apply a few drops of super glue to the exposed fabric threads where the carpet and seat cover meet at the four areas (Figure 59).

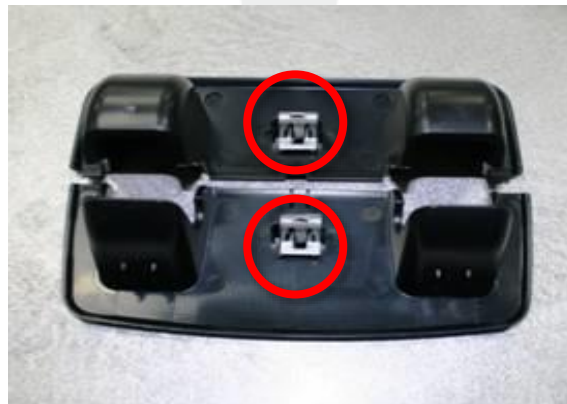
**Figure 60**

8. Install the two center attachment trim clips in the back of the 2<sup>nd</sup> row seat bezel (Figure 60).

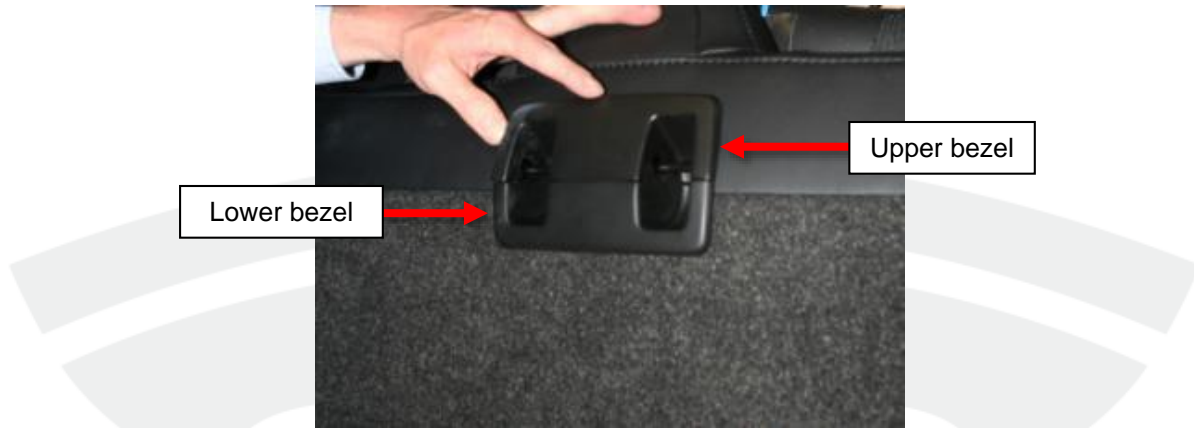
**Figure 61**

10. Install the upper half (upholstery side) of the finisher bezel to the seat back (Figure 61). Ensure that the bezel fits against the seat back frame and snaps onto the strikers. The two center trim clips secure the bezel to the seat frame.

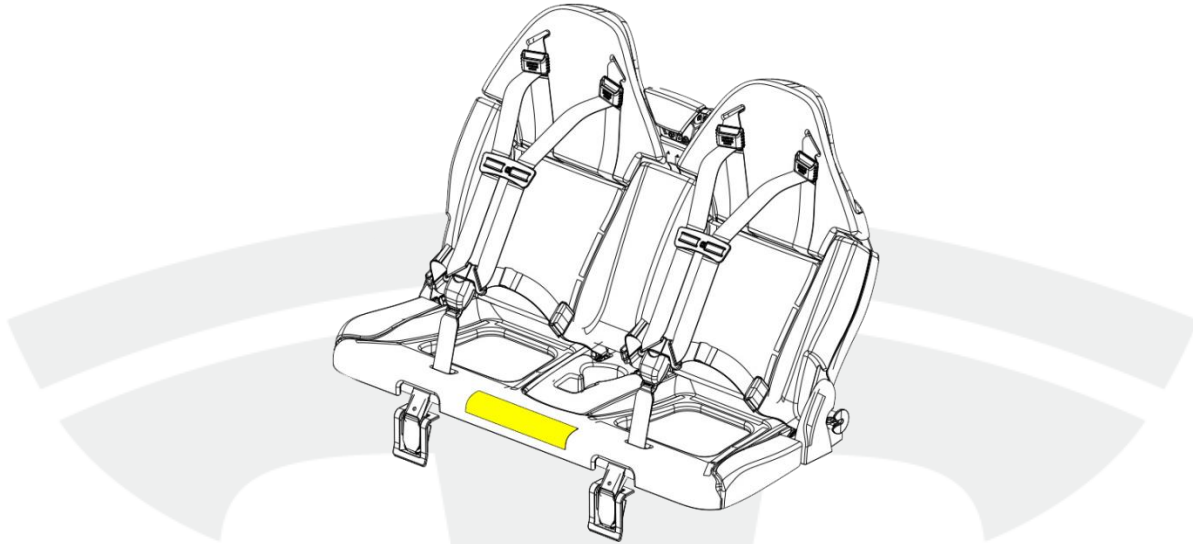
1. Inspect the regulatory label on the front of the third row seat assembly (Figure 62) and ensure that it is the correct seat for the vehicle's region. Do not install the seat if it has the incorrect regulatory label.

**Figure 62 (Regulatory label highlighted)**

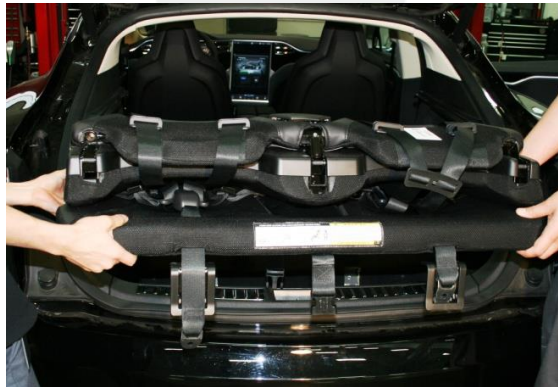
**Figure 63**

2. With an assistant, place the seat in position in the rear trunk area (Figure 63).

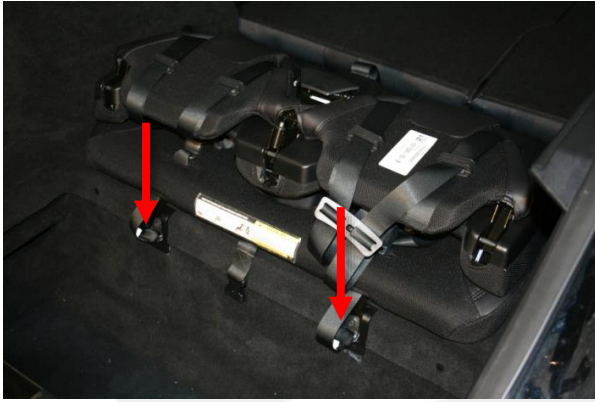
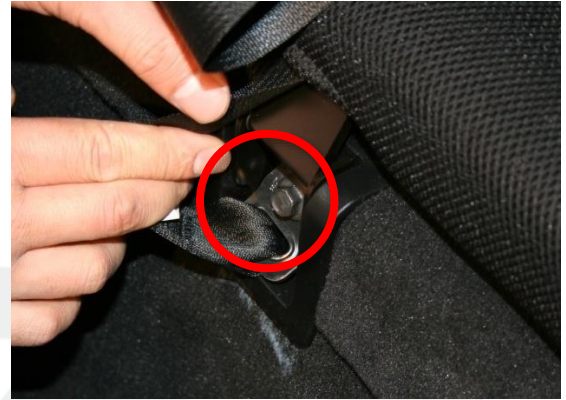
6. Ensure that the third row seat mounting brackets are flush with the body panel. If the insulation prevents the mount from sitting flush, trim the excess insulation or carpet as necessary (Figures 64 and 65).

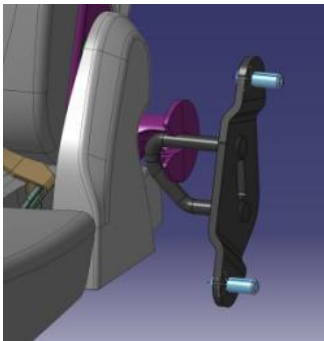
7. Insert the LH and RH mounting bolts through the seat belt loops.
8. Pull the seat belts aside and tighten the LH and RH mounting bolts (torque 26 Nm). Ensure that the seat belt loops are facing down when fastening the mounting bolts.
9. Raise the 2<sup>nd</sup> row seat to the normal upright position.
10. Unfold and latch the third row seat headrest. Lift the third row seatback towards the 2nd row seat. While lifting, ensure the side latches are engaging correctly into both left and right side strikers (Figures 66 and 67).

**Figure 66 (Correct alignment)**

**NOTE:** If the latches are aligned too high, the trunk floor carpet is keeping the seat from sitting in the proper position. Kneel on both sides of the seat cushion, using your body weight to compress the seat and carpet. The carpet should stay compressed, keeping the hooks in proper alignment permanently.

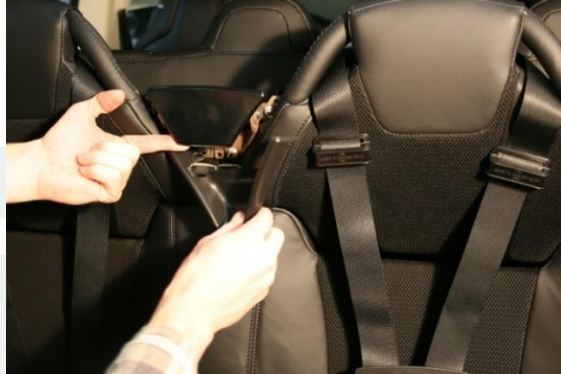
**Figure 68**

1. Remove the latch surround trim piece from the third row seat.
2. Secure the third row upper latch to the second row seat. The latch assembly comes with the nuts slightly loose, and self-aligns to the 2<sup>nd</sup> row seat striker (Figure 68).

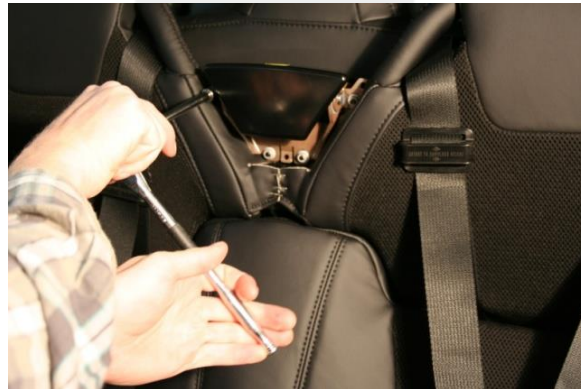
**Figure 69**

3. With the third row seatback still latched to the 2<sup>nd</sup> row seat, tighten the 4 latch nuts (torque 5.0 Nm) (Figure 69).

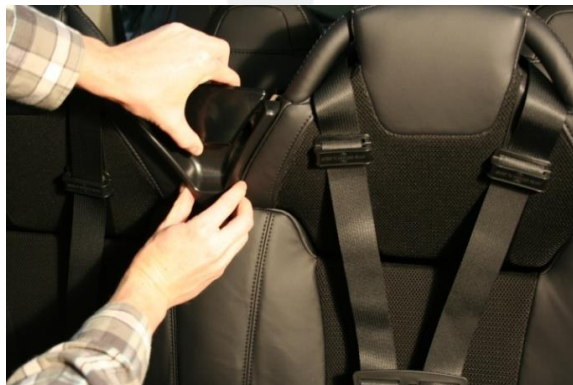
**Figure 70**

4. Unlatch the third row seat. Reinstall the latch surround trim (Figure 70).

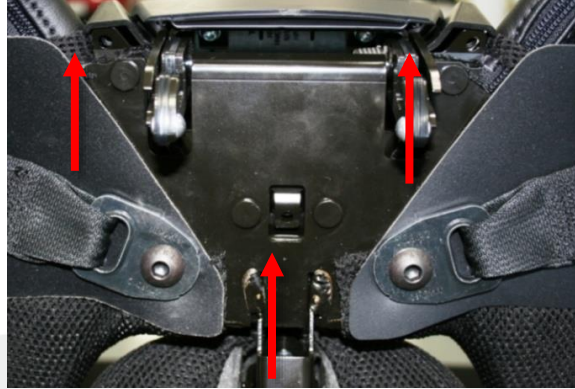
**Figure 71**

- Secure the latch surround trim with the 3 screws (torque 0.5 Nm) (Figure 71).
