Product Notice

PN 637

Models Affected: XT Pro

SUBJECT: *Non-sealed Outrigger Switches*

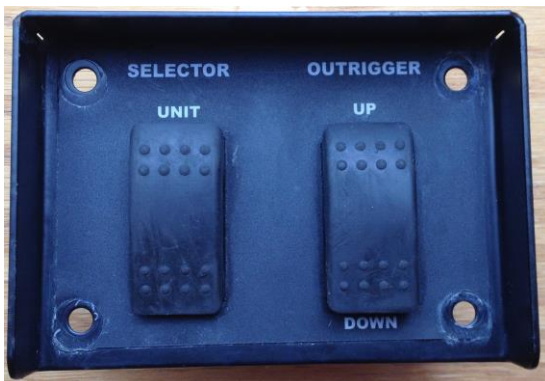
1. Non-sealed switches, as shown in figure 1 and figure 2, require replacing.

Figure 1 - Face side

2. If this style switch is present contact your local Terex dealer or Terex Utilities Service Department at 1-800-982-8975 or email machine information to utilities.warranty@terex.com to schedule an appointment for repair .
3. Terex Utilities recommends you perform this action within 60 days from receipt of this bulletin
4. Sealed switches, as shown in figure 3 and figure 4, do not require further action.

Because Terex Utilities wants your product to perform as you would expect please respond to this bulletin so Terex can repair all affected units. Terex will replace the non-sealed switches and harnesses with new sealed switches and harnesses at no charge.

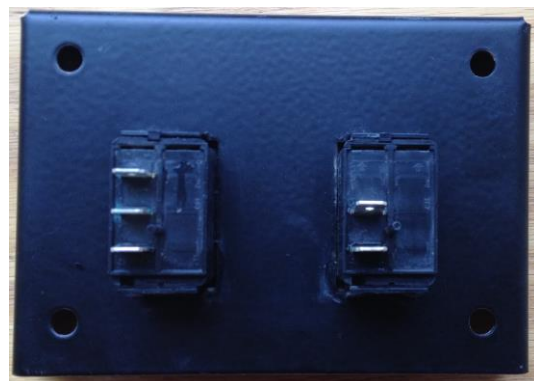
Figure 2 – Connector side

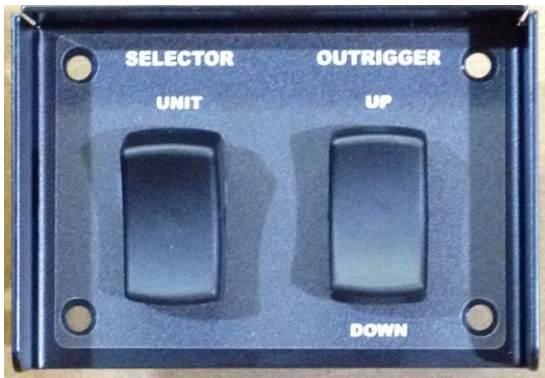
Figure 3 – Face side

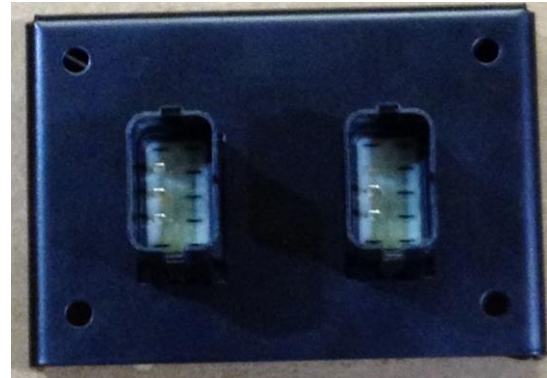
Figure 4 – Connector side

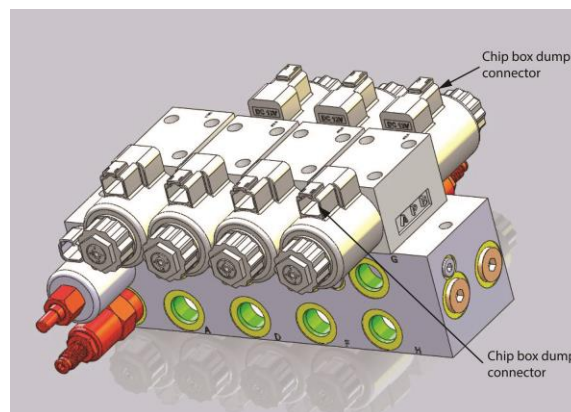
Figure 5 – Chip Box Solenoid Connectors

1. As soon as the unit is leveled with the outriggers, move the selector switch to the “UNIT” position. Keep the switch in this position anytime the boom is elevated or occupied.
2. Turn the master switch for the PTO off any time the unit is not in use, including during breaks and travel. Do not depend on the parking brake interlock to disable the system.
3. Avoid exposing these switches to water.
4. If the chip box attempts to move, remove the connectors from the chip box valve solenoids as shown in figure 5. Reconnect when its required to dump chips.
