HYUNDAI NEW THINKING. NEW POSSIBILITIES. Technical Service Bulletin	GROUP CAMPAIGN	NUMBER 16-01-015
	DATE APRIL 2016	MODEL(S) SANTA FE (NC)
SUBJECT: TAILGATE LIFTER BRACKET REPLACEMENT (SERVICE CAMPAIGN TZ9)

Description: On certain 2016MY Santa Fe (NC) the tailgate lifter brackets may show signs of surface corrosion.

This bulletin describes the procedure to replace the tailgate lifter bracket on both sides with updated service parts.

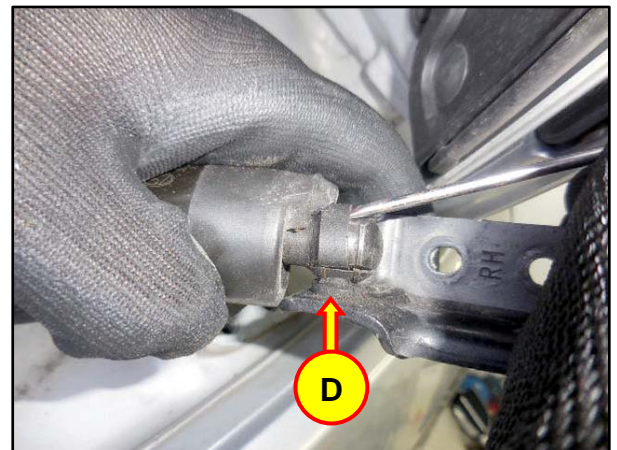
3. Using a Phillips head screwdriver, slightly lift up the socket clips (D) of both ends on the tailgate lifter.

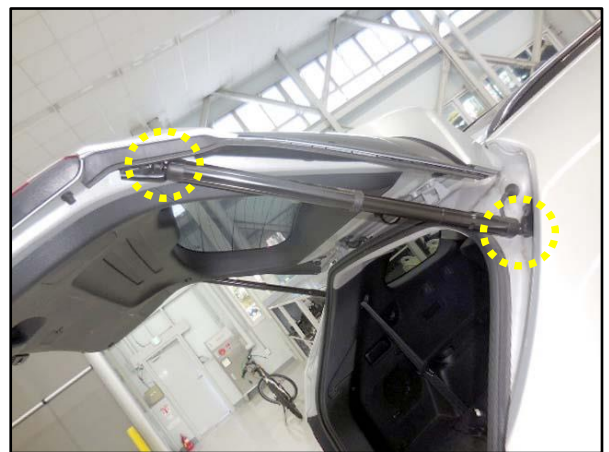
5. Install the tailgate lifter back to the new tailgate bracket.

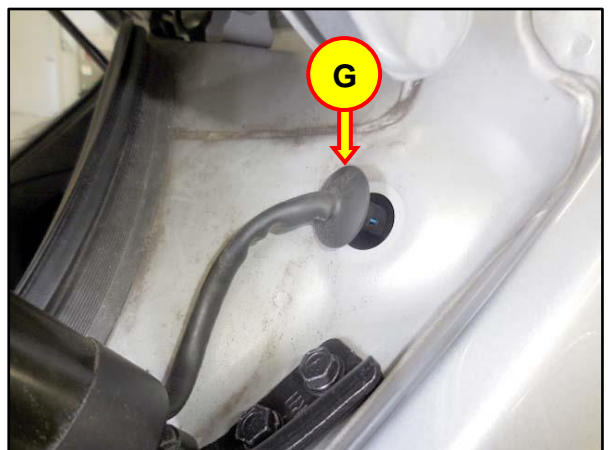
6. Check if the wire grommet (G) is securely installed. Reinstall the grommet (G) if necessary.
