Service Bulletin

File in Section: -
Bulletin No.: 16-NA-259
Date: August, 2016

Subject: Rattle Noise from Front Seat Back Easy Entry Release Handle

Brand:	Model:	Model Year:		VIN:		Engine:	Transmission:
		from	to	from	to		
Chevrolet	Camaro	2016	2017			All	All

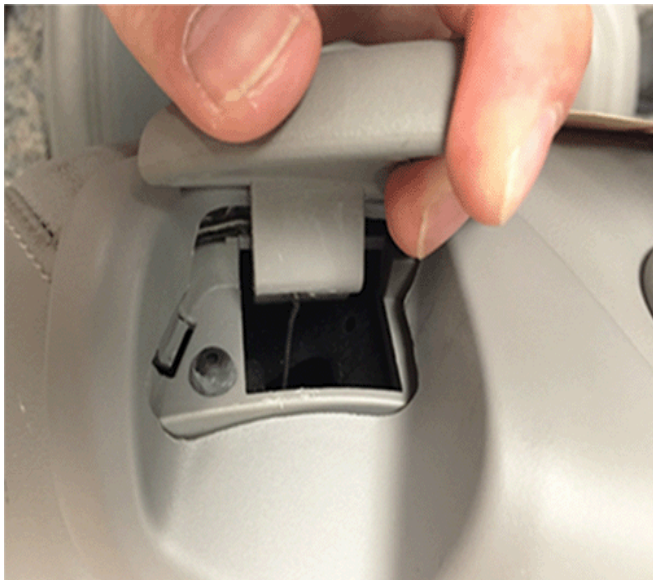
4571157

Involved Region or Country	North America and N.A. Export Regions
Condition	Some customers may comment on hearing a rattle noise coming from the driver or passenger front seat back easy entry release handle. They may note that the noise is more evident during high speed cornering.
Cause	The cause of the condition may be a lack of lubrication on the release cable for the seat back release lever.

Dealership technicians are to apply lubricant to the front seat back easy entry release handle, where the seat back release cable resides, following the Service Procedure below.
