Recall Campaign

Daimler Trucks
North America LLC

September 2016
FL708AB

Subject: TBB HDX Heater Hose Plumbing

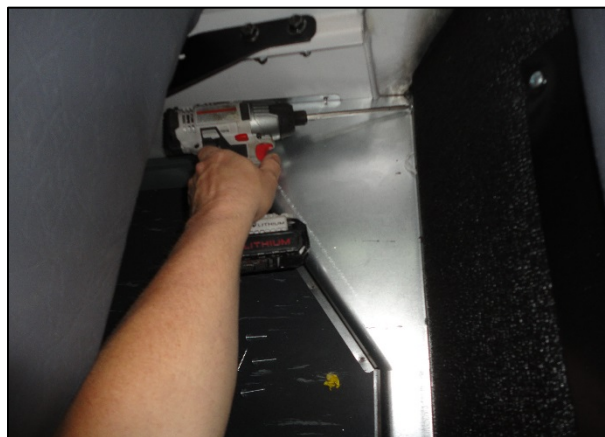
Figure 3, Removal of interior heater hose cover

4. Remove the hose cover located on the curb side of the bus in the corner of the bus body and the davenport. See **Figure 3**. Retain the screws for reinstallation.

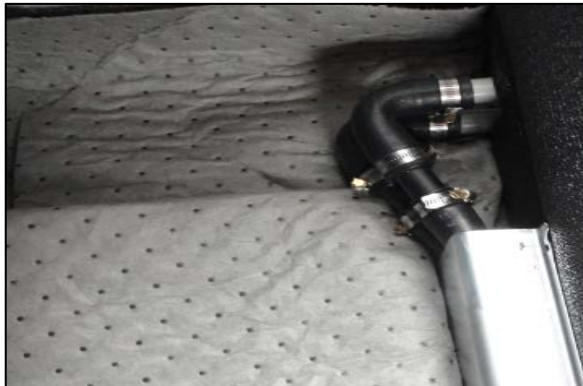
Figure 4, Place absorbent pad under the hoses

5. Place an absorbent mat under the hoses to catch any leftover coolant in hoses. See **Figure 4**.

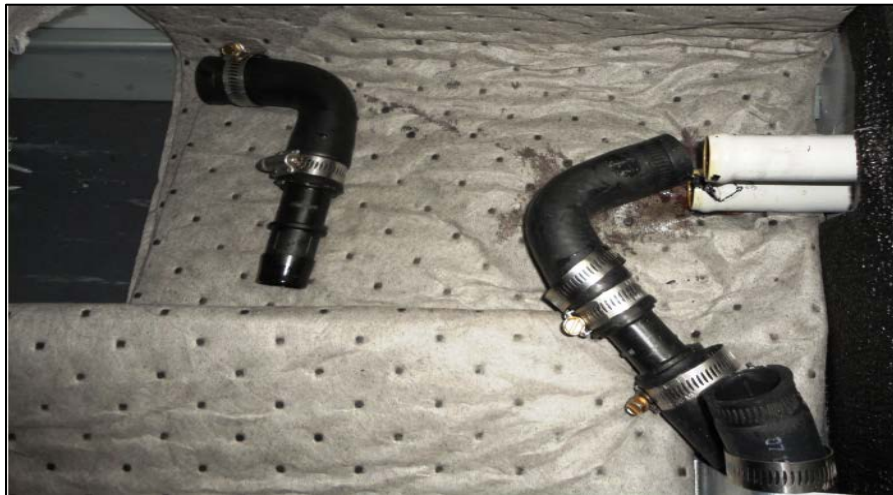
Figure 6, Removal of rubber elbow

On certain vehicles, a rubber elbow may have been used in place of a glass-filled nylon fitting. The elbow may restrict coolant flow and increase the stresses in the elbow and may lead to premature failure of the elbow. Failure of the rubber elbow may lead to hot coolant leaking inside the bus, increasing the risk of injury to passengers.

7. Remove other side of rubber hose elbow and discard hose, but keep clamps for reuse. See **Figure 6**.

Rubber elbows will be replaced with a brass fitting.

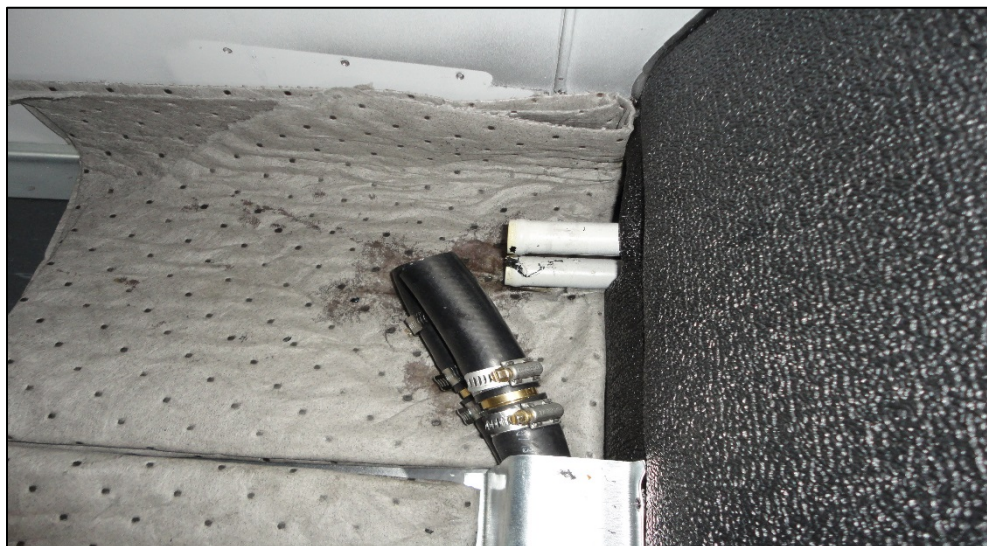
Figure 7, Installation of 4 inch hose and brass fittings

NOTE: The installation of the elbow and straight brass fittings will require additional clamps. They are included in the kit with the elbows and straight brass fittings.

8. Cut a 4 inch piece of the proper type hose, see **Table 2**. Install the straight brass fitting from the kit into the existing hose using clamps. See **Figure .7**

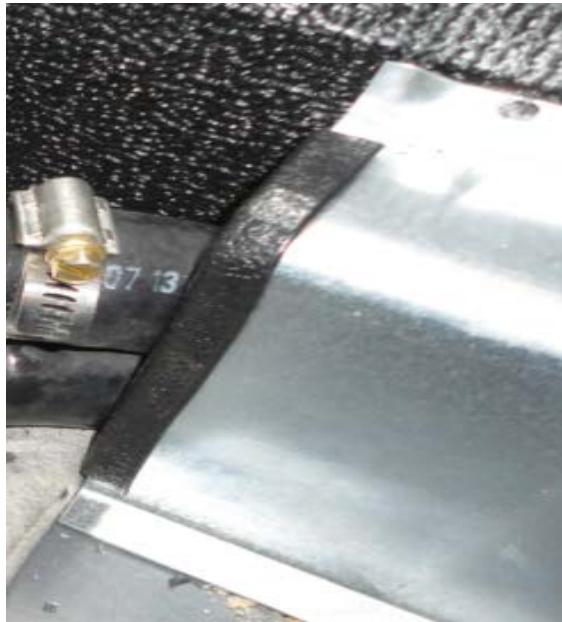
Figure 8, Installation of edge guard on metal cover

9. Install edge guard in the cover that has not been removed. See **Figure 8**.

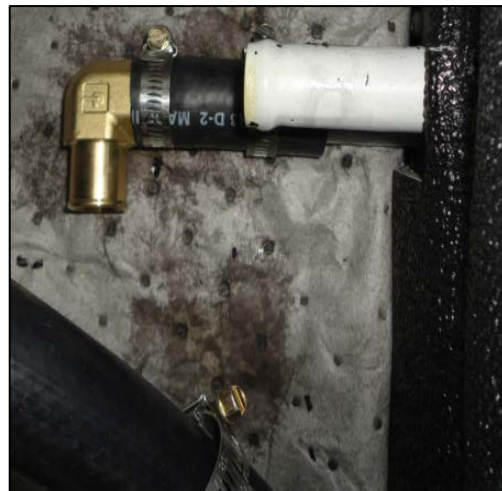
Figure 9, Installation of elbow on Davenport tubes

10. Install 3 inches of hose onto each of the brass elbow fittings (see **Table 2** for appropriate hose). Slide two clamps onto each hose. On each hose, slide the clamp closest to davenport down onto the lower davenport tube coming through the firewall, making sure the clamp is on other side of the nipple with enough hose. Tighten the clamps. See **Figure 9**.

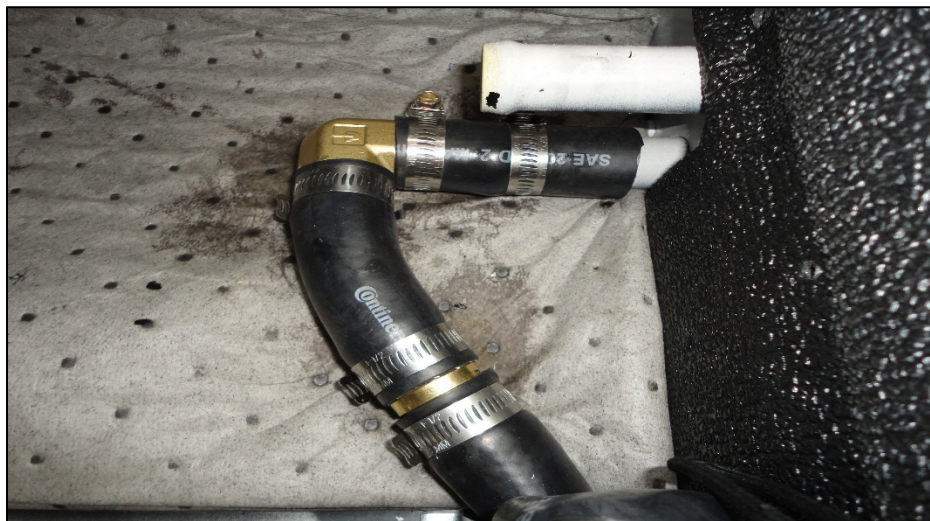
Figure 10, Installation of 4 inch lines onto elbow

11. Slide a clamp onto each 4 inch section of hose then install the hoses (connected earlier) onto the other side of elbows as shown in **Figure 10**, making sure the supply and return lines are installed correctly. Tighten the clamps after adjusting to ensure no kinks in the lines will restrict coolant flow.
