# Service Bulletin

**Subject:** Driver Door Lock Cylinder Cover Missing

**Models:** 2015-2017 Cadillac Escalade Models

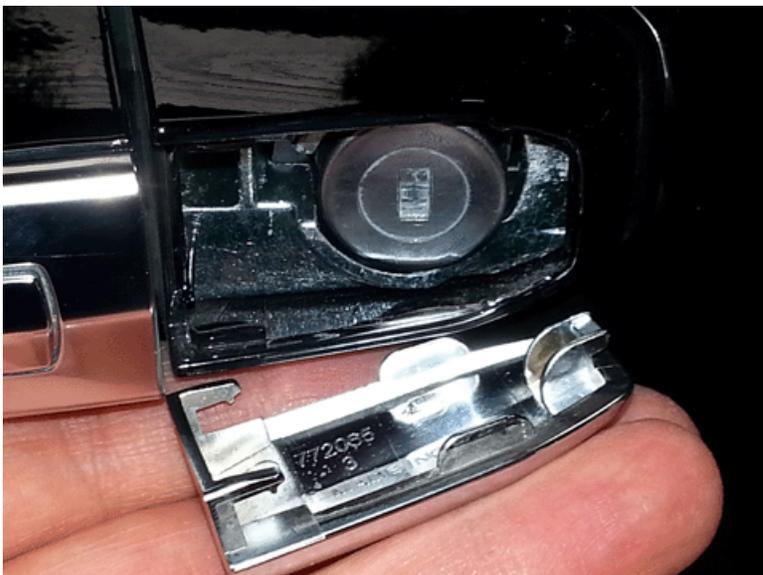
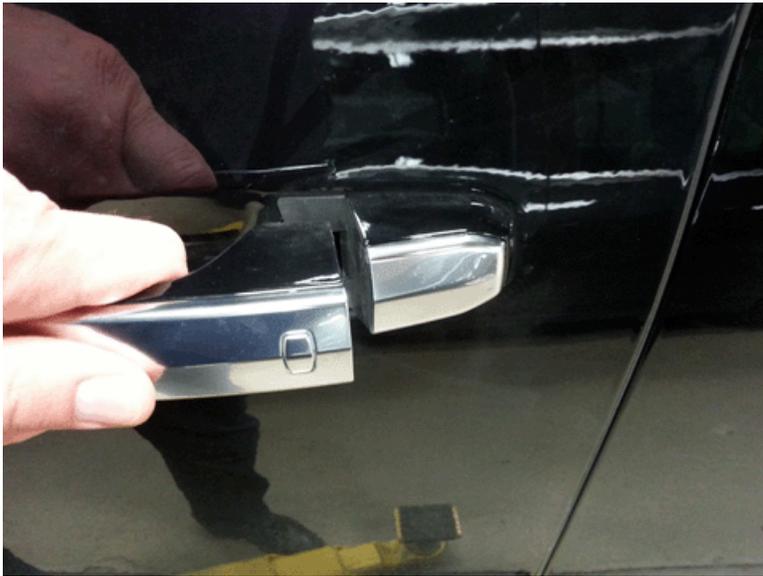
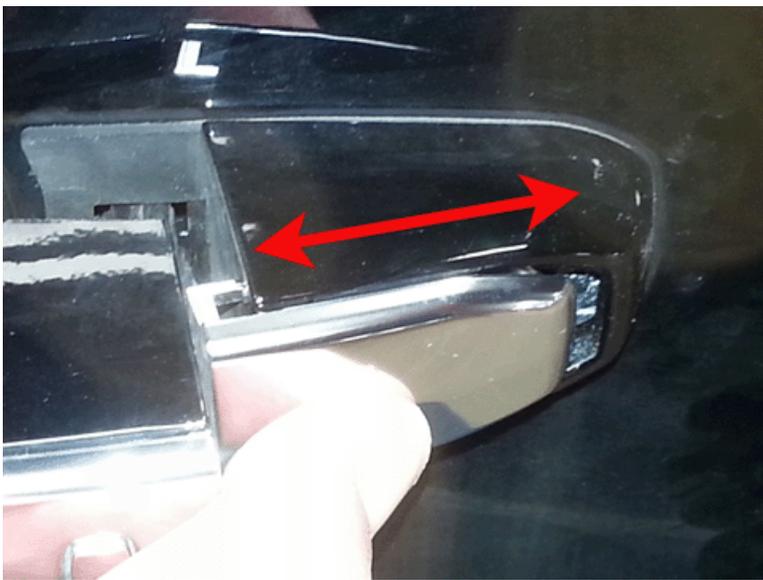
To install or remove the door lock cylinder cover, pull the door handle out and slide the door handle forward, then slide the cover forward to release it or slide the cover rearward to install it. See the pictures below for reference.

If this concern is encountered, inspect the inside of the vehicle (cup holders, storage bins, etc.) to determine if the original cover was placed there during vehicle transport.

If the original cover is not found in the vehicle, or if the cover is damaged, a replacement cover can now be ordered from CCA GM part number 13596115.
