# Service Bulletin

**Subject:** Rear HVAC and/or Rear Heated Seats Unwanted Operation (Controls Sensitive)

**Models:** 2015-2016 Cadillac Escalade Models

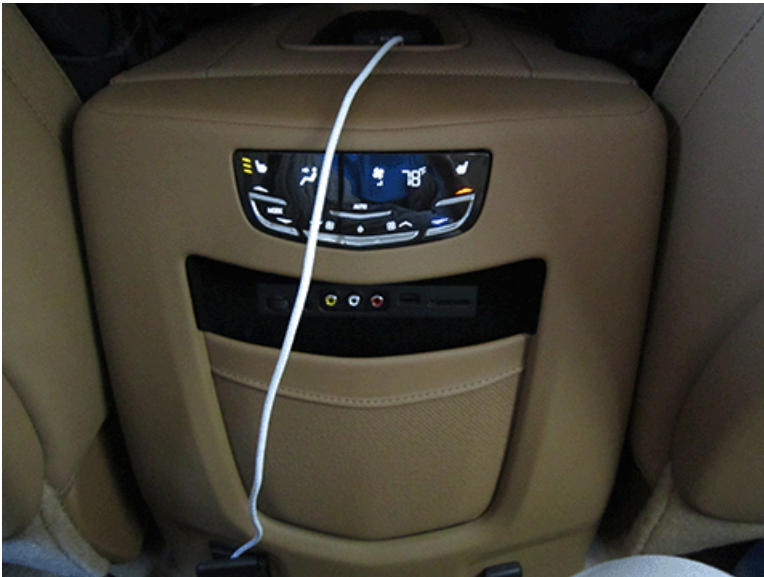
Some owners may comment that the rear/auxiliary HVAC and/or rear heated seats will change settings, or that the rear HVAC controls are too sensitive. In many cases, this concern is caused by a power cord touching or resting next to the rear HVAC controls. For example, if a cell phone power cord was plugged into the back of the center console and then run up to the top of the console where the cell phone would be plugged in, the cord would cut across the face of the rear/aux HVAC controls, as shown below.

- If the rear heated seat buttons continue to operate with the Rear Controls locked out, then the vehicle does Not have the updated rear/aux HVAC control head. IF the updated rear HVAC control head is Not present, technicians are to replace the rear HVAC control head with updated part number 84117015 to both update the rear control lockout feature, and to help further reduce the button sensitivity.

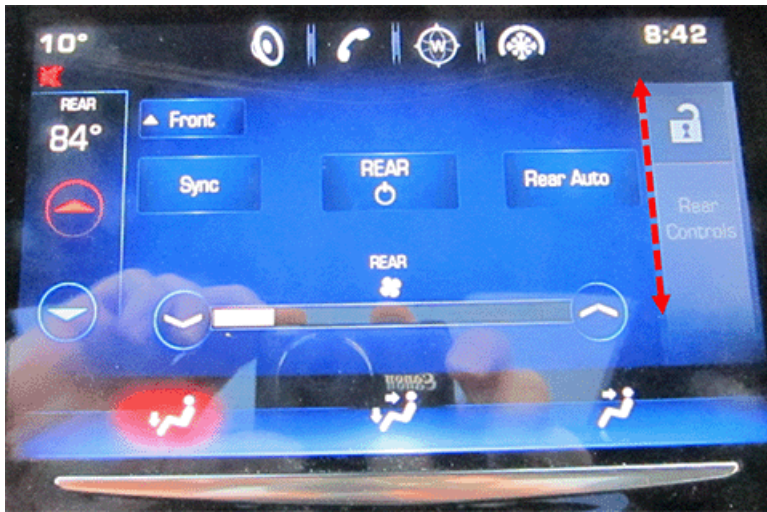
1. Press "Rear Climate Controls" Icon from the Home Page on the Front Climate Control display
2. On the right side of the screen, swipe the "Rear Controls" Lock out icon up or down to lock and unlock the rear controls (shown below), which will now lock out the rear heated seat buttons as well.

If it is found that the rear HVAC controls are still inadvertently being contacted and turning on, off, or changing settings, the driver can lock out the rear HVAC controls by doing the following from the front controls:
