Technical Service Bulletin Number

TSB150069

Anti-Polishing Ring Cylinder Liner Release to Prevent Bore Polish and Elevated Oil Consumption Caused by Piston Top Land Carbon Packing

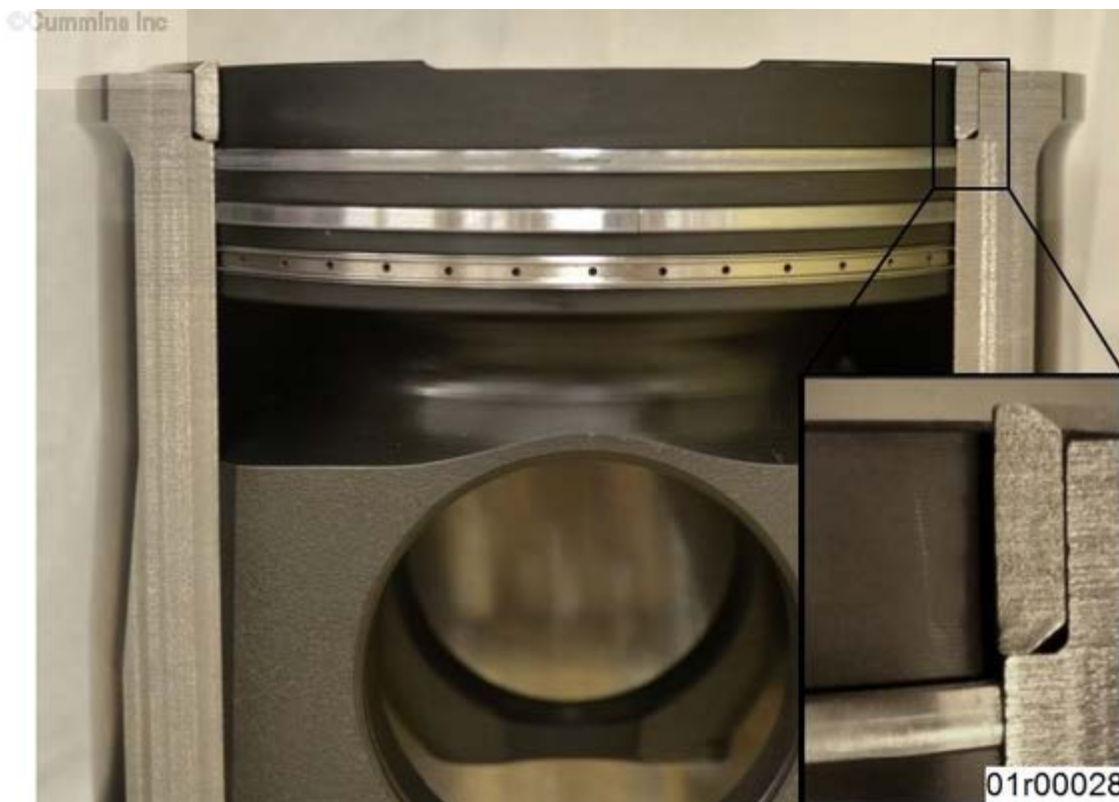
Figure 1, Cross-Section of Cylinder Liner, Anti-Polishing Ring, Piston, and Piston Ring Assembly

The anti-polishing ring is a removable carbon scraper ring that installs in a counterbore machined into the top of the cylinder liner. The anti-polishing ring overhangs the cylinder liner bore and continuously scrapes carbon from the piston top land area. This overhang controls the carbon thickness so that the carbon does **not** contact the cylinder liner and accelerate bore polish. See Figure 1.

Anti-polishing ring cylinder liners have been released for production and service to control cylinder liner bore polish caused by piston top land carbon packing. If heavy cylinder liner bore polish is identified as a result of piston carbon packing, the cylinder liners should be replaced with anti-polishing ring cylinder liners.

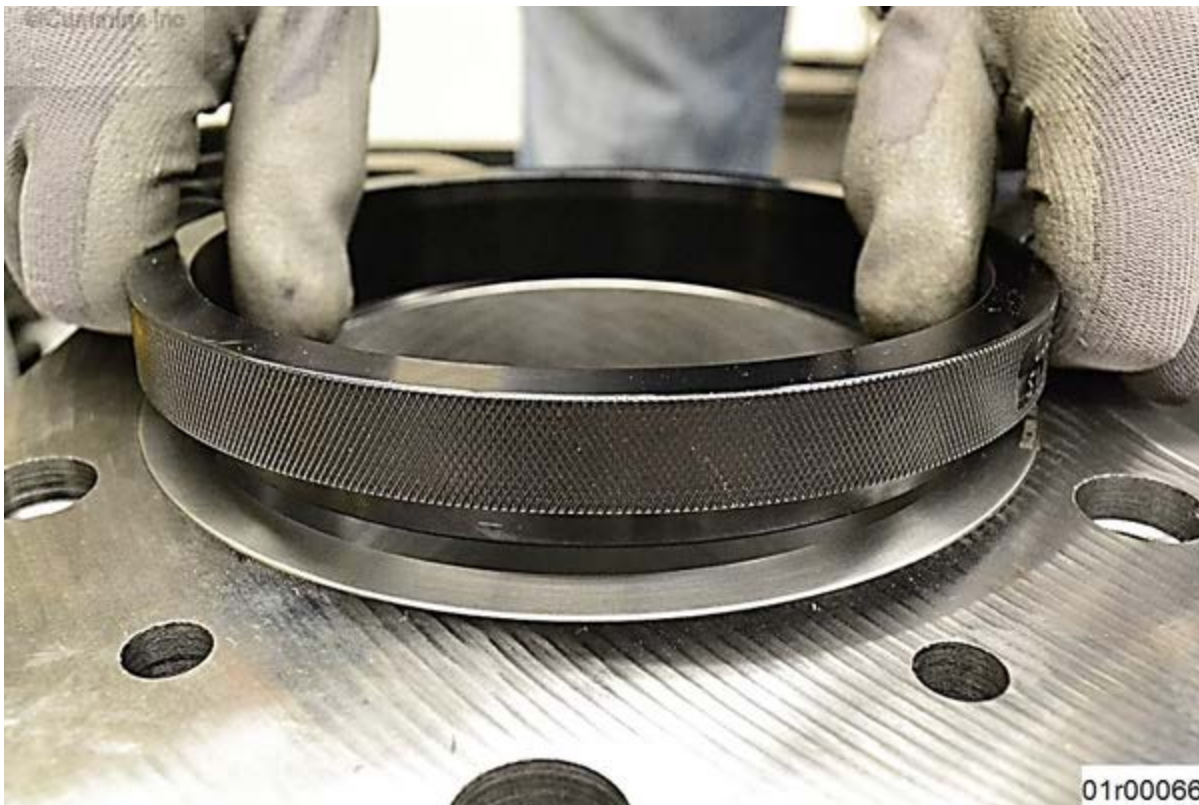
Figure 2, Piston Ring Compressor Adapter

1. Piston Ring Compressor Adaptor, Part Number 5299339, is required to install the piston, piston ring, and connecting rod assembly into an anti-polishing ring cylinder liner. See Procedure 001-054 in Section 1 for more information on using the Piston Ring Compressor Adaptor.

- o The piston, piston ring, and connecting rod assembly will **not** install into the anti-polishing ring cylinder liner with the anti-polishing ring installed because the inside diameter of the anti-polishing ring is too small for the piston rings to fit through. The Piston Ring Compressor Adaptor installs into the counterbore at the top of the cylinder liner which creates a flush surface so that the piston, piston ring, and connecting rod assembly can pass into the bore without catching the piston rings in the counterbore See Figure 2.

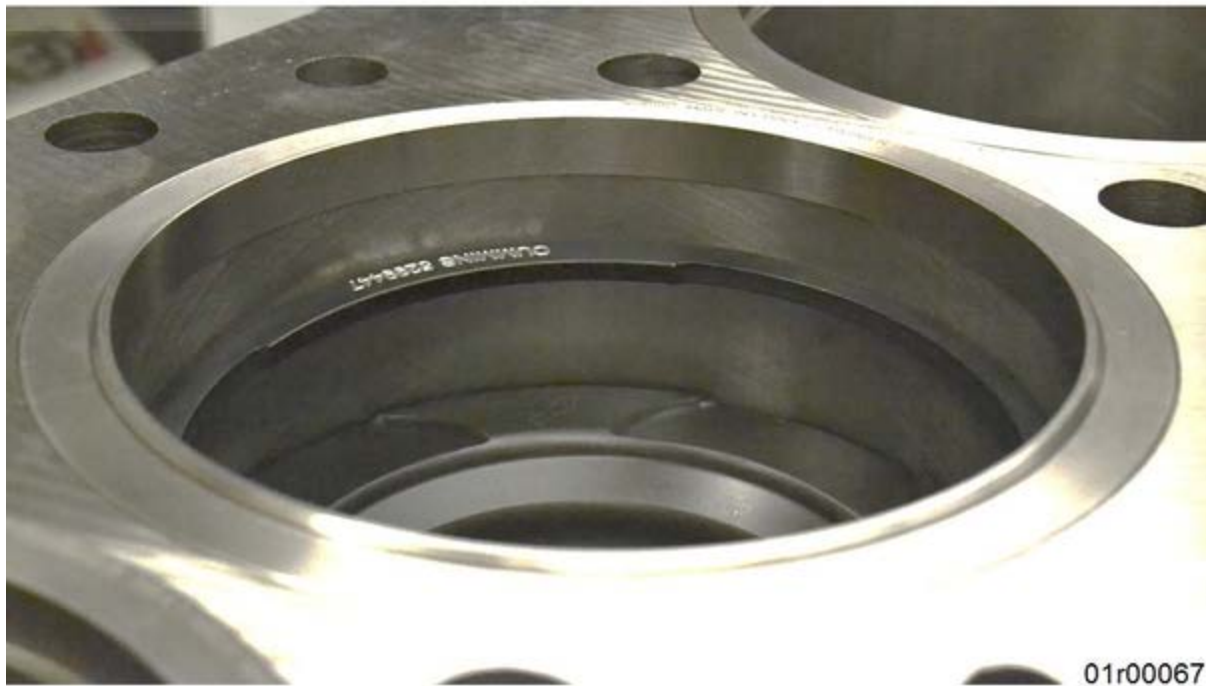
Figure 3, Anti-Polishing Ring Removal Snap Rings

2. Anti-Polishing Ring Removal Snap Rings, Part Number 5299447, can be used to remove the anti-polishing ring from the cylinder liner when removing the anti-polishing ring by hand is difficult. Most anti-polishing ring's will be removable by hand. Install the Anti-Polishing Ring Removal Snap Rings tool into the cylinder liner below the anti-polishing ring. Bar the engine over. As the piston moves to top dead center, the piston will push the snap ring up against the anti-polishing ring. This action will drive the anti-polishing ring out of the cylinder liner. See Figure 3.
