June 3, 2016

03585 Version 3

## Audio Unit Software Update

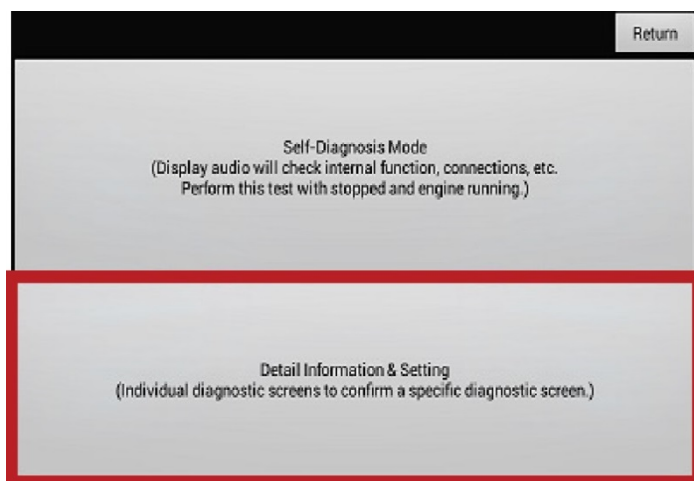
1. Start the engine and leave it running throughout the entire software update process.
2. On the HOME screen, press and hold the MENU icon, AUDIO icon, and Day/Night button at the same time for 3 seconds.
3. Select **Detail Information & Setting**.

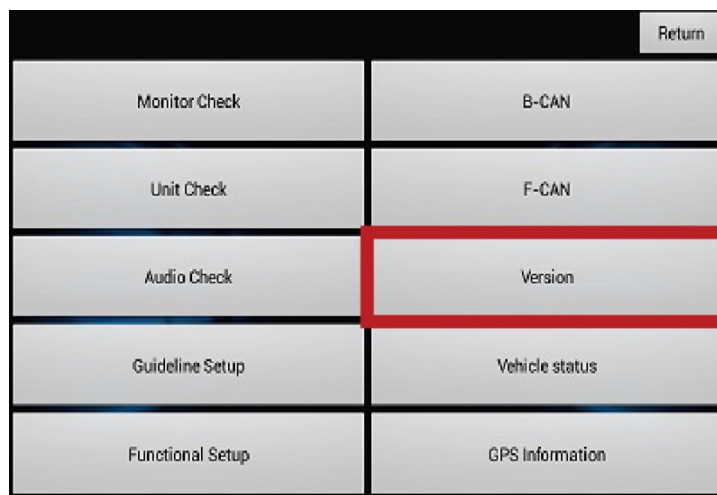
4. Select **Version**.

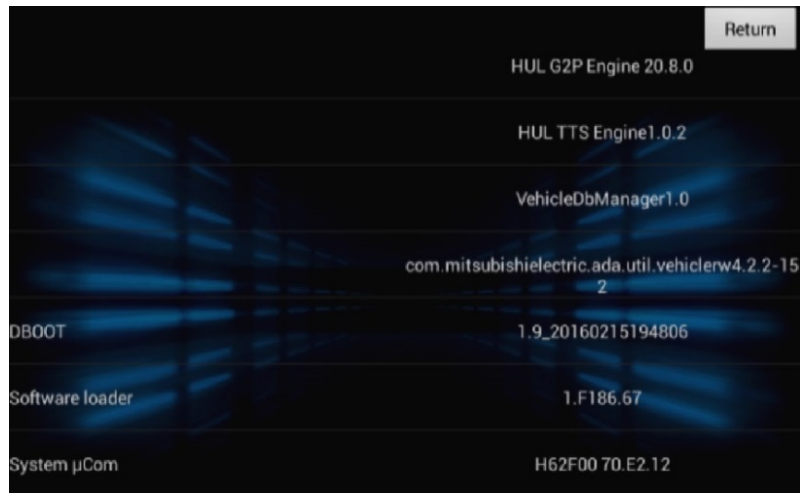
5. Scroll to **System µCom** and check the version.
- If you have version H61F00 70.**E2**.12 / H62F00 70.**E2**.12, go to the applicable software update procedure.
  - If you have version H61F00 70.**E0**.12 / H62F00 70.**E0**.12, go to the applicable software update procedure.

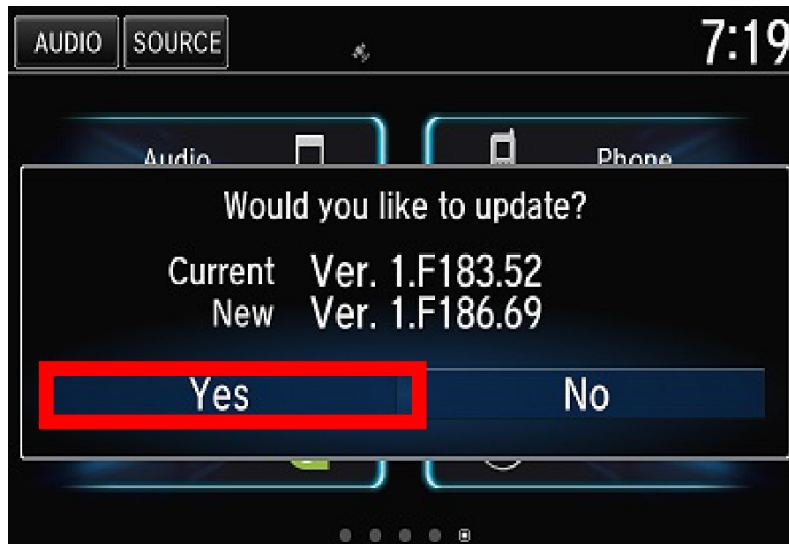
1. Connect the USB update device once the audio unit has booted up and the HOME screen appears.
2. Once the USB device is inserted, a pop-up screen appears with the current and new software versions displayed. (This may take a minute or two) Select **Yes**.

NOTE: Once you start the update, you do not have to stay with the vehicle.

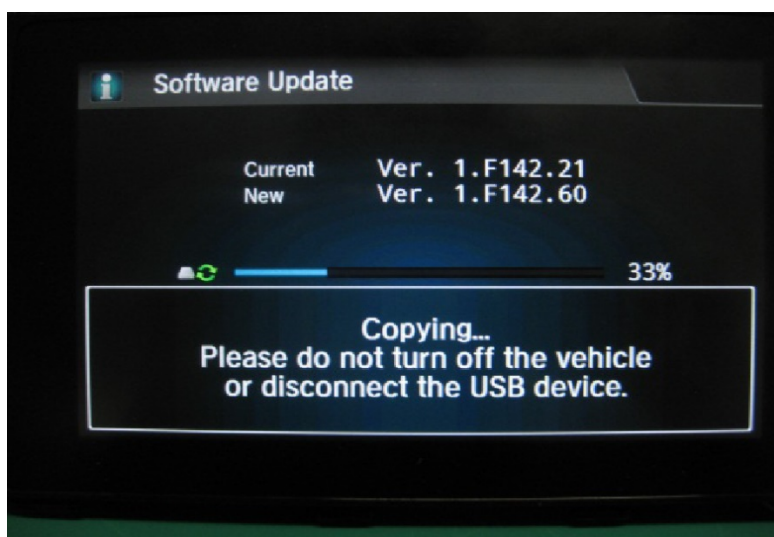
The main software update screen will appear and the update is copied from the USB device.

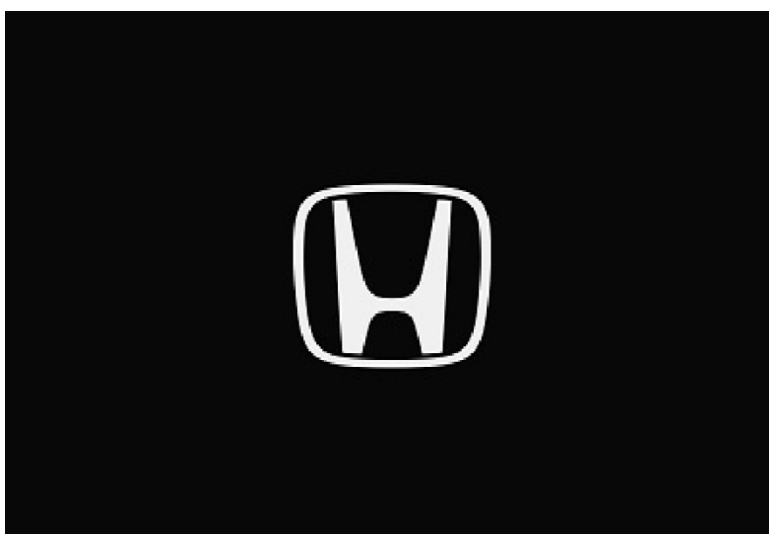
Once the update is copied, the audio unit reboots automatically.

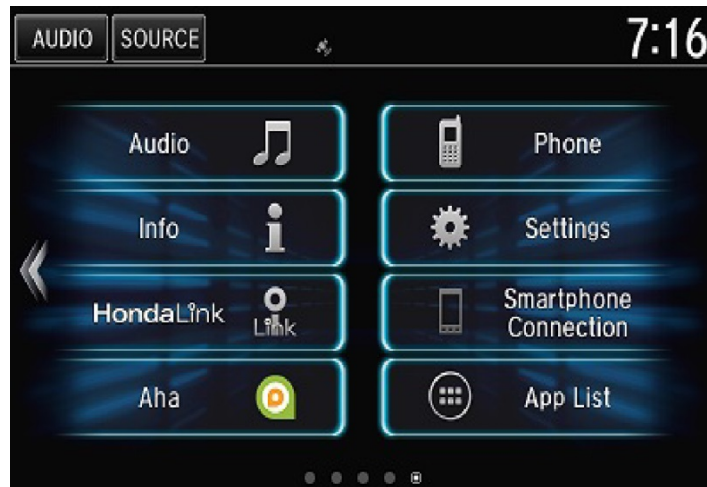
3. You may get a GPS check pop-up, if you do, follow the instructions to acquire the GPS signal.

NOTE: If you cannot acquire the GPS signal, remove the USB device and go to step 4.

The system lost power and is acquiring its location from the GPS satellites. This usually takes less than 10 minutes.

- \* Start the engine.
- \* Park the vehicle in an open area away from trees, power lines, and tall buildings.
- \* Remove loose articles, mobile phones, or electrical accessories located near the GPS antenna.
- \* If this screen is displayed repeatedly when starting the vehicle, see your dealer.

4. Once the HOME screen reappears, remove the USB device and go to SOFTWARE UPDATE CONFIRMATION.

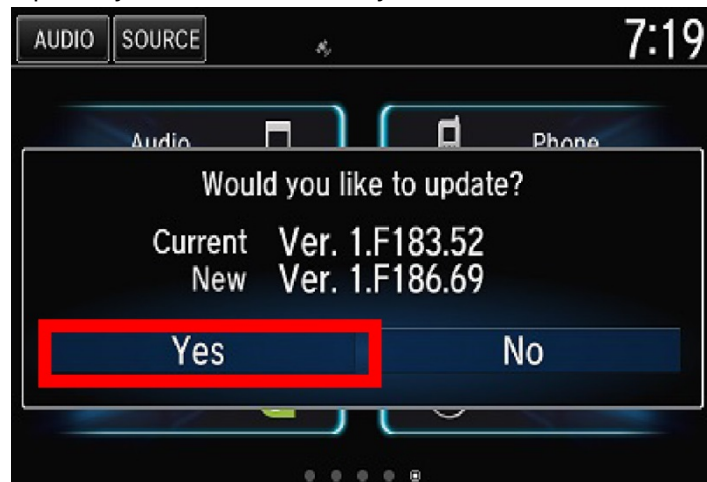
1. Connect the USB update device once the audio unit has booted up and the HOME screen appears.
2. Once the USB device is inserted, a pop-up screen appears with the current and new software versions displayed. (This may take a minute or two) Select **Yes**.

NOTE: Once you start the update, you do not have to stay with the vehicle.

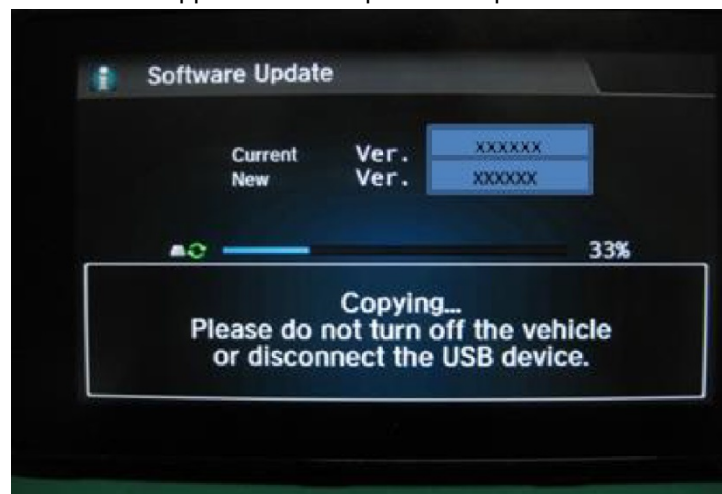
The main software update screen will appear and the update is copied from the USB device.

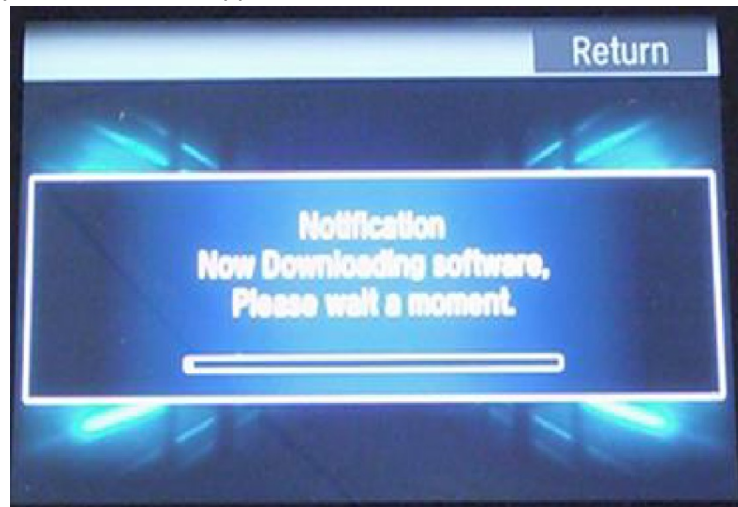
The system software update screen will appear and the software should finish downloading.

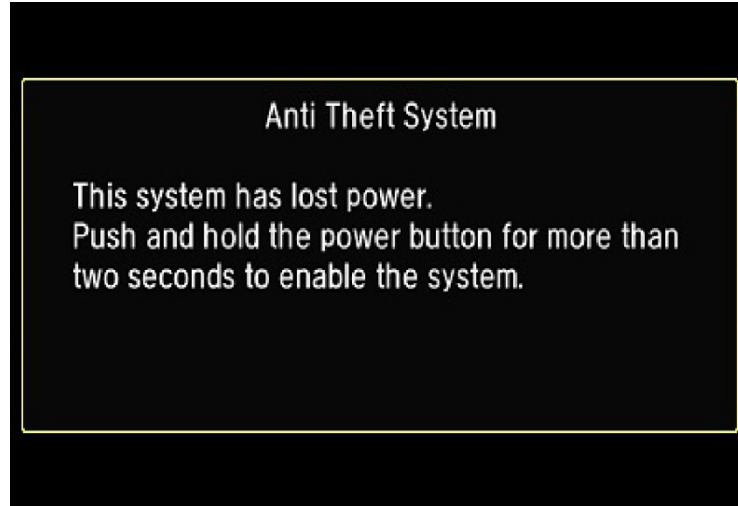
3. The **Anti Theft System** screen will appear. Push and hold the AUDIO icon for more than 2 seconds to enable the system.

NOTE: If nothing is done for 30 seconds the screen will go black, select the Day/Night button or BACK icon to return to the screen.

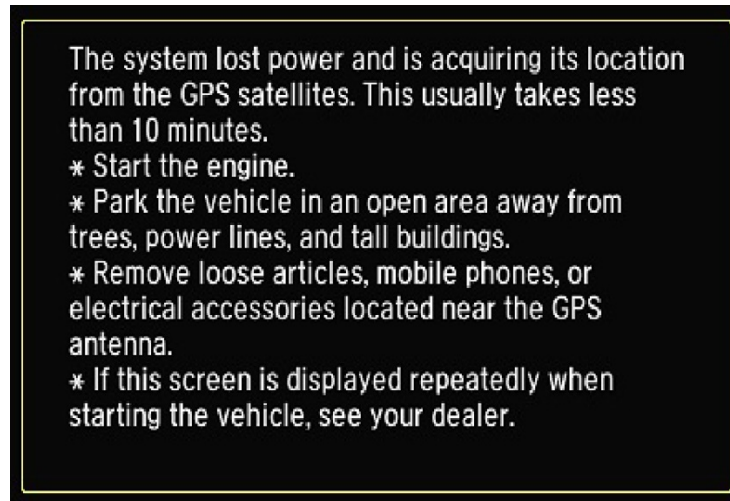
4. You may get a GPS check pop-up. If you do, follow the instructions to acquire the GPS signal.

NOTE: If you cannot acquire the GPS signal, remove the USB device and go to the next step.

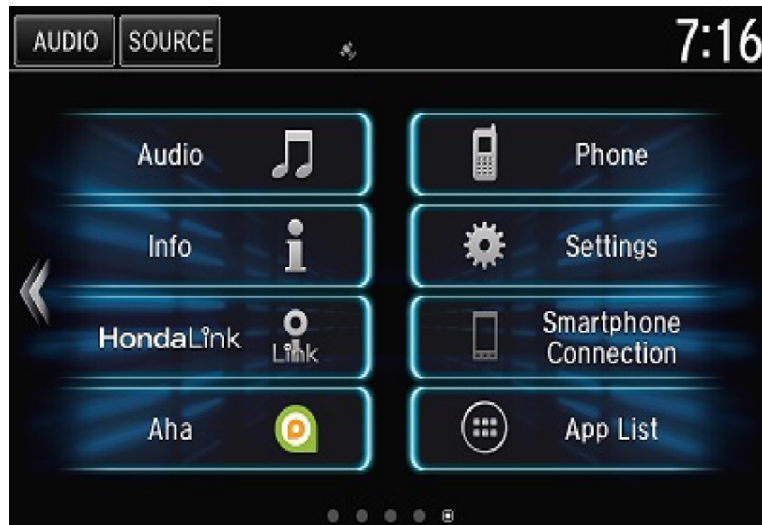
5. Once the HOME screen reappears, remove the USB device and go to SOFTWARE UPDATE CONFIRMATION.

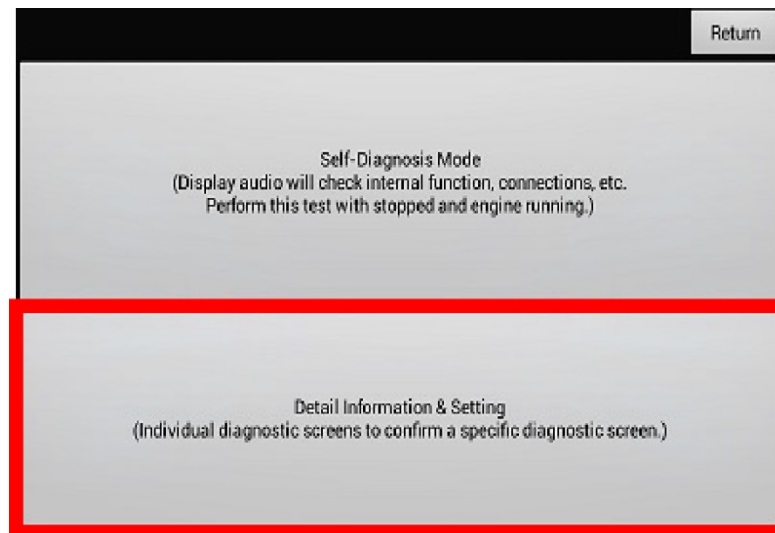
1. On the HOME screen, press and hold the MENU icon, AUDIO icon, and Day/Night button at the same time for 3 seconds.
2. Select **Detail Information & Setting**.

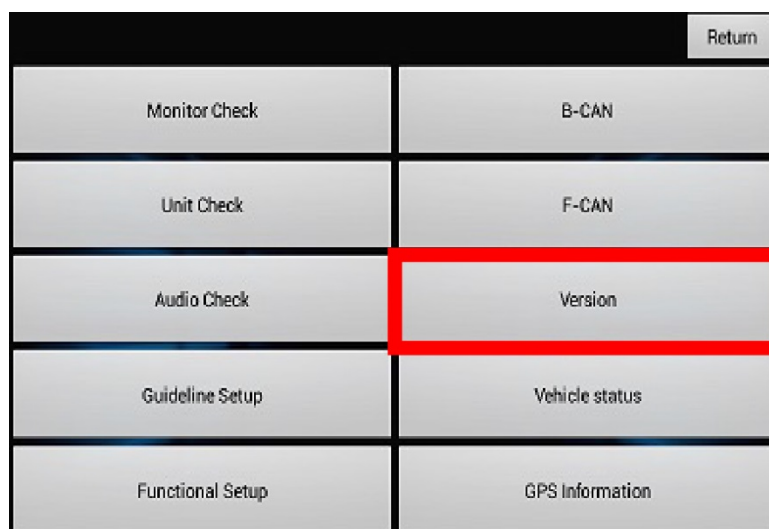
3. Select **Version**.

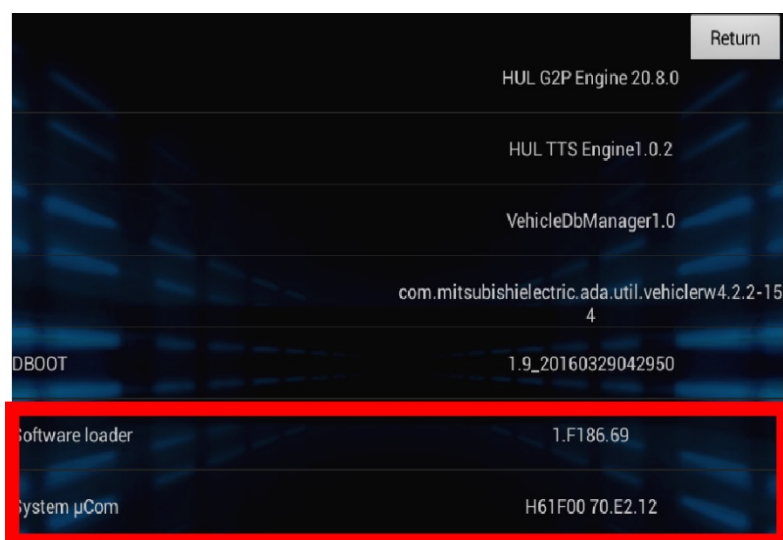
4. Scroll to **Software loader** and **System  $\mu$ Com** and check the versions. The software should be updated to the following:

- **Software loader** : 1.F186.69
- **System  $\mu$ Com** : H61F00 70.E2.12 (with XM radio function)  
H62F00 70.E2.12 (without XM radio function)

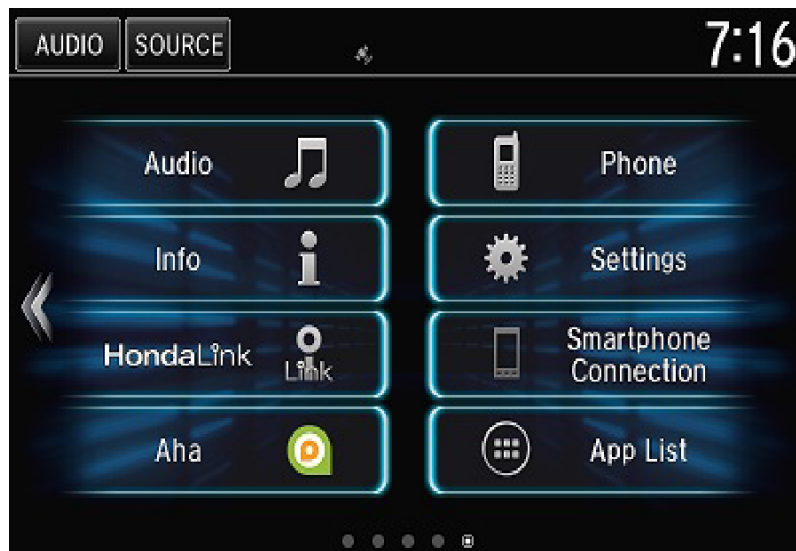
5. After verifying the software has been updated, select **Return** 3 times to return to the HOME page. Go to DELETING ERROR HISTORY.

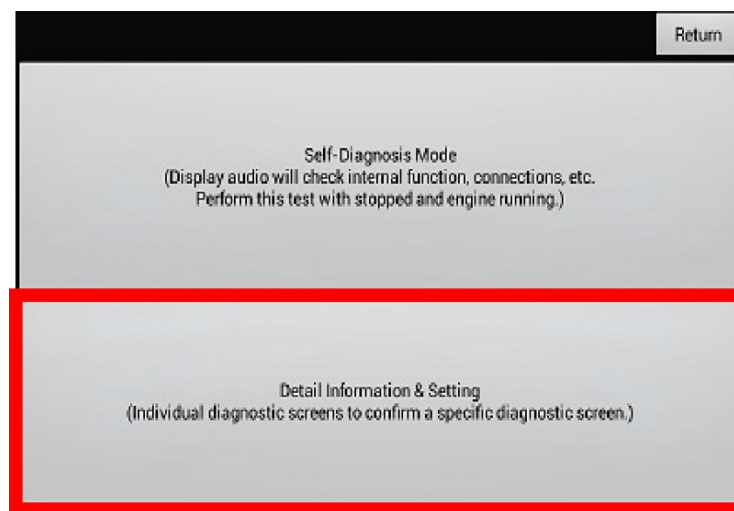
1. On the HOME screen, press and hold the MENU icon, AUDIO icon, and Day/Night button at the same time for 3 seconds.
2. Select **Detail Information & Setting**.

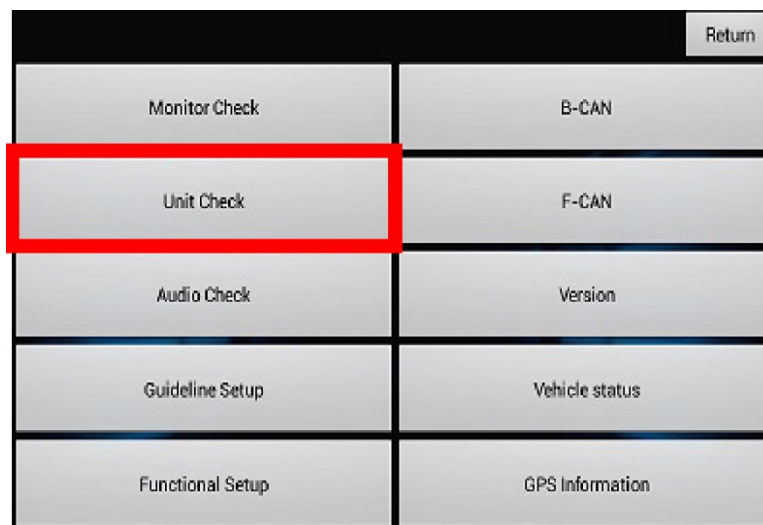
3. Select **Unit Check**.

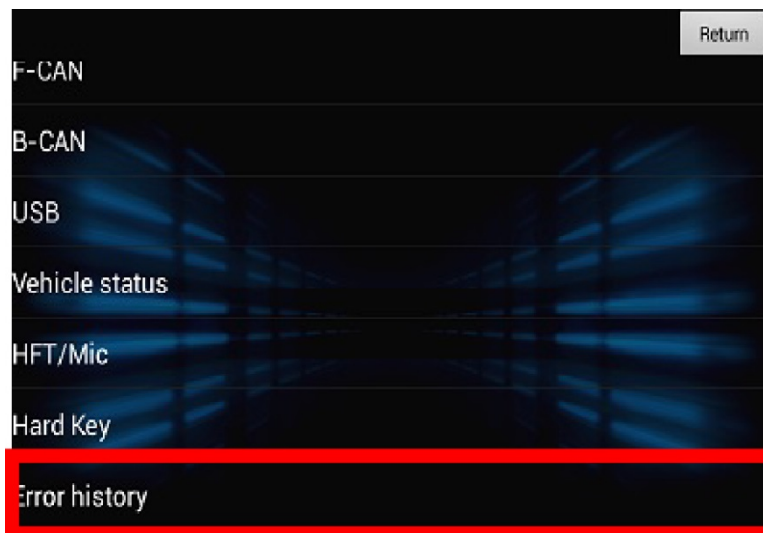
4. Select **Error history**.

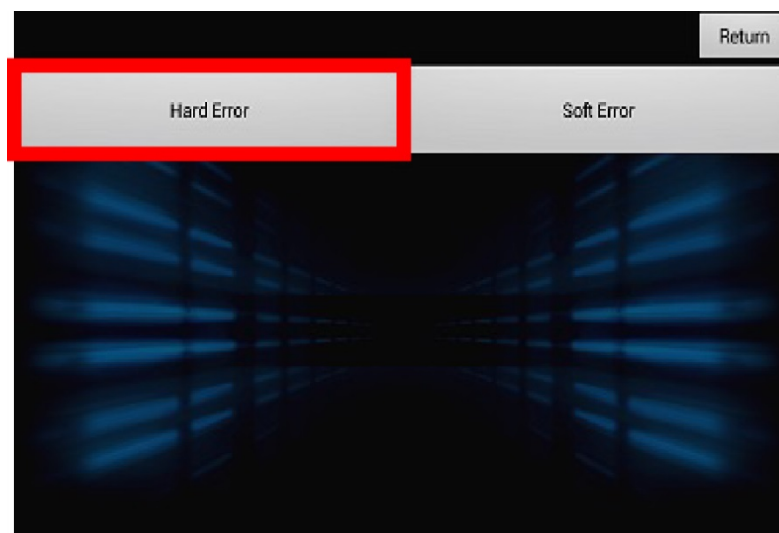
5. Select **Hard Error**.

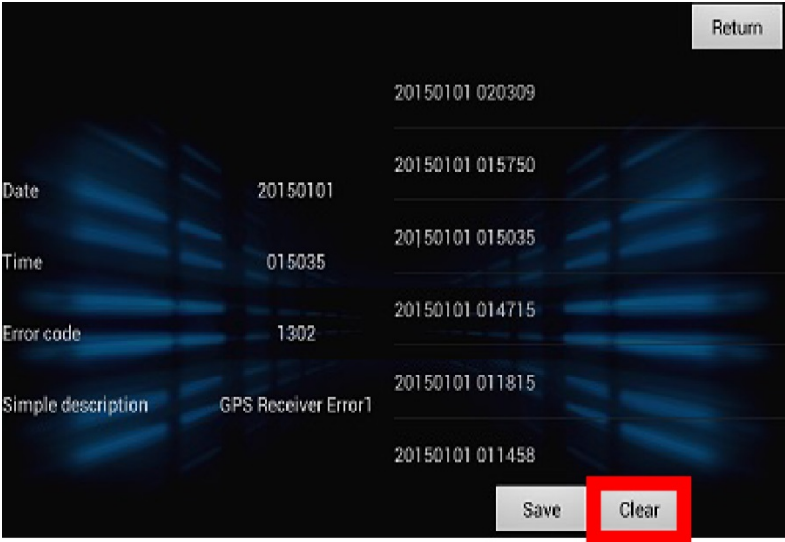
6. Select **Clear** on the bottom right.

The screenshot shows a dark-themed interface with a list of error entries. The entries are organized into columns for Date, Time, Error code, and Simple description. The 'Clear' button at the bottom right is highlighted with a red box.

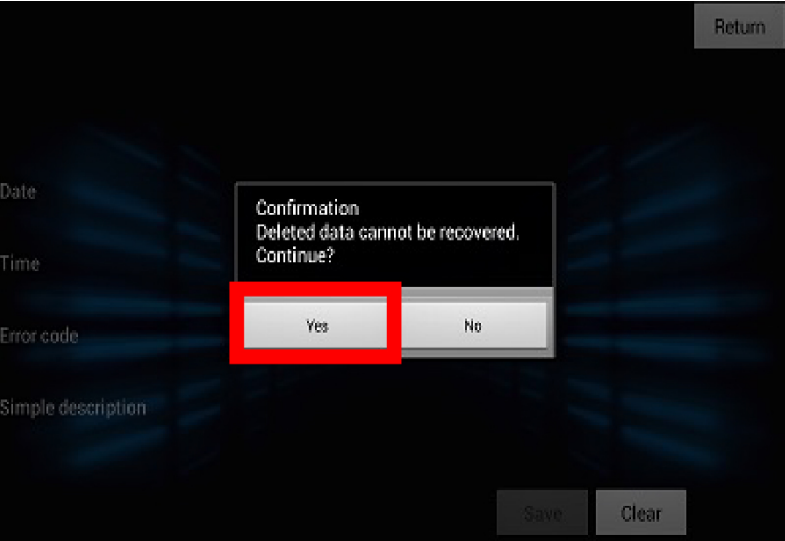
7. Select **Yes** on the **Confirmation** screen. The error history is now cleared, and the update complete.

The screenshot shows the same error history screen as before, but with a confirmation dialog box in the center. The dialog box asks for confirmation to delete data and has two buttons: 'Yes' and 'No'. The 'Yes' button is highlighted with a red box.
