**Title:** Power Window Binding

**Applies To:** ProStar, WorkStar, TranStar, DuraStar, TerraStar

This document will guide the user through initial diagnostic steps for window binding.

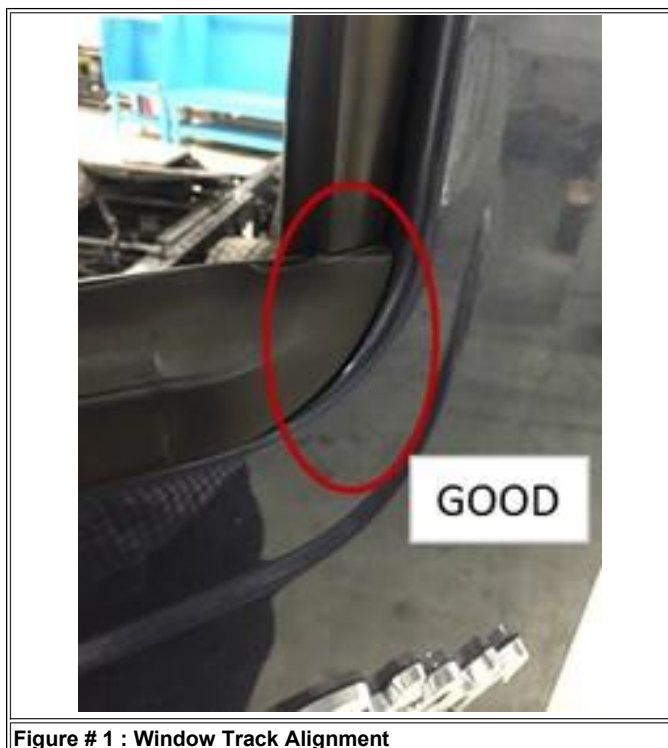
**Figure # 1 : Window Track Alignment**

Step	Action	Decision
1	<b>DIAGNOSTIC:</b> Perform visual inspection of the window tract experiencing the issue (See Figure 1 & 2)	<b>Yes.</b> Adjust window channel track to reflect proper alignment as shown in figure 1, and retest. If issue still persists go to Step 2.
		<b>No.</b> Go to Step 2

Step	Action	Decision
2	<b>DIAGNOSTIC:</b> Does the window continue to bind?  Note : If window track does not repair the concern, go ahead and continue window regulator/track diagnostics	<b>Yes.</b> Replace with window channel track with P/N : 3588772C1
		<b>No.</b> Release the vehicle.
