BULLETIN NUMBER:  
**CB16-K-002**

## SERVICE CAMPAIGN V1607 – AUTOMATIC TRANSMISSION SHIFT CABLE INSPECTION

- 2013-2014 Isuzu NPR Stripped Chassis Vehicles (Reach Van)  
With **Chassis** Manufactured During October 2013 and April 2014

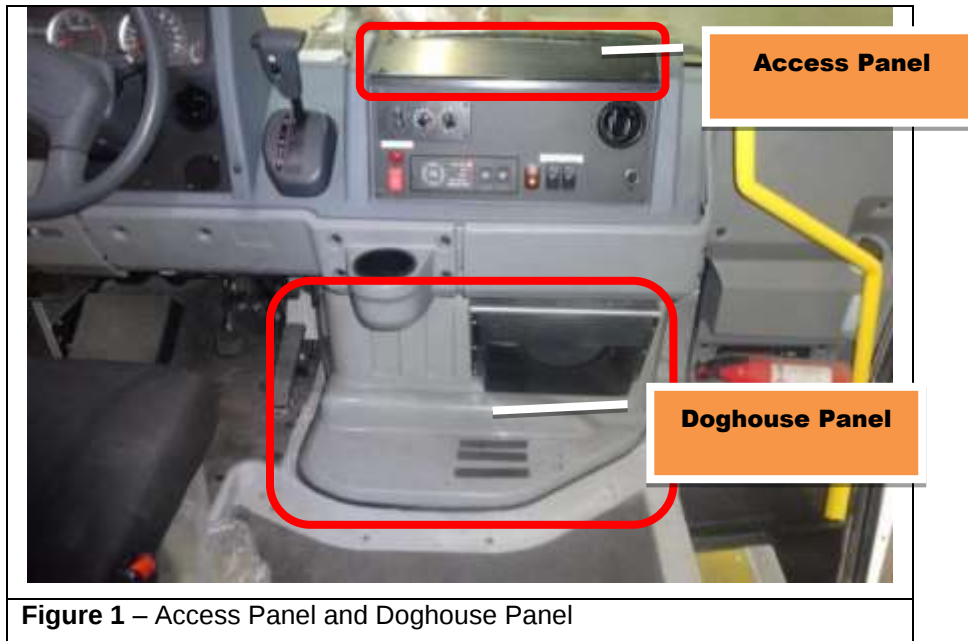
Figure 1 – Access Panel and Doghouse Panel

1. Engine OFF, apply the parking brake.
2. Block the front wheels.
3. Remove four (4) bolts to remove the dash board access panel (see Figure 1).

5. Remove the doghouse panel as shown in Figure 1 and open the hood.
6. Disconnect the negative (-) battery cable.
7. Working through the doghouse opening, remove the snap joint pin and washer which connects the shift cable to the transmission (see Figure 4) and save for reuse.

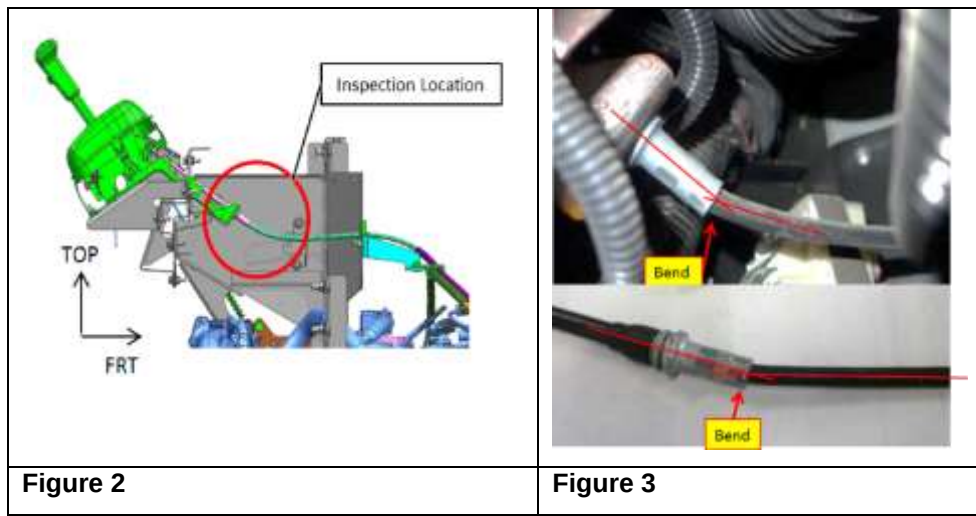
4. Inspect the shift cable for the bent condition at the location shown in Figures 2 and 3.
  - a. If the shift cable is **not** bent as shown in Figure 2, skip to Step 37.
  - b. If the shift cable is bent as shown in Figure 3, continue to Step 5.

In some 2013-2014MY Isuzu NPR Stripped Chassis (Reach Vans) with **chassis** manufactured by Isuzu Motors Limited during October 2013 and April 2014, the Automatic Transmission Shift Cable may be bent. Over time and with use, the bent cable may fatigue and break. If the cable breaks, the driver may be unable to shift the transmission out of Park or from one gear to another.

The Automatic Transmission Shift Cable must be inspected and, if found to be bent, replaced. This service will be performed for customers at **no charge**.

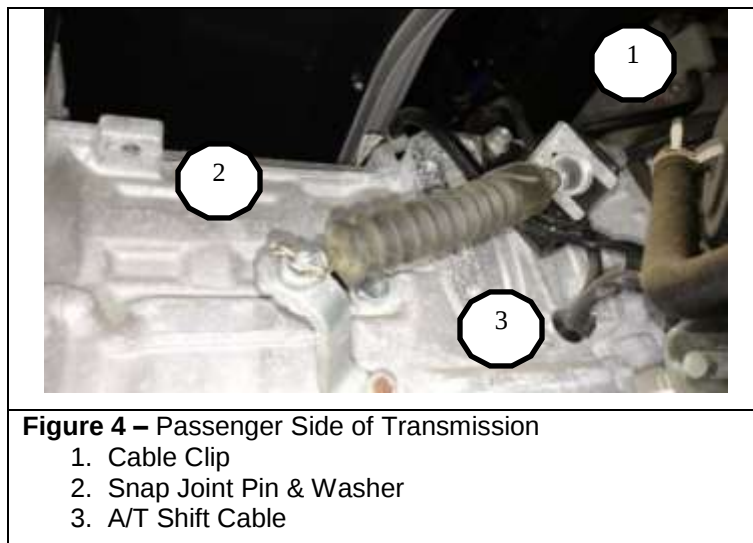
8. Remove the cable clip that secures the shift cable to the transmission (see Figure 4) and save for reuse. Remove the shift cable from the bracket.

**NOTE:** Use a hook and pick tool and pry up at the middle of the clip for easy removal.

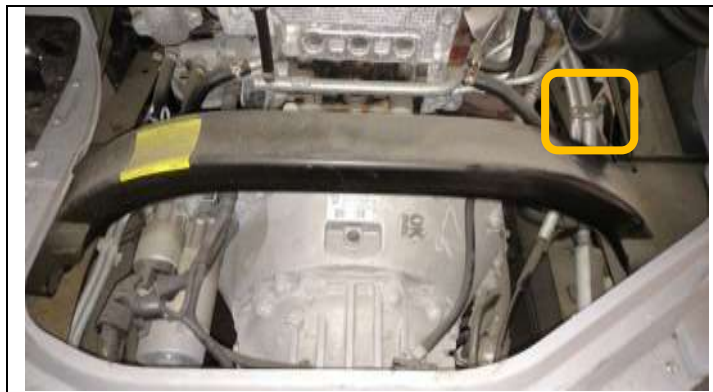
**Figure 5 – Mounting Bracket at Passenger Frame Rail**

9. From the doghouse opening, remove the shift cable from the mounting bracket at the passenger frame rail next to the transmission flywheel housing. Remove the 12mm bolt and nut to separate the bracket from the frame rail (see Figure 5). Keep the bracket and mounting hardware for installation of the new shift cable.

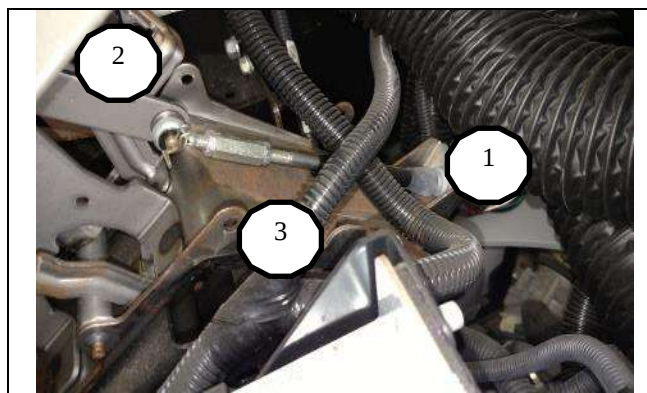
**Figure 6 – From Under the Shifter**

10. Working through the dashboard access panel, remove the snap joint pin and washer which connects the shift cable to the shifter (see Figure 6) and save for reuse.

11. Remove the cable clip that secures the shift cable to the dashboard (see Figure 6) and save for reuse. Remove the shift cable from the bracket.

1. Cable Clip
2. Snap Joint Pin & Washer
3. A/T Shift Cable

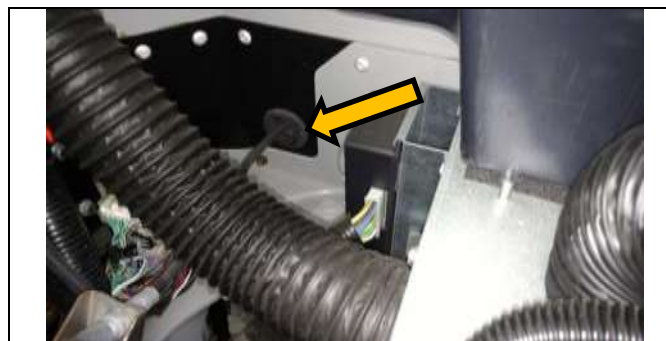
**Figure 7 – Rubber Grommet at the Engine Wall**

12. Remove the rubber grommet at the engine wall (see Figure 7).

25. Reinstall the rubber grommet at the engine wall.

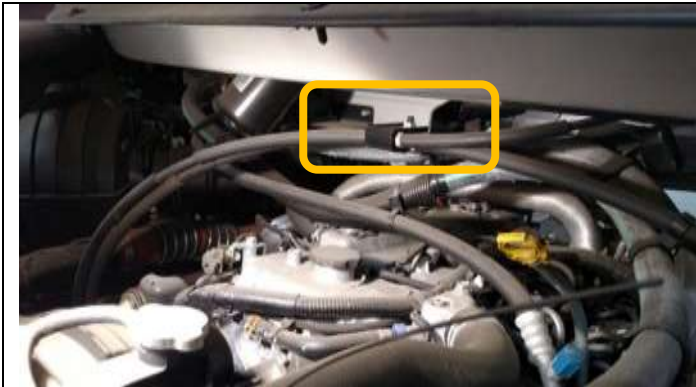
**Figure 8 – Cover Bracket Location**

13. From the front of the vehicle, remove the shift cable from the mounting bracket above the engine. Loosen the 12mm retaining nut and move the top of the bracket to the side (see Figure 8).

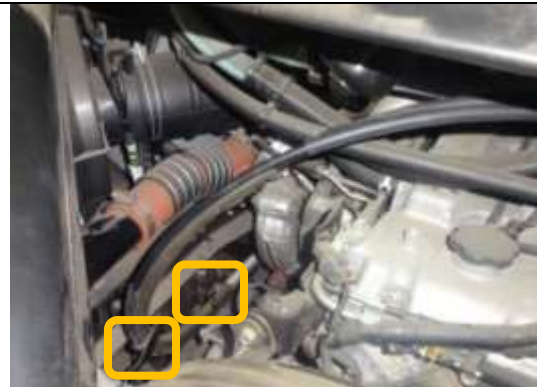
**Figure 9 – Clip Band Locations**

14. Remove the shift cable from the two (2) clip bands at the frame rail on the passenger side (see Figure 9).

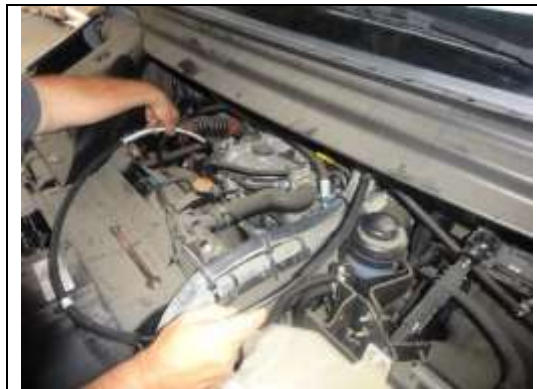
**Figure 10 – A/T Shift Cable Removal**

15. Remove the shift cable assembly (see Figure 10).

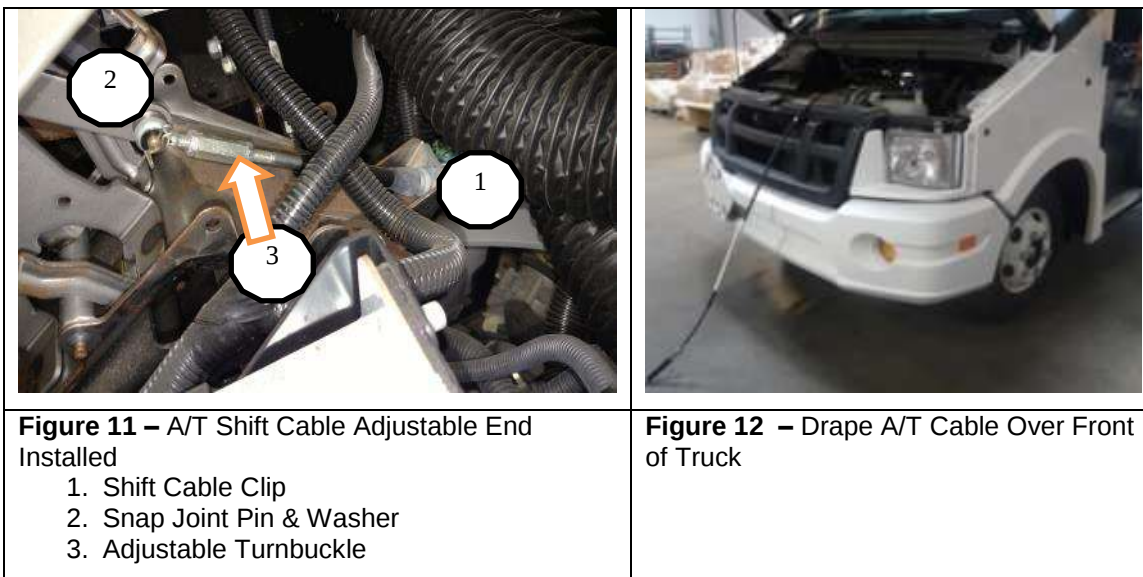
16. Partially install the new shift cable starting at the engine wall. Feed the end of the shift cable with the adjustable end through the engine wall, up to the base of the shift lever. Rest the other end of the shift cable over the front of the truck (see Figures 11 and 12).

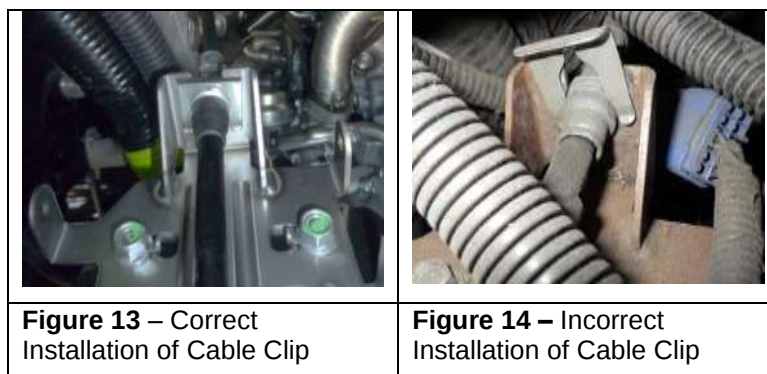
17.Route the shift cable into the shifter frame bracket and properly secure with the cable clip (see Figures 13 and 14).

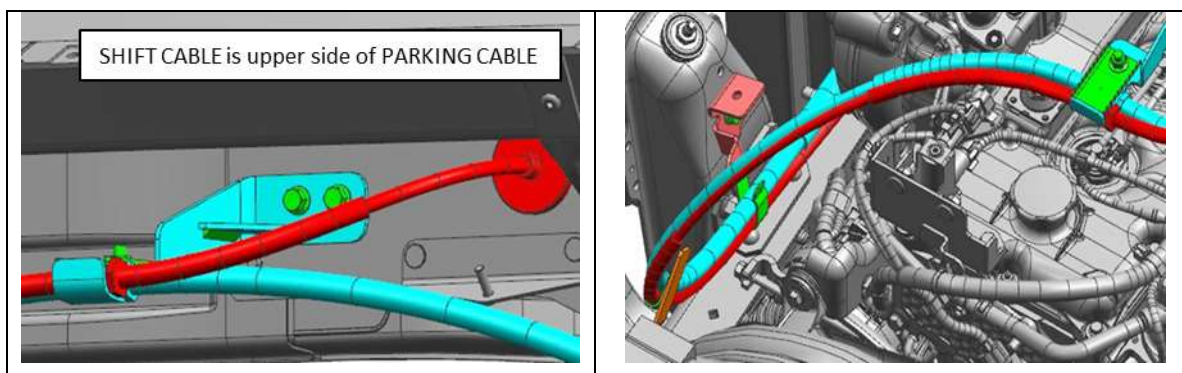
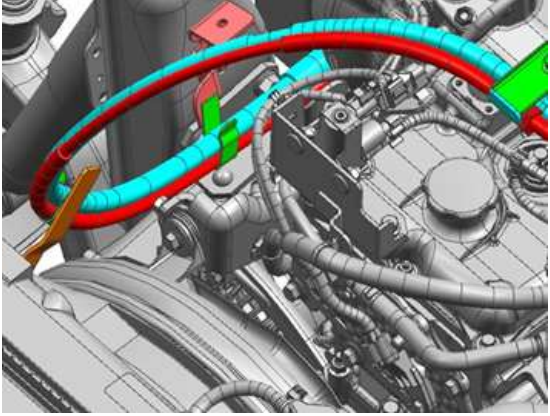
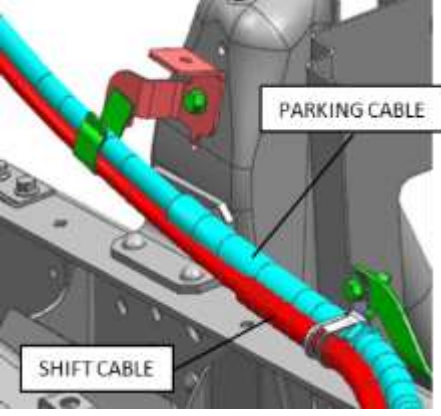
| <p><b>Figure 15</b></p> | <p><b>Figure 16</b></p> |

19.Carefully route the remainder of the shift cable (see Figure 15) over the parking brake cable and into the mounting bracket over the engine. Then feed the end of the cable back toward the transmission. The shift cable should be installed into the band clips and then the parking brake cable on top (see Figures 16, 17 and 18).

23. Reconfirm the shift cable is properly seated in the band clips (see Figure 17).

24. Secure the shift cable to the cover bracket (see Figure 15). Tighten to the specified torque.

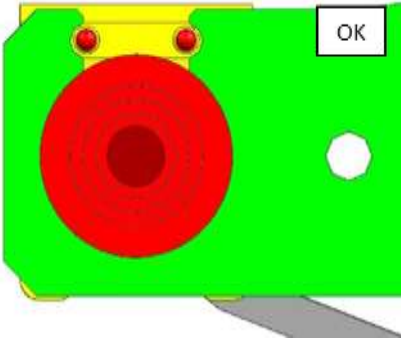
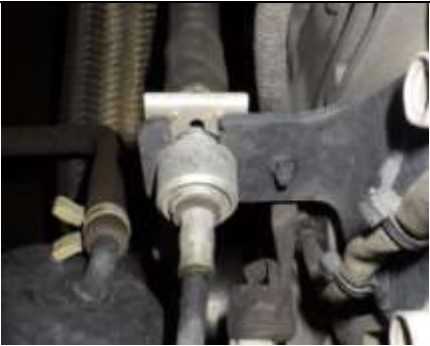
| <p><b>Figure 19 – Correct Installation of the Cable Clip</b></p> | <p><b>Figure 20 – Incorrect Installation of the Cable Clip</b></p> |

20. Insert the shift cable into the bracket at the transmission and install the cable clip. Be sure to completely install the clip (see Figures 19 and 20).

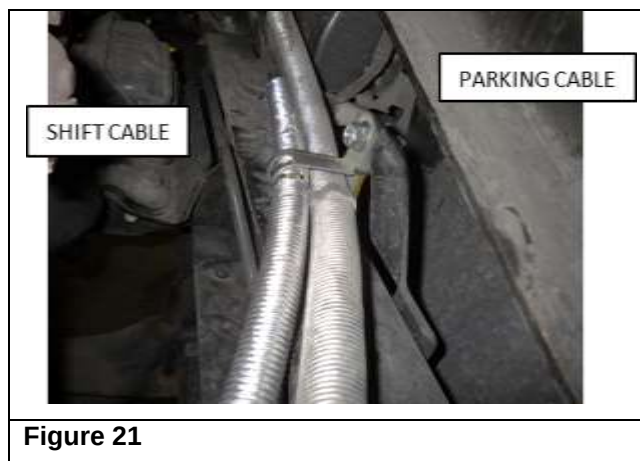
21. Install the snap joint pin and washer which connects the shift cable to the transmission.
22. Secure the cables in the clip band and bolt to the frame (see Figure 21). Tighten to the specified torque.

**Tightening Torque:** 14-26 Nm (10-19 ft lb)

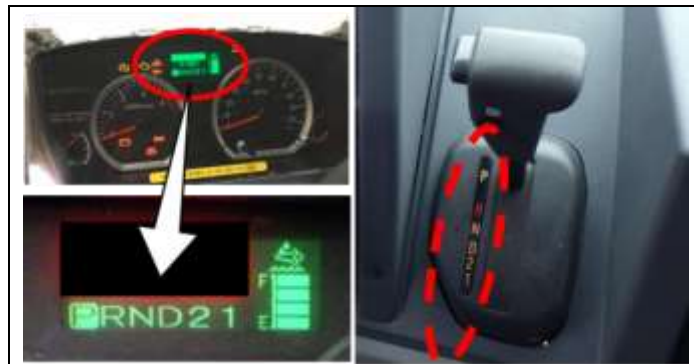
**Figure 22 – Operation Check**

28. Move the shift lever through all gear positions. See if the multi-information display (MID) matches the position selected with the shift lever (see Figure 22).

- If the selected gear and the MID display match in every position, no adjustment is necessary. Skip to Step 36.
- If any one position does not match, the cable must be adjusted. Continue to Step 29.

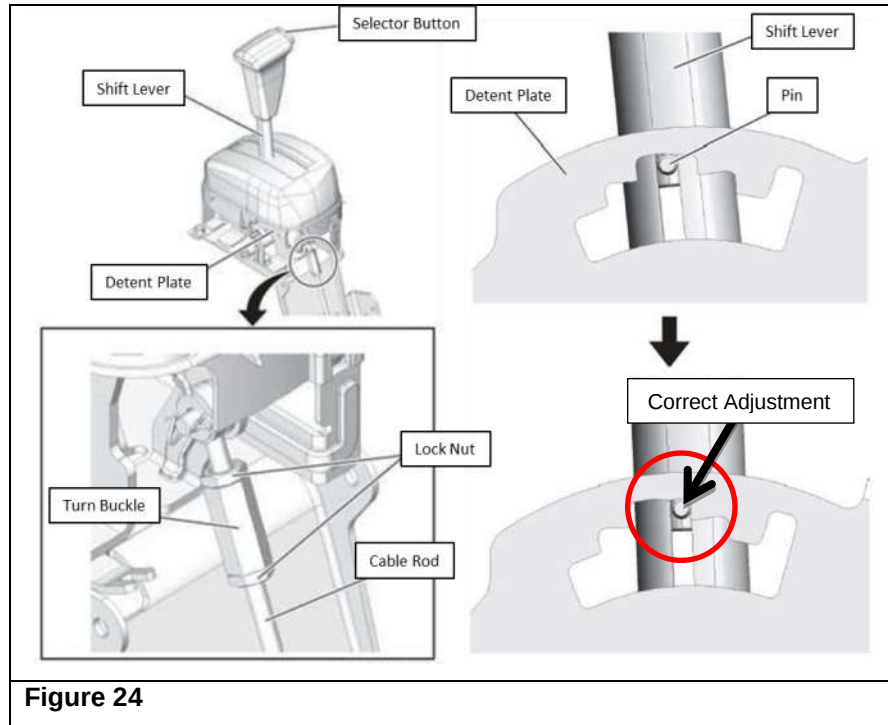
**Figure 24**

30. Loosen both lock nuts at the adjustment end of the shift cable at the base of the shifter.
31. Adjust the control cable length by rotating the turnbuckle until the pin touches the upper-right corner of the detent plate (see Figure 24).

32. Push and release the selector button of the control lever three (3) times and confirm the pin smoothly operates without interference of the detent plate.
33. Tighten both 10mm turnbuckle lock nuts to the specified torque.
