IB15-L-001A

EXHAUST GAS TEMPERATURE (EGT) SENSORS 1 AND 2 – TEST PROCEDURE

AFFECTED VEHICLES

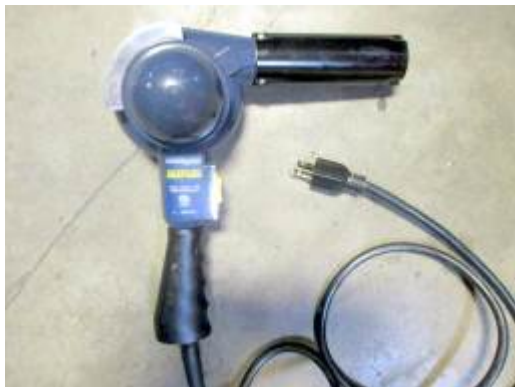
Figure 3 – 110V Heat Gun

3. Check the sensor's dynamic resistance by warming the sensor tip by hand or by using a standard 110V heat gun (see Figures 3 through 5). The temperature vs. resistance response is inversely proportional; therefore the resistance value shown on the DVOM should decrease as the sensor is heated (see Figure 6). Stop applying heat if the resistance drops below 1KΩ.
 - a. If the sensor resistance decreases when heated, the sensor is working properly and should not be replaced.
