## Service Campaign 66-07

**AFFECTED:** 2013, 2014 & 2015 Winnebago Journey and Itasca Meridian models  
2014 & 2015 Winnebago Forza and Itasca Solei models

**SUBJECT:** Engine Air Water Separator Enhancement

**Engine Air Water Separator Enhancement**

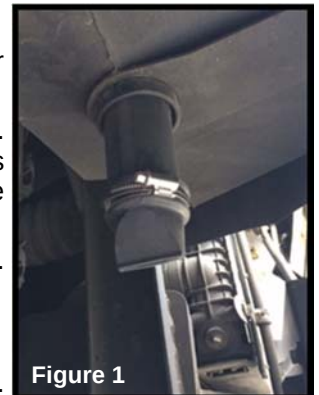
Figure 1

- If the drain circuit resembles Figure 1, the campaign does not need to be completed. You can notify us by completing the postcard included with this letter or contacting us at [or@wgo.net](mailto:or@wgo.net) or (800) 537-1885 with your Winnebago Body Serial Number and we will remove your coach from the campaign.
- If the drain circuit resembles Figure 2, the campaign will need to be performed. Contact your Winnebago Industries, Inc. dealer to arrange for a service appointment.
