Inner Rear View Mirror Poor Appearance

Service Category Vehicle Interior

Section Mirror (int)

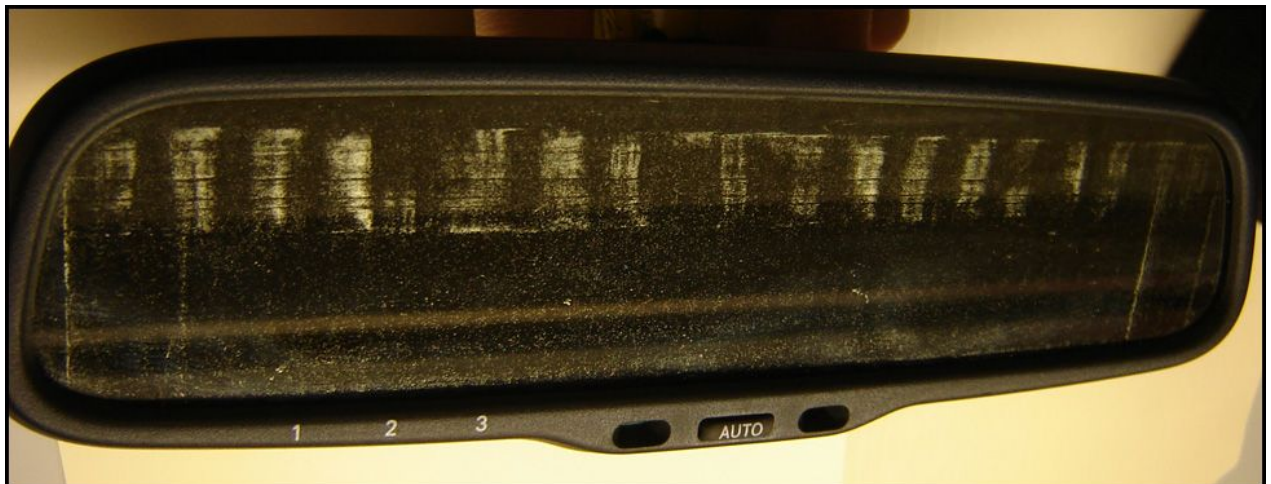
Some 2006 – 2009 model year IS 250/350, 2008 – 2009 model year IS-F, 2007 – 2009 LS 460/460L, and 2008 - 2009 LS 600h models may exhibit a discolored and/or “striped” condition inside the inner rear view mirror glass as shown in Figure 1. An improved service part has been developed to correct this condition.

1. Remove the inner rear view mirror. Refer to the Technical Information System (TIS), applicable model and model year Repair Manual:
 - [2008](#) / [2009](#) LS 600h
Vehicle Interior – Mirror (Int) – “Mirror: Inner Rear View Mirror: Removal”
 - [2007](#) / [2008](#) / [2009](#) LS 460/460L
Vehicle Interior – Mirror (Int) – “Mirror: Inner Rear View Mirror: Removal”
 - [2006](#) / [2007](#) / [2008](#) / [2009](#) IS 250/350
Vehicle Interior – Mirror (Int) – “Mirror: Inner Rear View Mirror: Removal”
 - [2008](#) / [2009](#) IS-F
Vehicle Interior – Mirror (Int) – “Mirror: Inner Rear View Mirror: Removal”
2. Install the NEW inner rear view mirror.

Torque: 1.8 N•m (18 kgf•cm, 16in•lbf)
