Subject: Limited Service Campaign (LSC) GLI
247 Specific 2016 Model Year AWD (All Wheel Drive) RC 300 and RC 350 Vehicles
Incorrect Driver's Carpet Floor Mat

**TECHNICAL INSTRUCTIONS
FOR
LIMITED SERVICE CAMPAIGN GLI
CARPET FLOOR MAT REPLACEMENT
CERTAIN 2016 MY RC 300 AWD & RC 350 AWD**

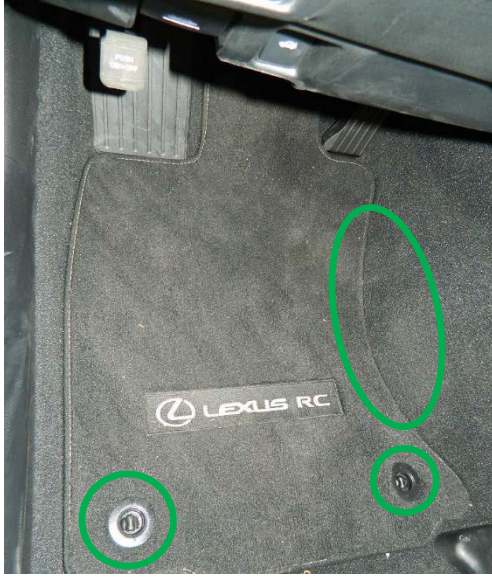
THIS IS THE CORRECT FLOOR MAT

a) Inspect the left front floor mat and compare to the photos.

The mat should fit around the transmission tunnel as shown.

Both rear hold down clips should line up and be secured.

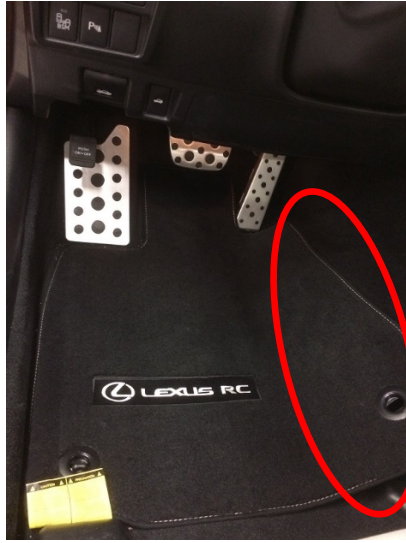
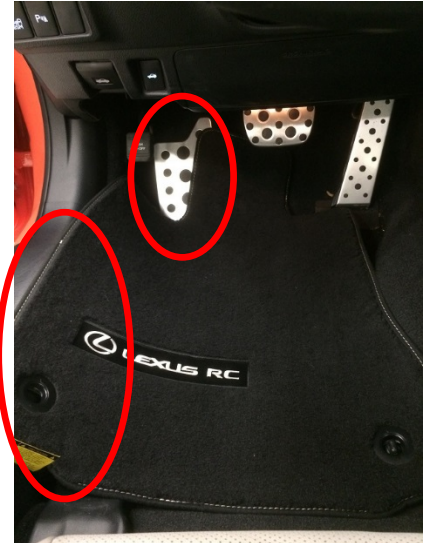
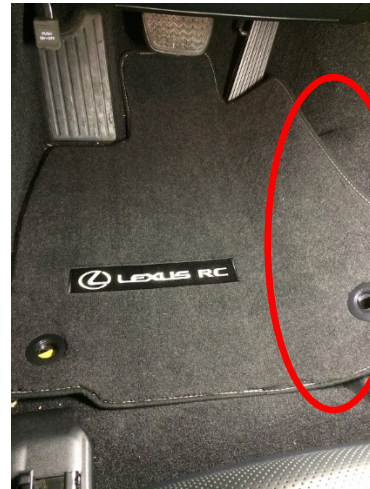
**THIS IS THE INCORRECT MAT
REPLACE ALL 4 FLOOR MATS**

The edge of the mat does not fit in the vehicle correctly.

The dead pedal may be partially covered.

One or both rear hold down clips do not line up and are unsecured.

NOTE: All-weather floor mats are not involved in this LSC. If all-weather floor mats are installed in the vehicle and the carpeted floor mat is NG, place the new mats in the trunk. DO NOT install the carpeted mats on top of or under the all-weather mats.

- Ensure the new floor mats are installed correctly.
