September 23, 2016

04872 Version 1

**Tailgate Will Not Swing Open****AFFECTED VEHICLES**

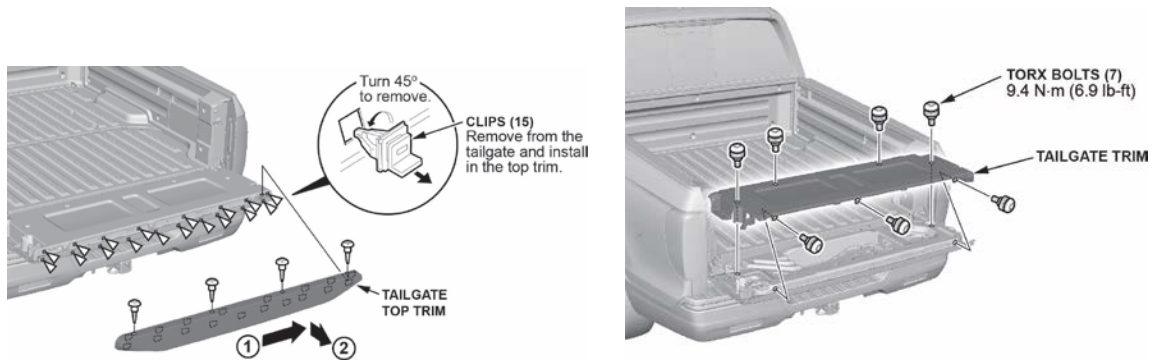
1. Open the tailgate in the drop down mode.
2. Remove the tailgate trim.

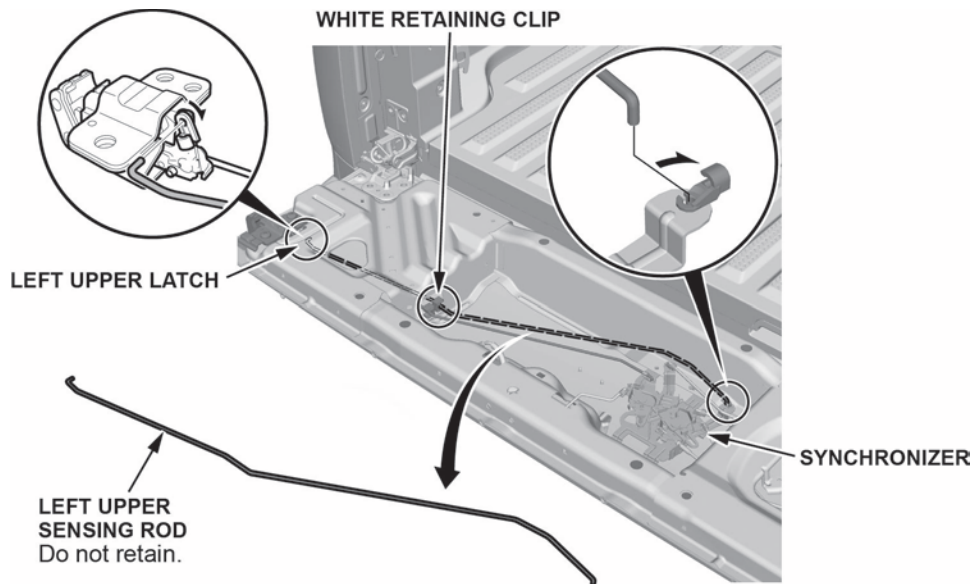
3. Disconnect the left upper sensing rod from the synchronizer.

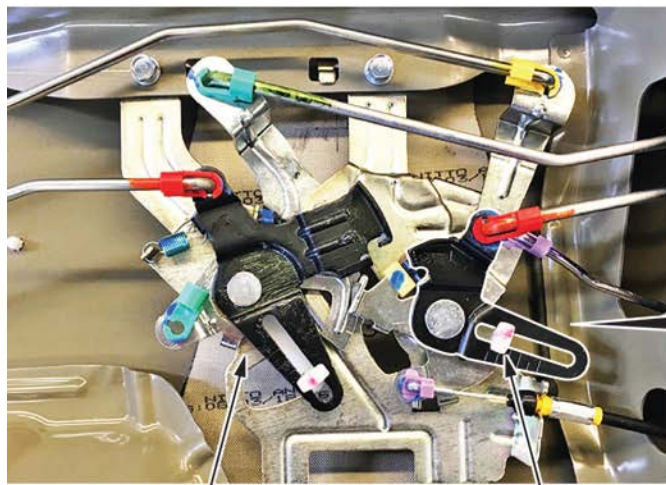
9. Verify the position of the plastic anvil and make sure it is in the range as shown

SYNCHRONIZER

PLASTIC ANVIL

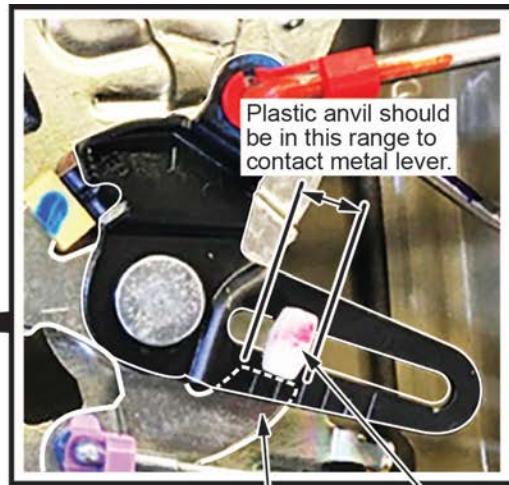
METAL LEVER

PLASTIC ANVIL
