September 28, 2016

01800 Version 2

LKAS Does Not Keep Vehicle in Detected Lane

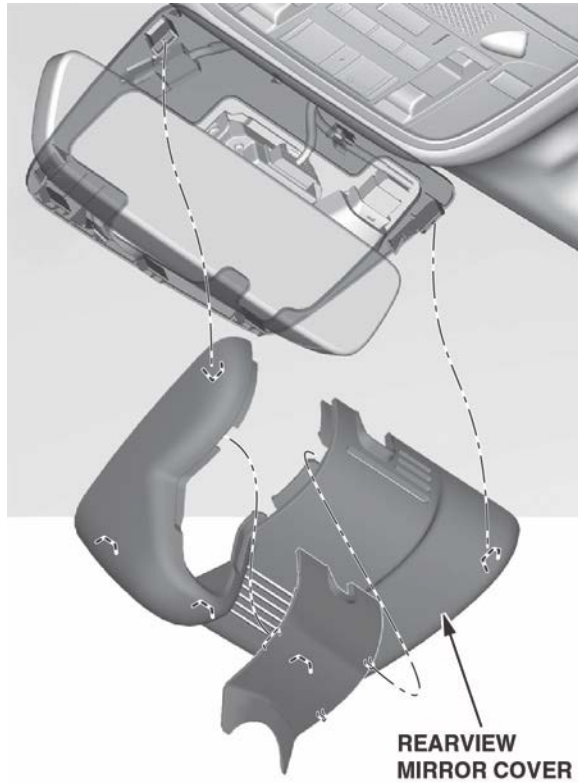
1. Remove the rearview mirror cover.

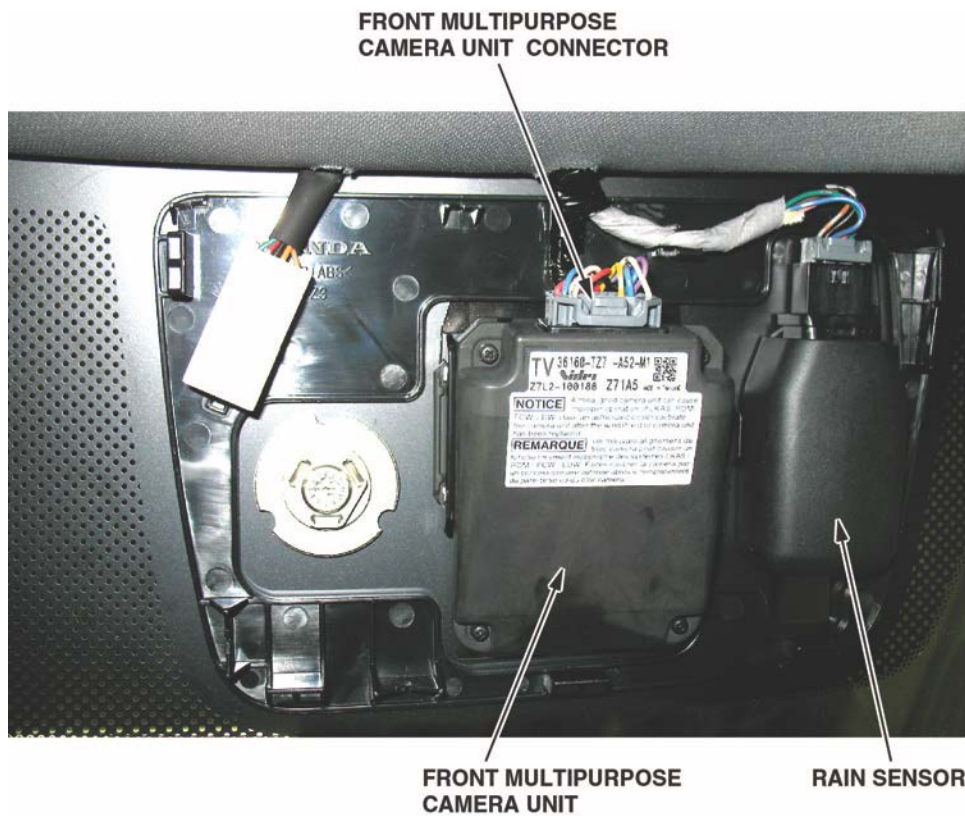
5. Disconnect the front multipurpose camera unit connector.

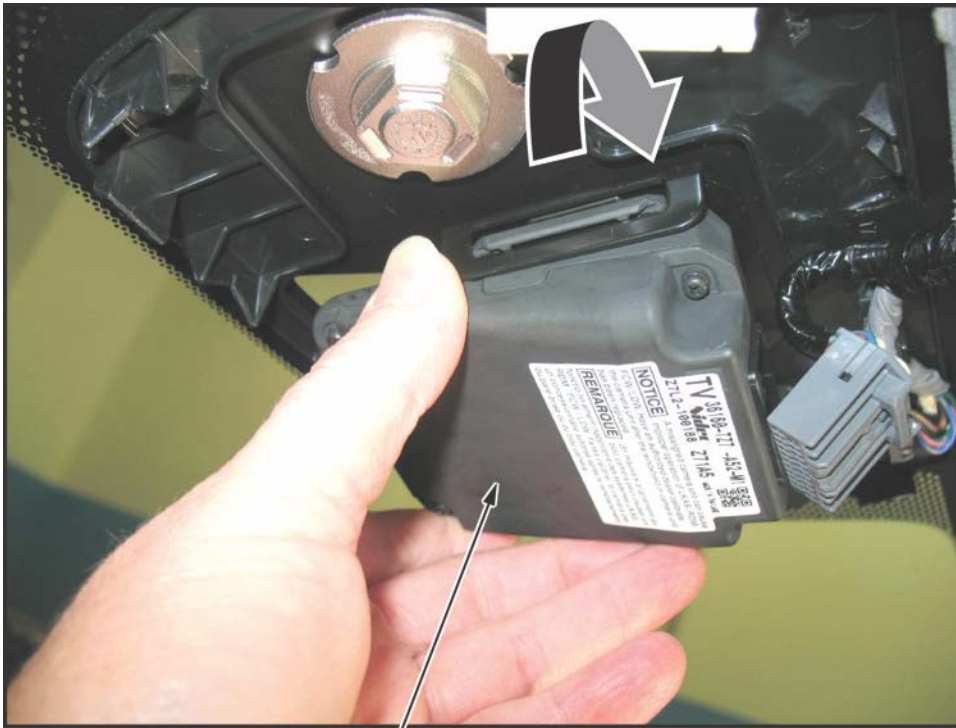
**FRONT MULTIPURPOSE
CAMERA UNIT**

6. Remove the front multipurpose camera unit.

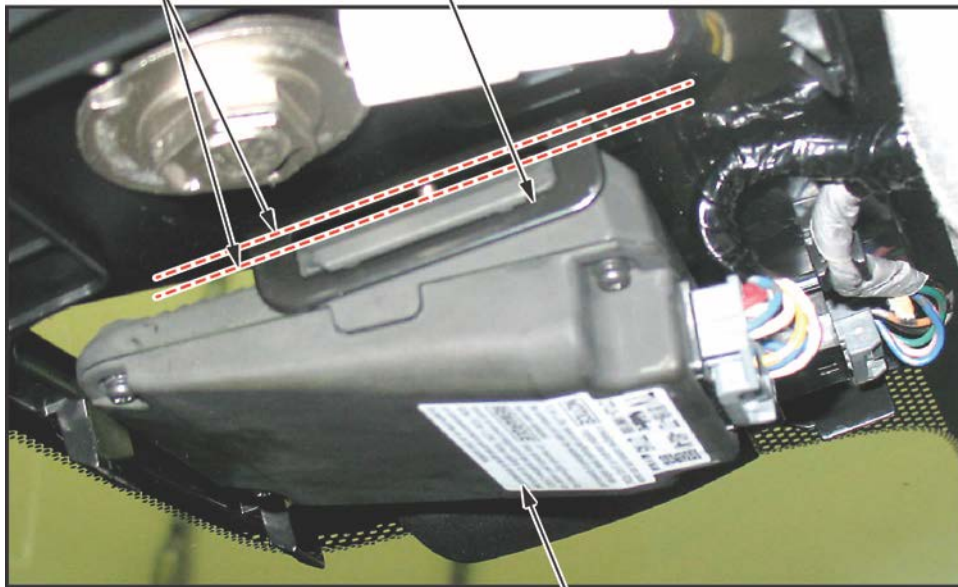
**FRONT
MULTIPURPOSE
CAMERA UNIT**

**BRACKET AND
CAMERA UNIT
PARALLEL**

BRACKET

9. Make sure the harness does not put any pressure on the camera, forcing it out of position while docked in its bracket. The gap between the camera base and the top of the bracket should be parallel. If it is not, shift the harness to relieve the pressure off the spring clips that hold the camera in place.
