VOLVO CAR SERVICE AND PARTS BUSINESS

Technical Journal

TITLE: Front lid on center console comes loose or gets stuck

VOLVO	olvo Car Customer Service	TJ 30825	
Title	Cover/armrest tunnel compartment	Page	1 (13)
Action	Adjustment	Operation number:	98608-2

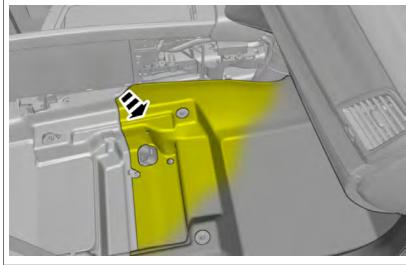
Applies to the right-hand side

Fold the carpet to the side.

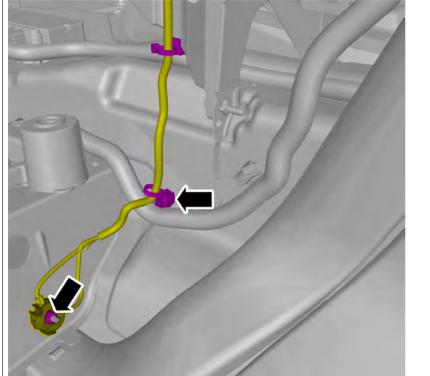
Loosen the clip. Remove the nut.

Torque:

M6,10 Nm

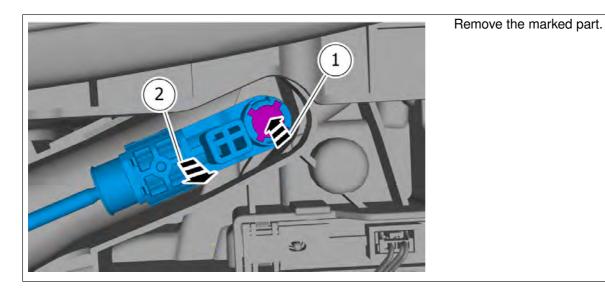
Fold the carpet to the side. Remove the screw. On both sides.

Torque:

Floor console, to Body, 11 Nm

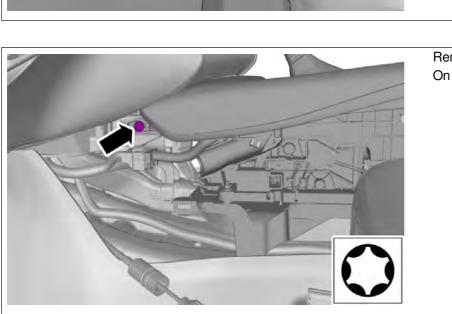
Remove the screw. On both sides.

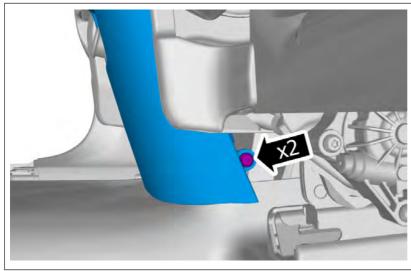
Remove the screw. On both sides.

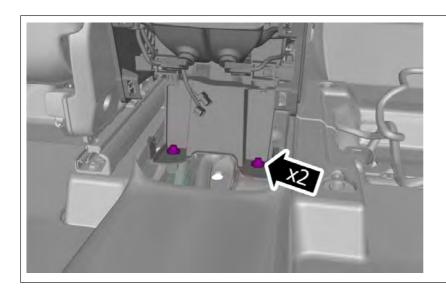
Remove the screws.

Torque:

Floor console, to Body, 11 Nm

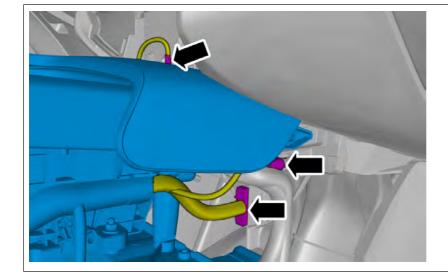
Caution! The number of connectors, cables and cable ties may vary depending on the vehicle specification.

Disconnect the connectors.

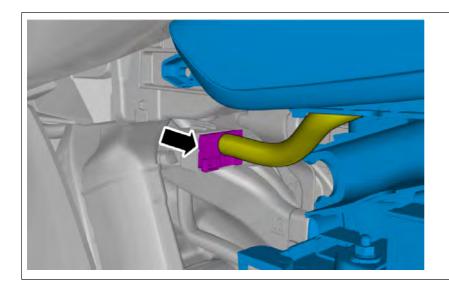
Caution! The number of connectors, cables and cable ties may vary depending on the vehicle specification.

Disconnect the connectors.

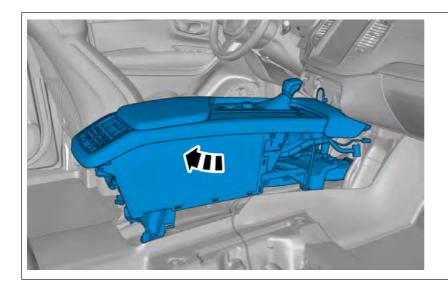
Note! This step requires the aid of another technician.

Remove the marked part.

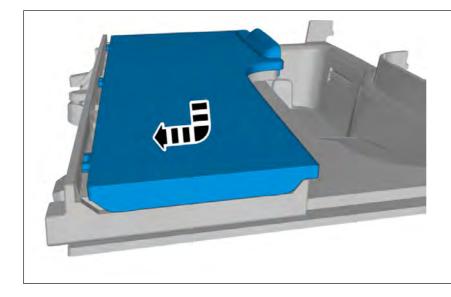
Note! Make sure that the component is installed.

Install the marked component.

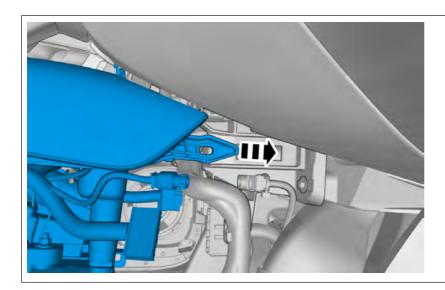
Note! Note the position.
--	--------------------------
