**March 1, 2016**

03188 Version 6

**Safety Recall: Piston Pin Snap Ring Inspection**Supersedes 16-017, dated February 26, 2016, to revise the information highlighted in **yellow**.**AFFECTED VEHICLES**

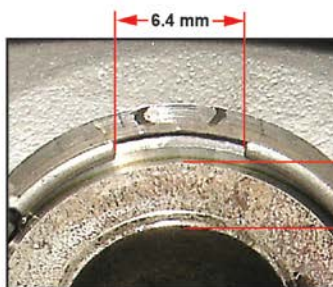
SNAP RING MISSING -  
NO GOOD

- If the snap ring is misset, take a clear picture of the misset snap ring and contact Tech Line to assist you with obtaining replacement piston assemblies.
- If a snap ring is missing and the engine cylinder wall does not have any damage, take a clear picture of the piston pin with the missing snap ring and contact Tech Line. They will assist you with obtaining the replacement piston assemblies.
- If the snap ring is missing and the engine has cylinder wall damage, order a replacement short block.

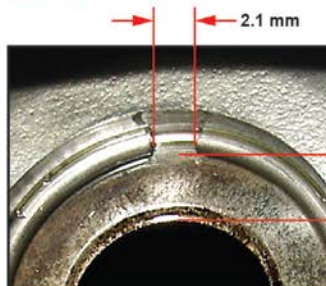
SNAP RING OUT OF  
PLACE - NO GOOD

17. Rotate the probe to confirm that the snap ring is fully engaged in the piston pin groove. A properly seated snap ring will have a 6 mm gap at the ends of the snap ring, as shown above. A misset snap ring will have a much smaller gap, around 2 mm.
18. Take a photo of each snap ring. Focus on getting a clear picture of each snap ring gap. You will need to take a picture of each side of all four pistons for a total of eight pictures.

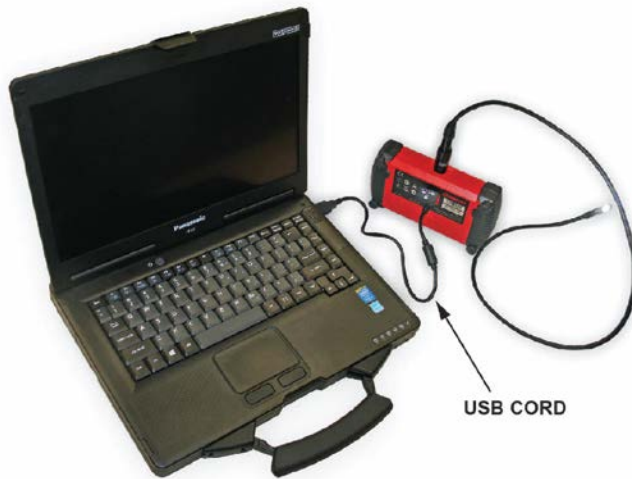
20. After all photos are taken, save them to your computer by connecting the borescope to it using the included USB cable. Give the photos to your warranty administrator for the warranty claim to be paid. Eight images of the snap rings must be included in the warranty claim or it may be rejected.
