## Drive Axle Flange to Hub RTV Gasket, Installation CHU, CXU, GU

### FSB 773-001, Drive Axle Flange to Hub RTV Gasket, Installation

(October 2016)

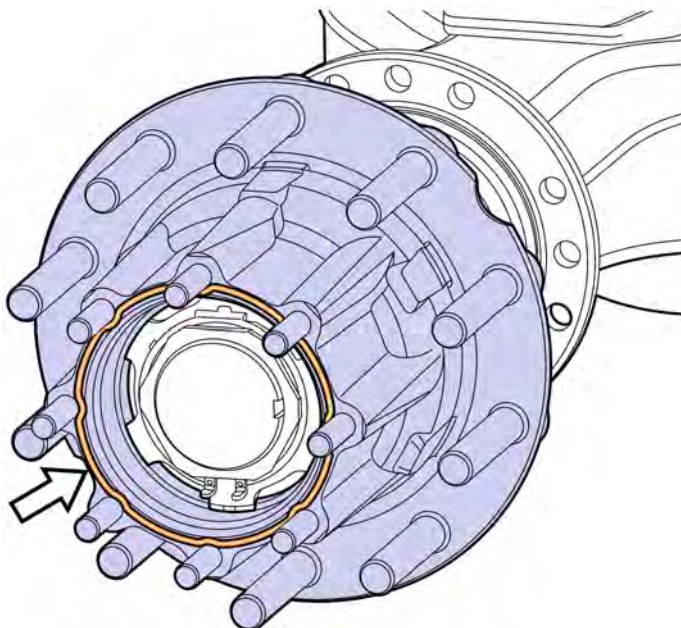
W7115590

Certain MACK trucks built after 09/30/2016 may use one of 3 types of gaskets on the MACK drive axles. The truck could be built with a rubber o-ring, a flat paper gasket, or Room Temperature Vulcanizing (RTV) gasket material use to seal the mating surfaces of the hub and drive axle flange. This document contains only information for the additional work needed during a Pre-Delivery Inspection (PDI) on a vehicle built with RTV used on the drive axle flange gasket. When a MACK truck is delivered as a "Decked Unit" from Macungie, the drive axles are removed for transport and a temporary cover is bolted to the hub to prevent axle lubrication from leaking during transport. Upon delivery, the drive away company driver reinstalls the drives axles with new gaskets (O-ring or paper gasket only) and hand torques all mounting fasteners. For MACK trucks delivered with RTV, the delivery driver will reinstall the axles and hand tighten fasteners without cleaning or installing new RTV gasket material. Follow the steps in this document to identify and repair MACK trucks delivered with RTV gasket during the PDI.

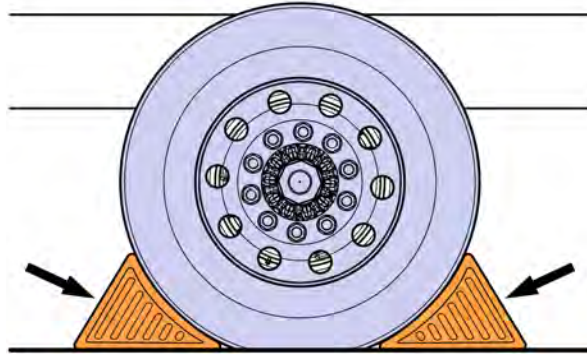
W7086748

- 1 Park the vehicle on a level surface.
- 2 Apply the parking brake.
- 3 Place the transmission in neutral or park.
- 4 Install the wheel chocks on the rear wheels.

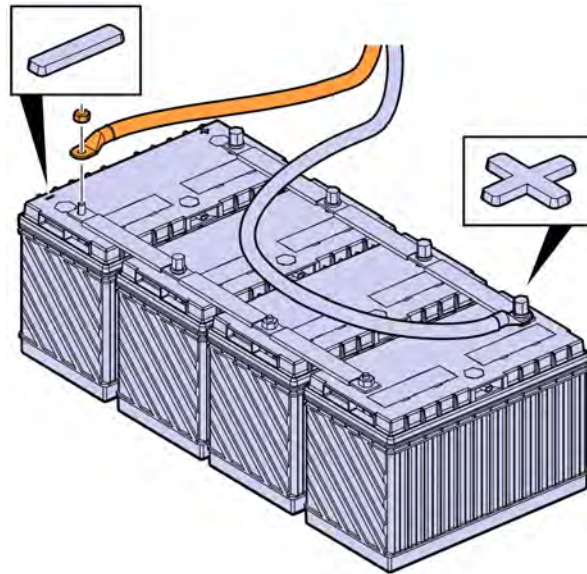
W3086747

- 5 Disconnect the cable from the battery's negative terminal.

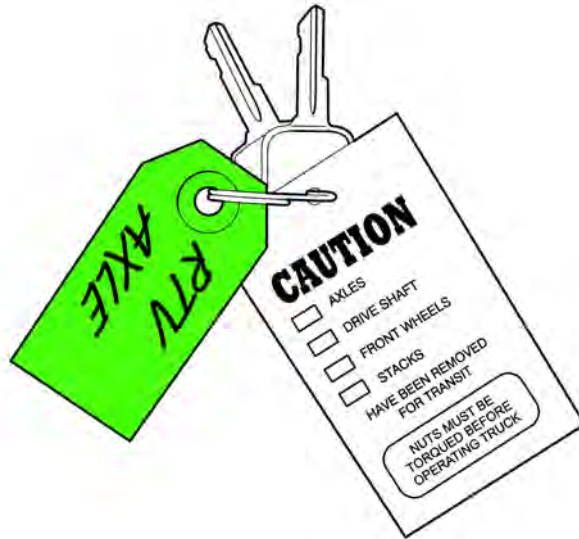
W7115835

- 1 During PDI, Identify whether or not the truck has an RTV gasket by looking for the green colored tag with **RTV** written on it attached to the keys as shown in the figure below.

**Note:** If the green colored tag with **(RTV)** written on it is attached to the keys, additional steps are required to repair the truck axle shaft flange during PDI. Proceed to step 2 for installation of RTV gasket.

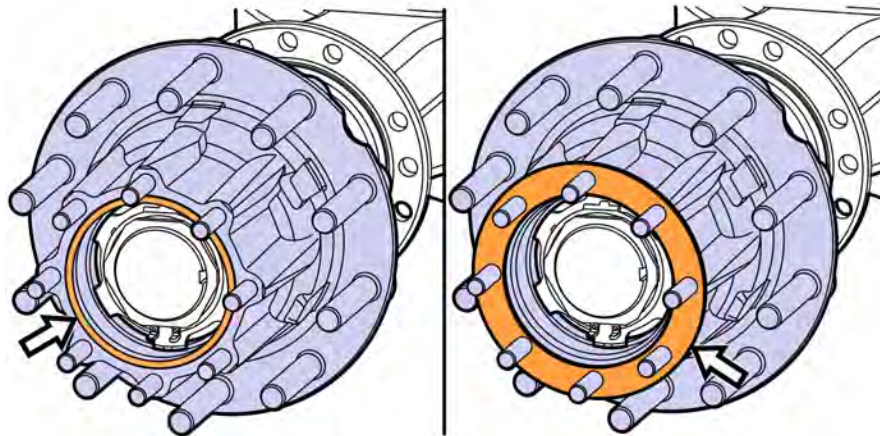
W7115836

**Note:** If the truck was built with an o-ring or flat paper gasket on the truck axle shaft flange, the delivery driver will install new o-rings (part number 3199066) or flat paper gaskets (part number 3973009) when they reinstall the drive axles.

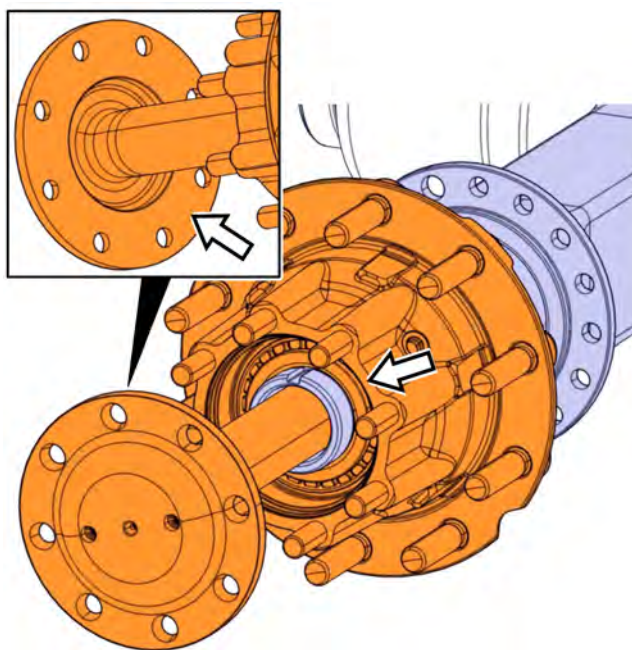
W7115837

- 2 Ensure the hub and axle shaft mating surfaces are dry, free of debris, burrs, and score lines.

**Note:** RTV will not adhere properly with any oil on the hub or axle flange surface. Ensure the mating surfaces are dry before applying a new bead of RTV gasket material.

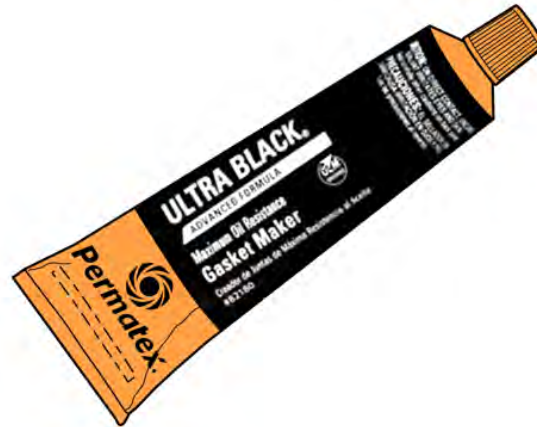
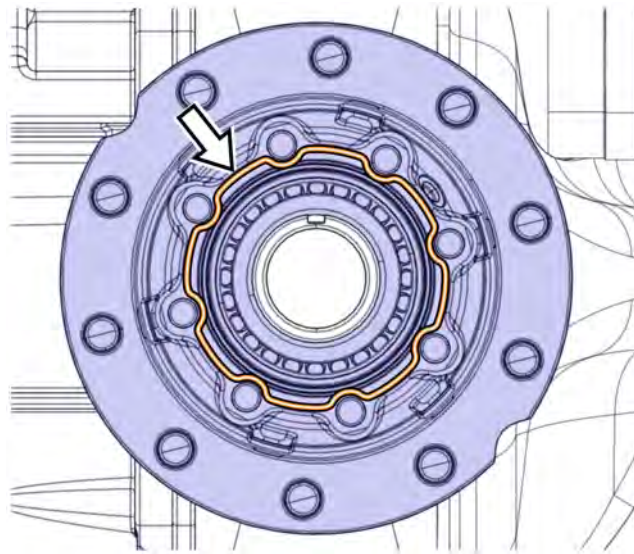
W7115838

- 3 Apply a continuous 5 mm (0.19 in) bead of Ultra Black RTV Silicone Gasket Maker to the hub as shown in the figure below.

- 4 Immediately install axle shaft onto hub mounting surface to avoid premature curing of the RTV gasket material.

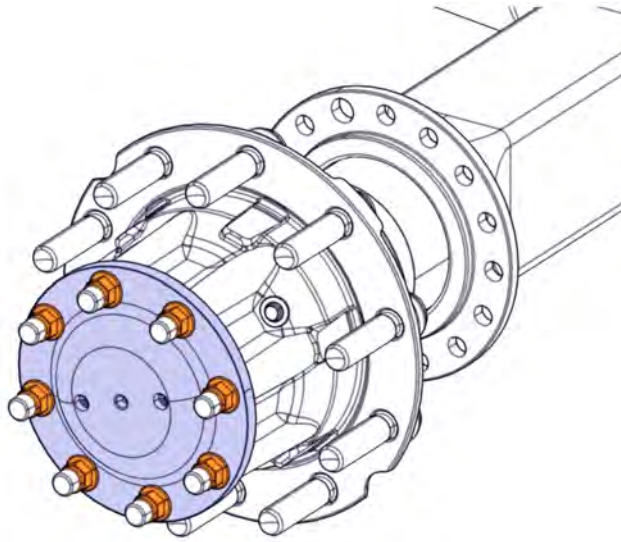
W7115839

- 5 Install the tapered cones, washers, and lock nuts onto hub studs.

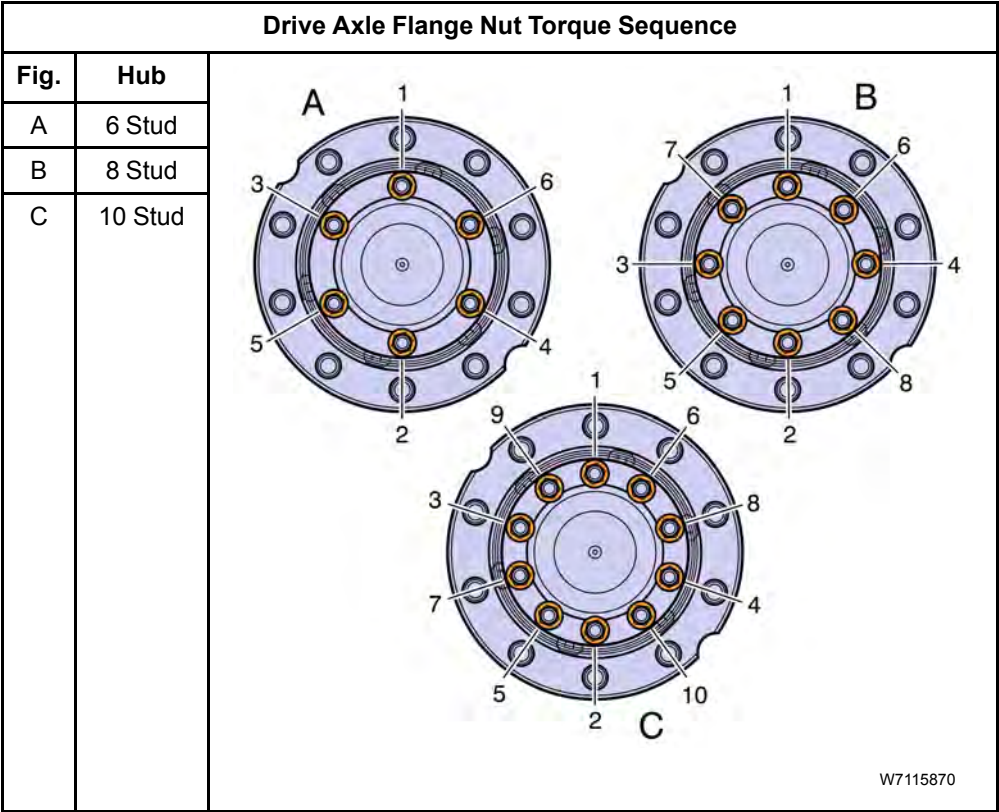
- 7 Tighten the axle shaft flange lock nuts to  $136 \pm 20$  Nm ( $100 \pm 15$  ft-lb) and in the sequence shown in the figure below.

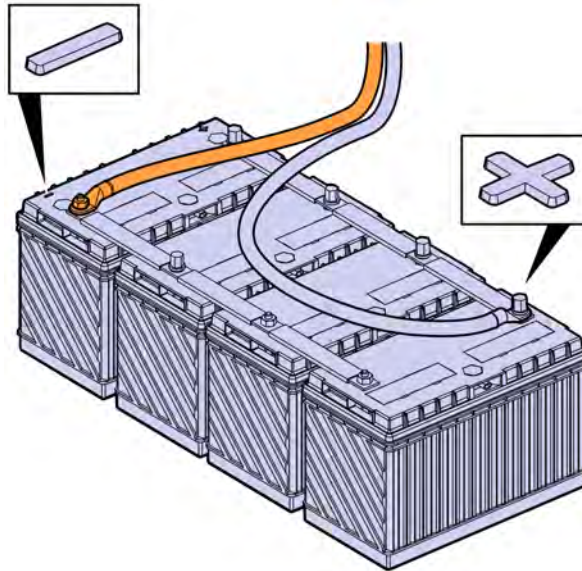
W3086758

- 1 Connect the cable to the battery's negative terminal.

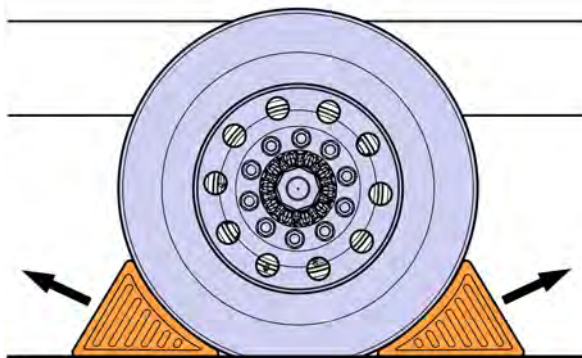
W7086759

- 2 Remove the wheel chocks from the rear wheels.
