Service Bulletin

16-068

Driver's Dashboard Panel Warped

Year	Model	Trim	VIN Range
2016	Fit	Suzuka produced vehicles	JHMGK5HG \$ 000003 thru JHMGK5HG \$ 007296

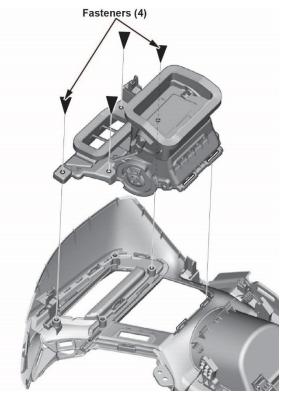
5. Remove the air outlet and the beverage holder.

- 6. Reinstall the air outlet and the beverage holder onto new driver's dashboard panel.
- 7. Install removed parts in reverse order.
