Service Bulletin

Bulletin No.: 16-NA-198

Subject: Holes/Tears in Fabric of Sunroof Air Deflector

Brand:	Model:	Model Year:		VIN:		Engine:	Transmission:
		from	to	from	to		
Cadillac	CT6	2016	2016	SOP 2016	Prior to 1G6KK-5R66GU1-51485	All	All

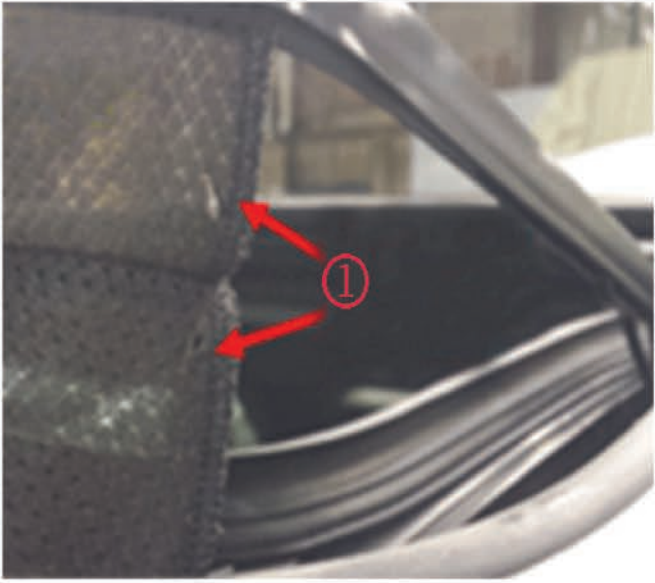
<p style="text-align: right; font-size: small;">4533530</p> <p>Some customers may comment on seeing tears (1) or a large hole in the sunroof air deflector fabric.</p>
Cause	The cause of the condition may be an interference where the air deflector is contacting the sunroof housing front beam and guide rails.

Replace the sunroof air deflector and reposition the deflector pivot brackets following the Service Procedure below.

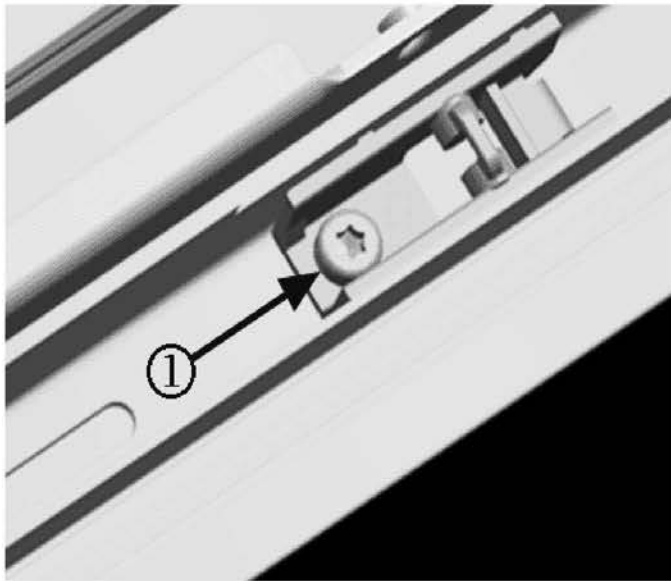
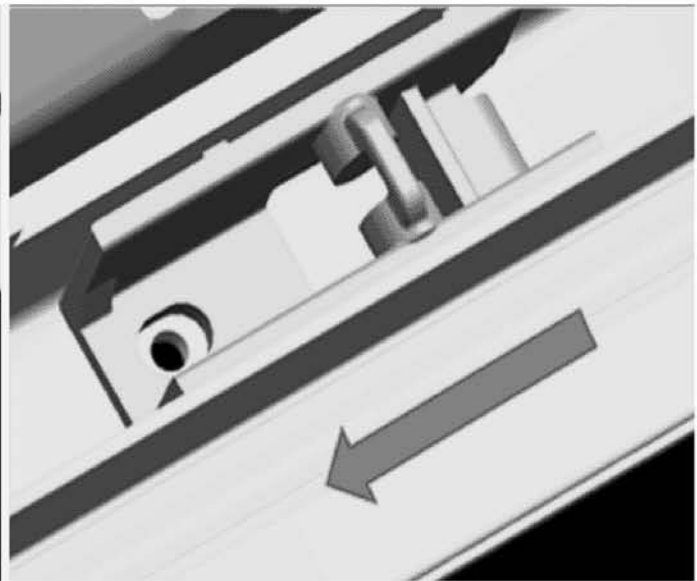
4533533

2. Before installing the new deflector, reposition the deflector pivot brackets:
 - 2.1. Remove the pivot bracket retaining screw (1).
 - 2.2. Move the pivot bracket to the forward position.
 - 2.3. Reinstall the screw.

Tighten the screw to a **maximum 1.5 N•m (13 lb in)**.

- 2.4. Repeat steps #2.1–2.3 on opposite side.
3. Install the new sunroof air deflector. *Refer to Sunroof Air Deflector Replacement (With C3U) in SI.*
