Technical Bulletin

21 16 01 June 16, 2015 **2036110** Supersedes Technical Bulletin V211507 dated August 21, 2015 to update the engine oil supply pipe to turbo charger part number.

Engine Lacks Performance, Shaft of Turbine Fan of Turbo Charger Broken or Seized

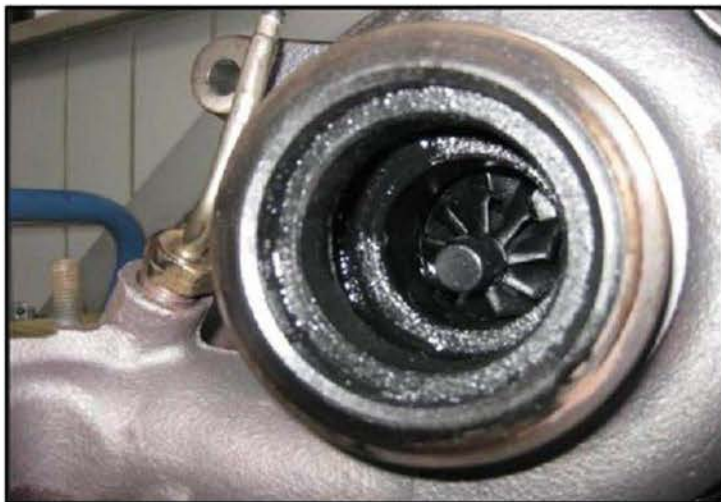
To confirm a broken shaft on the turbocharger the diesel particulate filter (DPF) must be detached on the turbocharger. This is the only way to check the turbocharger for damage and engine oil ingress on the exhaust side (figure 1).

Figure 1 (broken turbocharger shaft, engine oil ingress on exhaust side)

- If turbocharger is found to be damaged, the DPF must be reattached at the turbocharger before proceeding to the following steps:

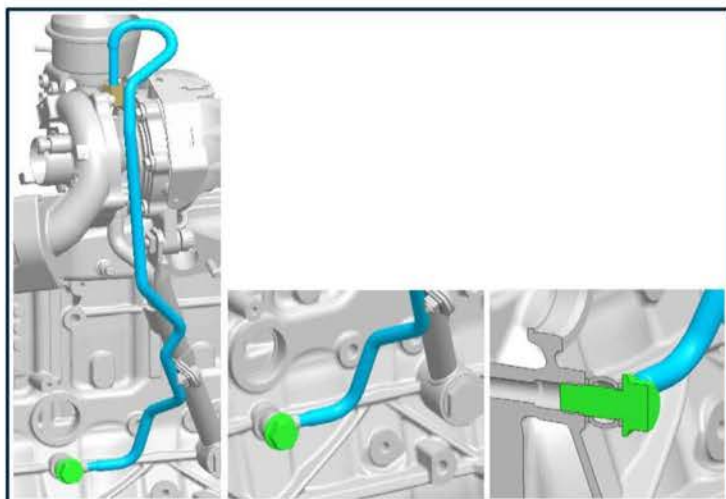
Figure 2

- Replace the oil filter according to the repair manual and thoroughly clean the inside of the oil filter housing.
- Drain the engine oil according to the repair manual.
- Unscrew the banjo bolt for the oil supply pipe on the cylinder block. Replace the banjo bolt with the hex head bolt with part number WHT 005 747 (figure 2, in green) and tighten it according to the repair manual to block oil supply to the damaged turbocharger.

Flush out the oil circuit while the faulty turbocharger/particulate filter is installed and the intake hose removed from the turbocharger.

- Fill up the engine oil according to the manufacturer guidelines.
- Run the engine at idle speed for about 15-20 minutes.
- Replace the oil filter according to the repair manual and thoroughly clean the inside of the oil filter housing.
- Replace the oil filter housing cap (03L 115 433).
- Drain the engine oil according to the repair manual.
