Service Bulletin

Subject: Front Seat Lateral Movement, Clunk, Squeak, Click Noise or Shift While Cornering

Models: 2012-2016 Buick Regal
2012-2016 Buick Verano
2011-2015 Chevrolet Cruze
2016 Chevrolet Cruze (VIN P)
2013-2015 Chevrolet Malibu
2016 Chevrolet Malibu Limited (VIN 1)
2014-2016 Chevrolet Impala (VIN 1)
2014-2016 Chevrolet SS

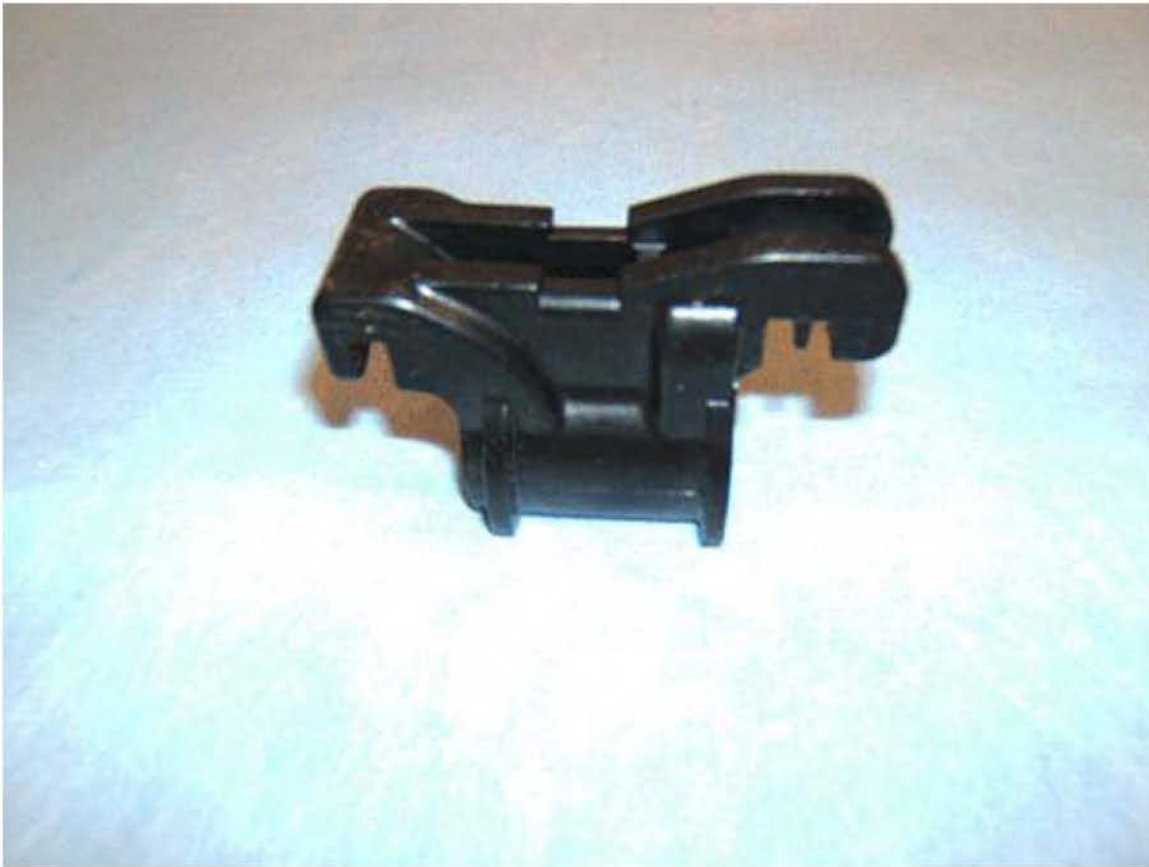
Some customers may comment on a lateral movement in the seat while cornering. This condition has also been described as a clunk, squeak, click noise or shift in the seat. This condition occurs on the driver side 6-way manual or power adjusted seat. This condition may also be present on the passenger side seat if the vehicle is equipped with a 6-way adjustable passenger seat.

This condition may be caused by movement between the seat pan and the seat cross tube.

A clip has been made available to eliminate the lateral seat movement. Use the following steps to install the clip to the driver side seat. If the vehicle is equipped with a 6-way adjustable passenger seat, repeat the procedure on the passenger seat.

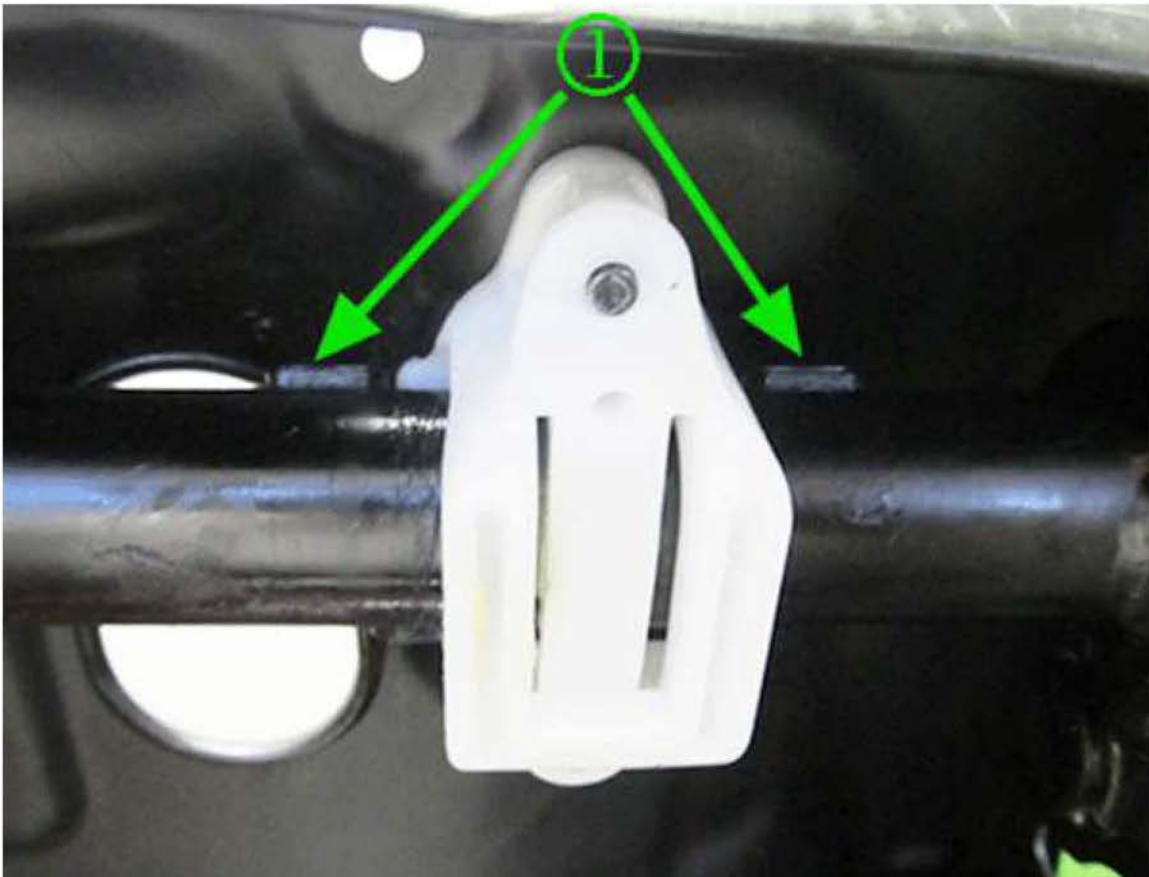
Important: On some vehicle models, a production change added welded brackets (1) to the seat crossbar on each side of the guide block to help retain its position. On these particular vehicles, it will be necessary to rework the new clip service part to ensure proper installation to the crossbar.

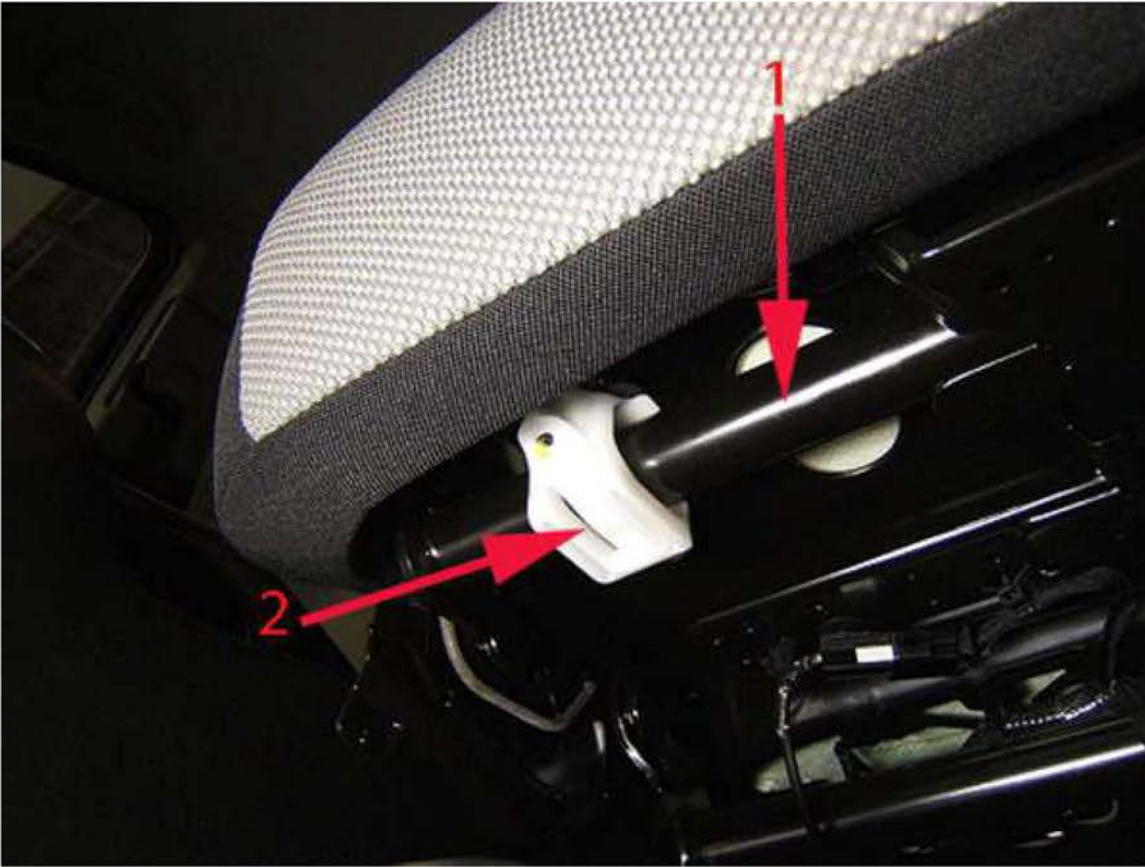
Note: Cruze shown, all others similar.

1. Raise the front of the seat bottom to the highest position and move the seat assembly to the rearmost position.
