MODEL
2016MY
Sorento (UMa)

NUMBER
137

TECHNICAL SERVICE BULLETIN

SUBJECT: SERVICE ACTION: TAIL GATE LATCH REPAIR (SA 234)

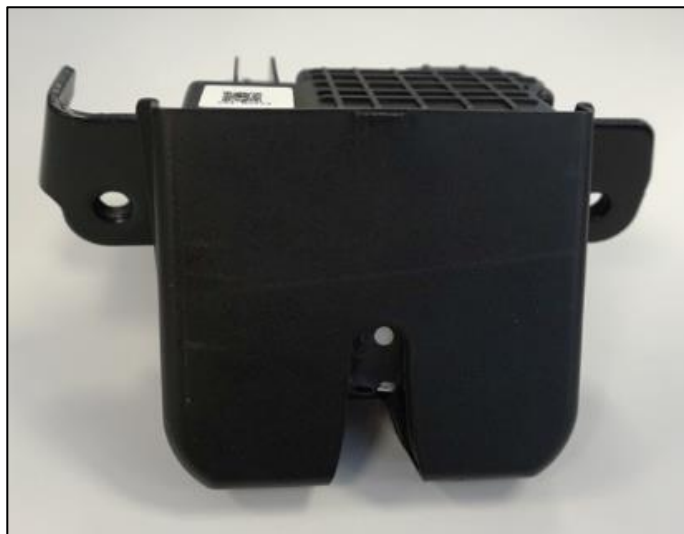
This bulletin provides the procedure for installing updated components within the rear latch, on some manual tail gate-equipped 2016MY Sorento (UMa) vehicles, produced from November 17, 2014 to November 30, 2015 that may exhibit a concern of not opening from the outside. Kia is requesting the completion of this Service Action on all affected vehicles. Before conducting the procedure, verify the vehicle is included in the list of the affected VINs.

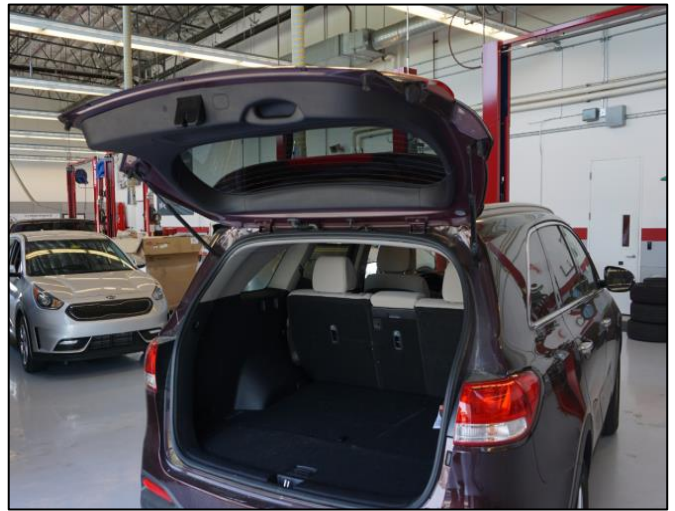
1. Open the tail gate.

If the tail gate will not open from the outside, it may be necessary to open the tailgate using the manual release. Refer to page 4-37 of the Owner's Manual for additional information.

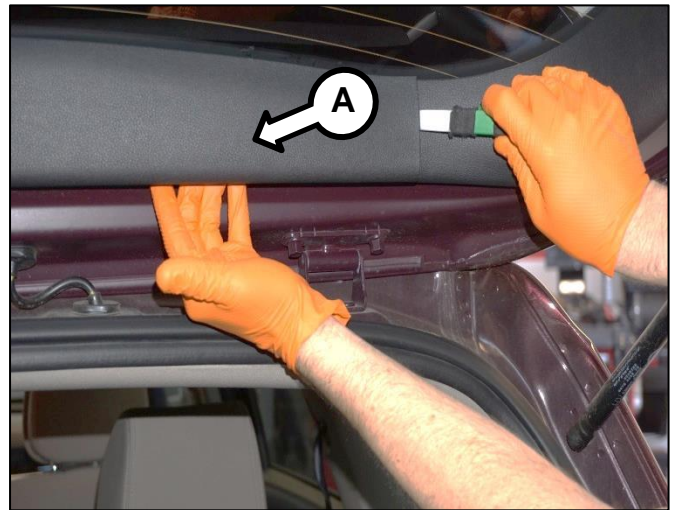
2. Use a non-marring trim panel tool to remove the center section of the tail gate trim (A).

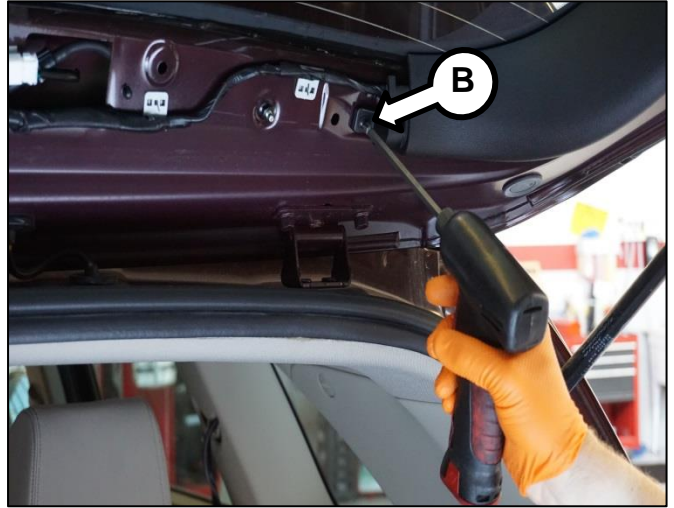
3. Remove the 1 screw (B) from the right side and corresponding screw from the left side.
Remove the trim pieces completely.

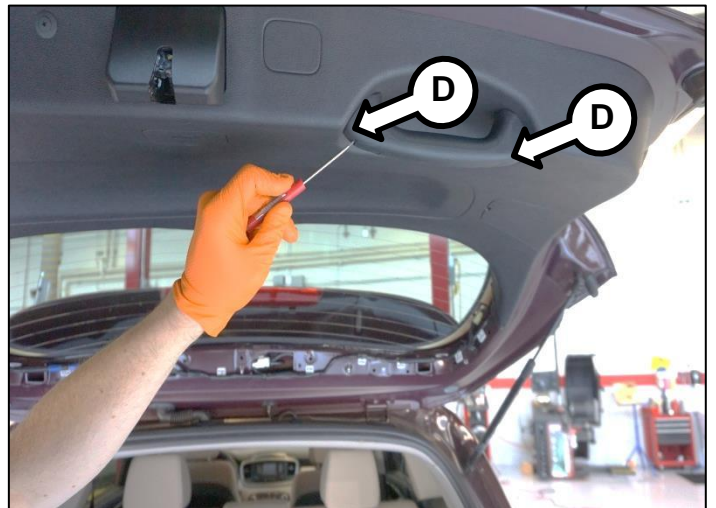
4. Using a small flat-headed screwdriver, remove the 2 caps (D) from the inside tail gate handle.

Apply tape to the end of the screwdriver to prevent damaging the handle caps.

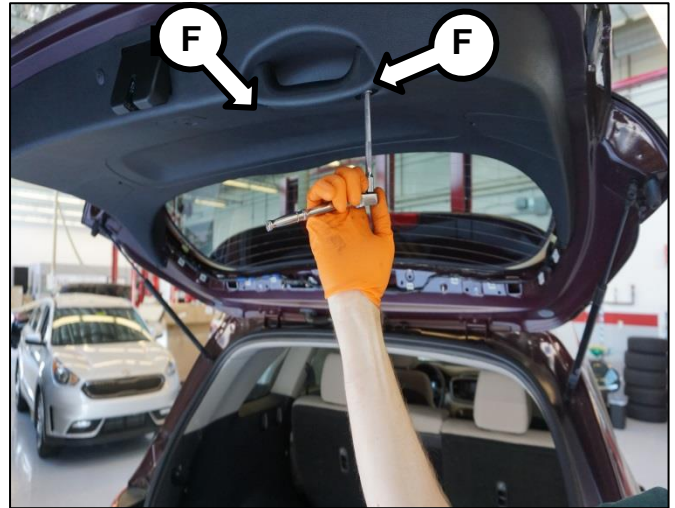
- 5. Loosen and remove the 2 mounting bolts (F) from inside the tail gate handle.

Tightening Torque: 70~104 in-lb (7.85~11.80 Nm)

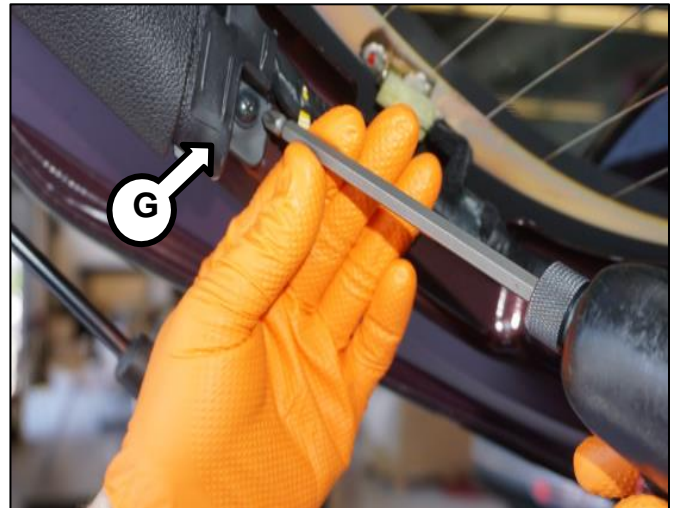
- 6. Remove the screw (G) from the corresponding side of the tail gate trim.

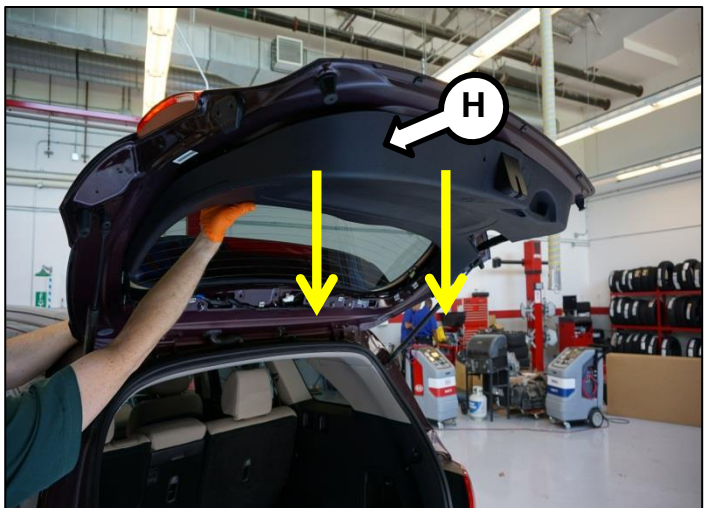
- 7. Dislodge the bottom portion of the tail gate trim (H) using a non-marring trim panel removal tool. Apply downward force to release the retention clips. Remove the trim from the tail gate.

Apply even pressure to avoid breaking the retaining clips.

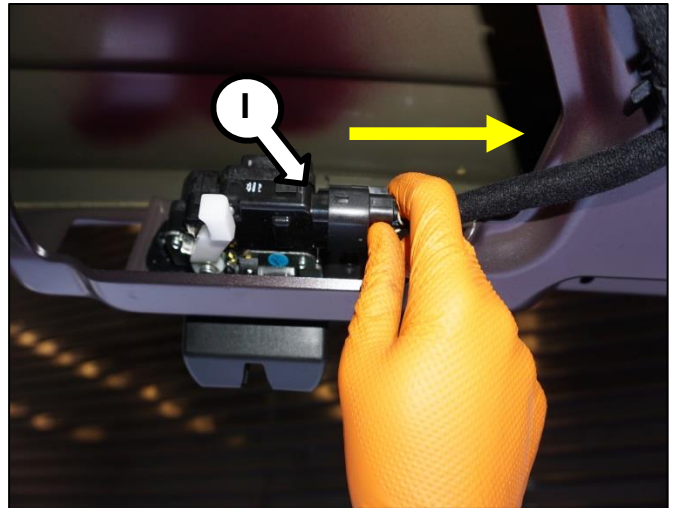
8. Disconnect the tail gate latch connector (I) by depressing the locking tab and pulling to the right.

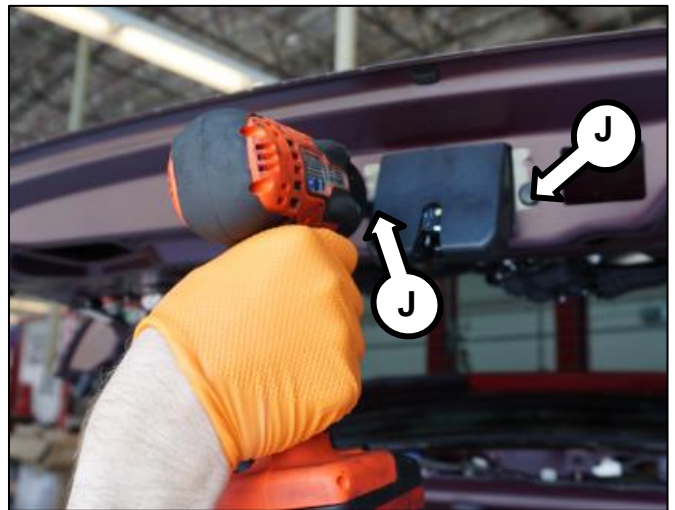
9. Remove the 2 bolts (J) securing the tail gate latch.
Remove the tail gate latch from the vehicle.

**Tightening Torque: 61~91 in lb.
(6.8~10.9 Nm)**

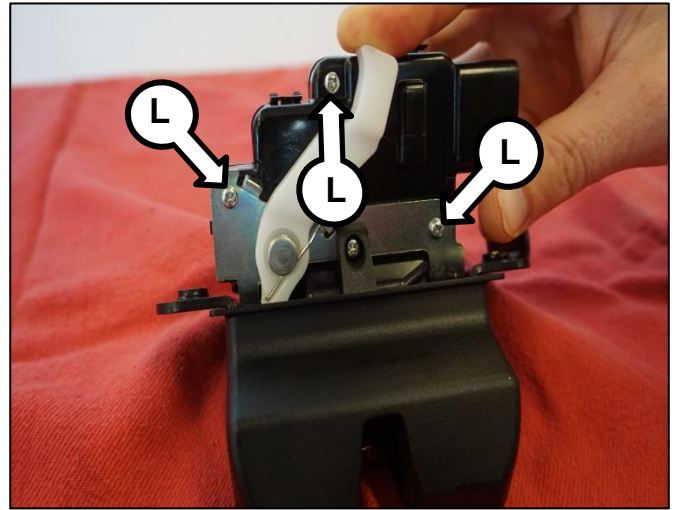
10. Remove the 3 screws (L) from the tail gate latch using a Phillips screwdriver.

To remove the center screw, move the manual release to the right, to gain sufficient clearance.

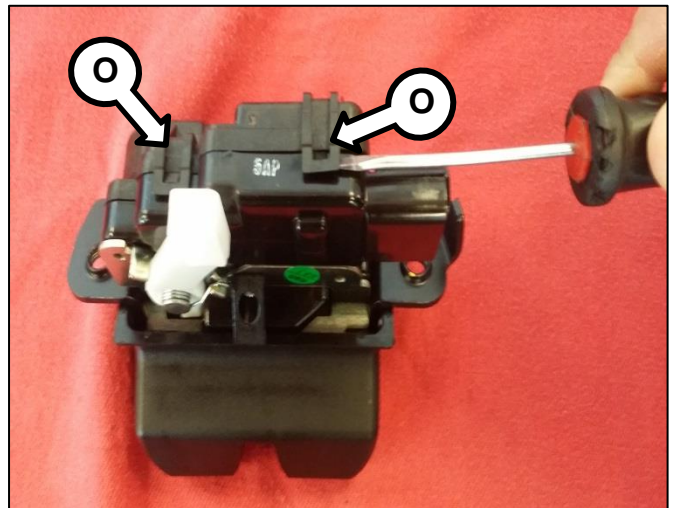
11. Remove the cover from the actuator assembly by releasing the 2 clips (O).

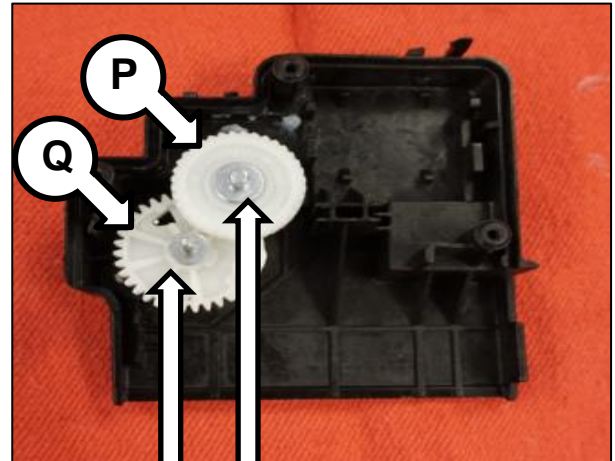
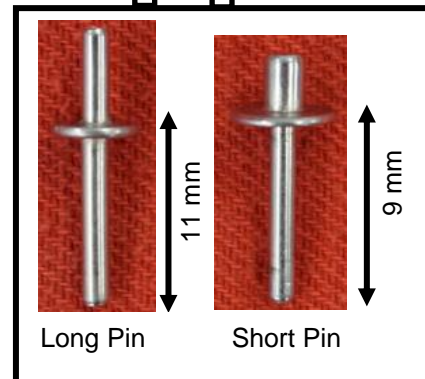
12. Remove gears (Q) and (P), from the cover by removing long and short pins. Discard the originally installed gear (Q), return spring below the gear (Q), and the latch cover, as they will be replaced later in this procedure.

After removing the gears, inspect for broken gear piece(s) within the latch assembly.

Failure to inspect for, and subsequently discard any broken gear piece(s), may result in a malfunction in the operation of the latch.

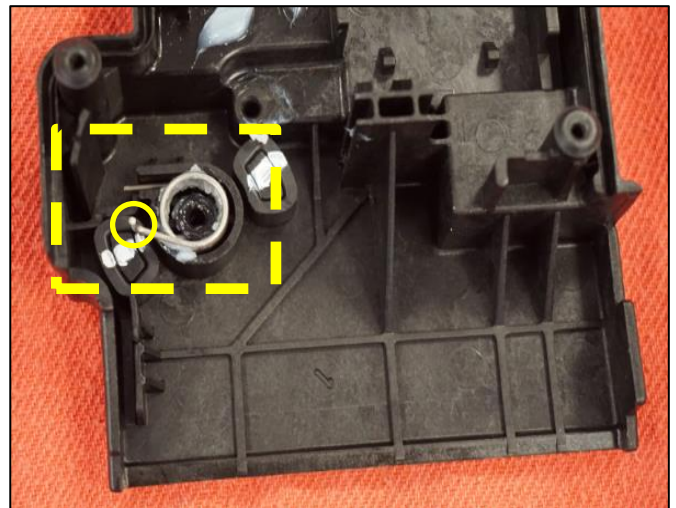
13. Install the new return spring onto the new cover with the angle side pointing upward, as shown.

Ensure the return spring is correctly seated, as shown. Failure to correctly seat the spring will result in a malfunction in the operation of the latch.

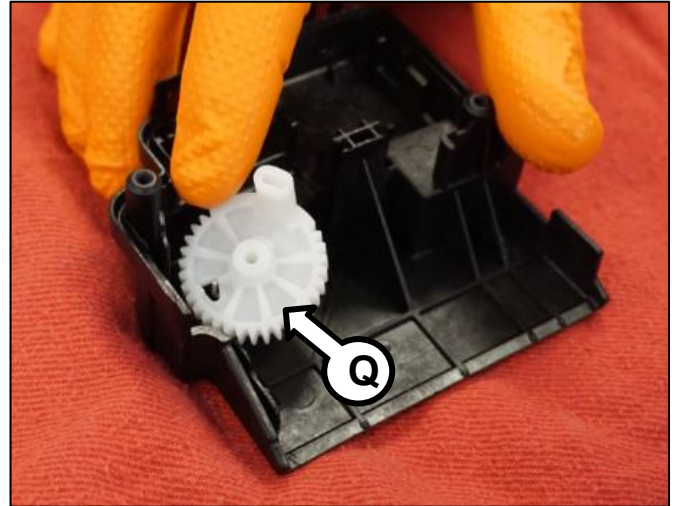
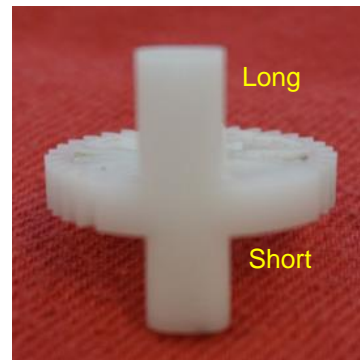
- 14. Position the gear (Q) with the short shaft facing downward, touching the rubber damper, then connect the spring to the opening on the gear.

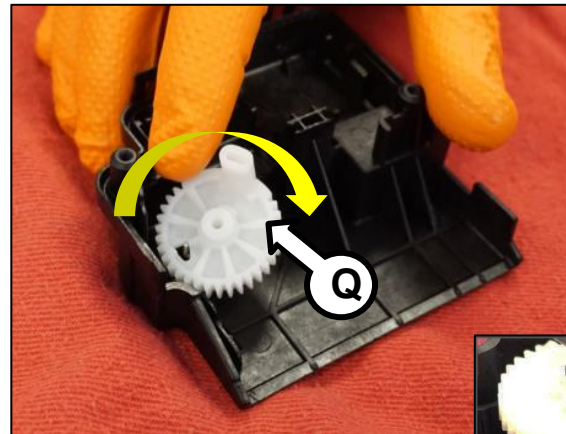
- 15. Position gear (Q) by rotating it clockwise past the rubber damper as shown, and install gear to cover using the long pin.

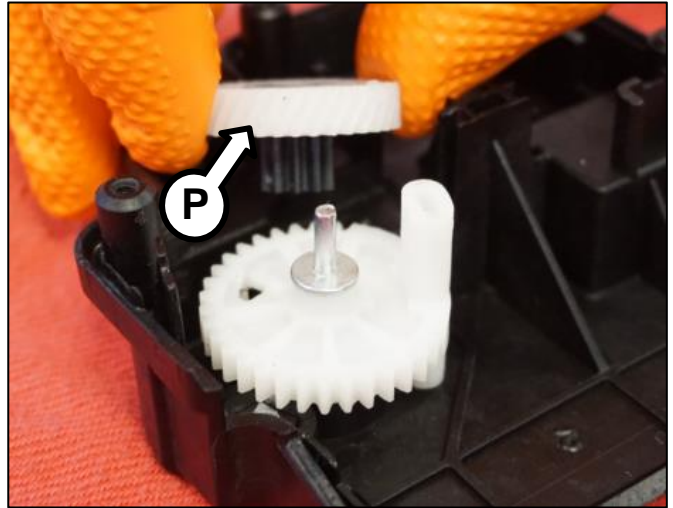
16. Assemble gear (P) and attach it to the cover using the short pin.

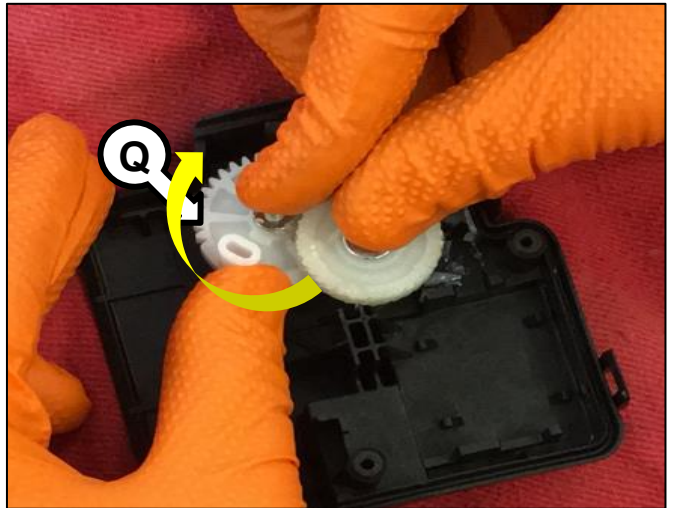
17. Hold the pins as shown, and rotate the gear (Q) clockwise using the long shaft on gear (Q). Ensure the gear set moves smoothly and returns to the rubber damper.

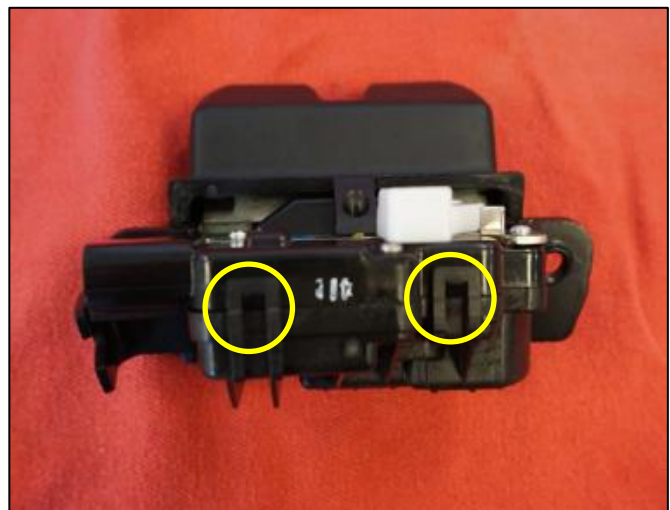
18. Position and hook the new actuator cover with gears to the latch assembly.

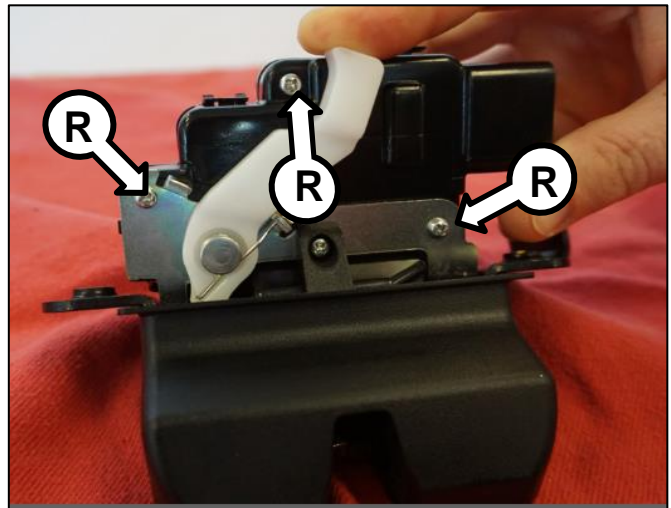
19. Install the 3 screws (R) from the tail gate latch using a Phillips screwdriver

To install the center screw, move the manual release to the right, to gain sufficient clearance.
