GROUP ELE	MODEL 2011 – 2015MY Sorento (XMa)
	NUMBER 108	DATE June 2016
TECHNICAL SERVICE BULLETIN		
SUBJECT: AIRBAG WARNING LIGHT ON

This bulletin provides information related to the replacement of the clock spring assembly on 2011MY – 2015MY Sorento (XMa) vehicles. If the Airbag Warning Light is on with any of the DTCs listed below, follow the procedure outlined to resolve the issue.

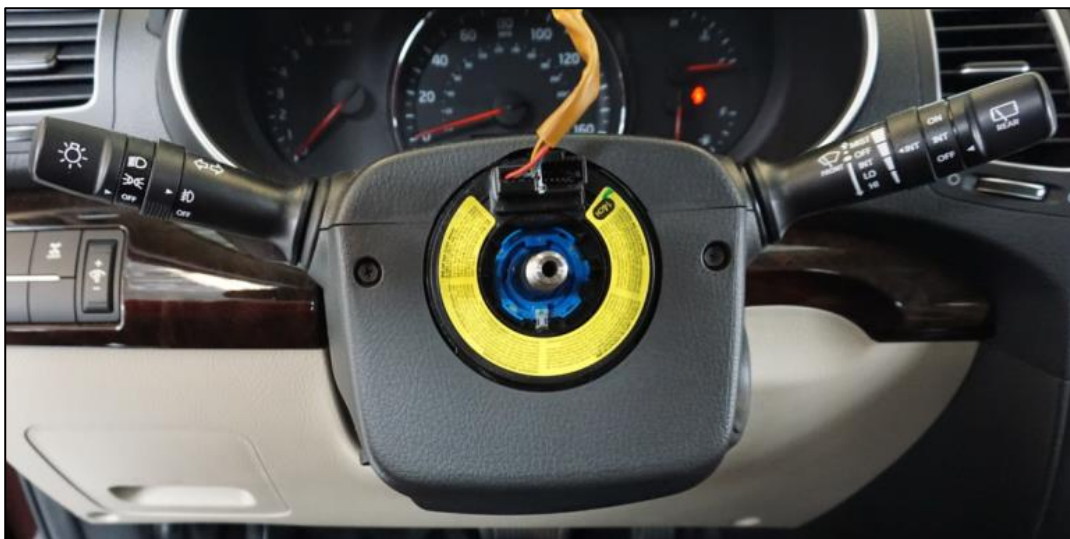
- B1346/B134600 Driver Airbag Resistance too high (1st stage)
- B1347/B134700 Driver Airbag Resistance too low (1st stage)
- B1481/B148100 Driver Airbag Resistance too high (2nd stage)
- B1482/B148200 Driver Airbag Resistance too low (2nd stage)
- B1348/B134800 Driver Airbag resistance circuit short to Ground (1st stage)
- B1349/B134900 Driver Airbag resistance circuit short to Battery (1st stage)
- B1483/B148300 Driver Airbag resistance circuit short to Ground (2nd stage)
- B1484/B148400 Driver Airbag resistance circuit short to Battery (2nd stage)

1. Place the ignition key in the "ON" position and record the customer's radio presets.
2. Turn the steering wheel so that the front wheels face straight ahead.

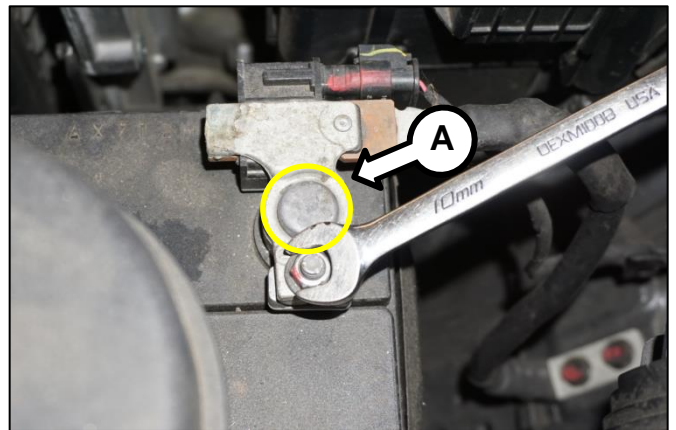
3. Turn the ignition off, and disconnect the negative terminal of the battery

After disconnecting the negative terminal of the battery, wait about thirty seconds before proceeding with the repair.

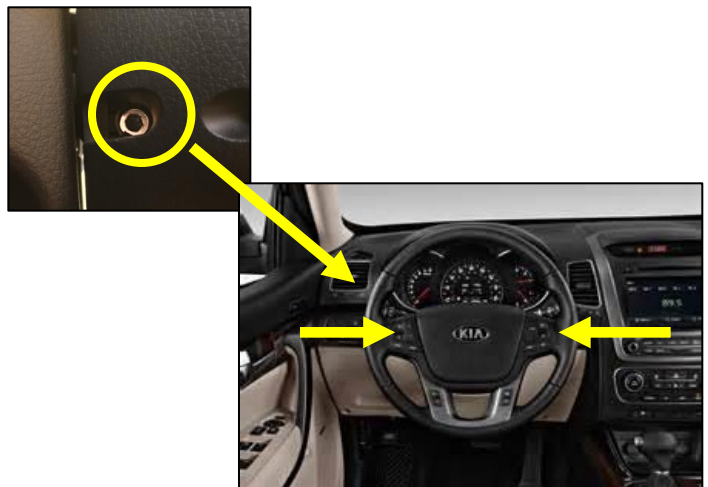
4. Remove the air bag by loosening the Torx® bolts as necessary.

The removed air bag module should be stored in a clean, dry place with the pad cover face up.

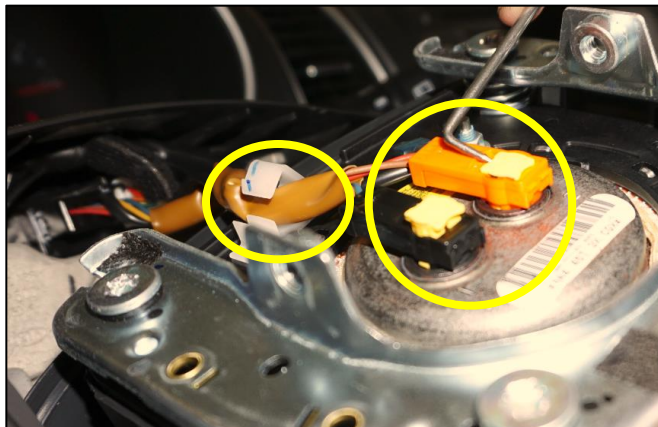
5. Disconnect the electrical connectors and harness retaining clip, as shown.

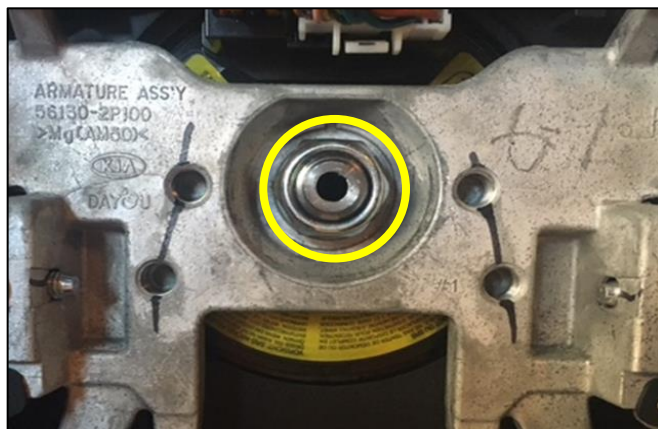
6. Remove the lock nut.

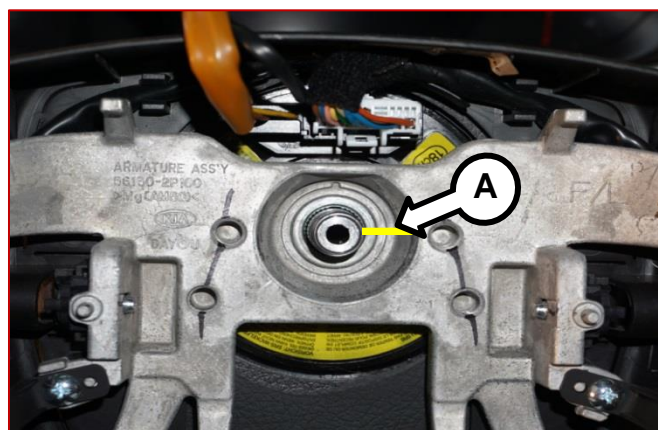
7. Mark the steering wheel (A) to assist in realignment.

Remove the steering wheel by using a steering wheel puller.

39.2 ~ 49.0 N.m (4.0 ~ 4.5 kgf.m, 28.9 ~ 36.2 lb-ft)

Do not hammer on the steering wheel to remove it. This may damage the steering column.

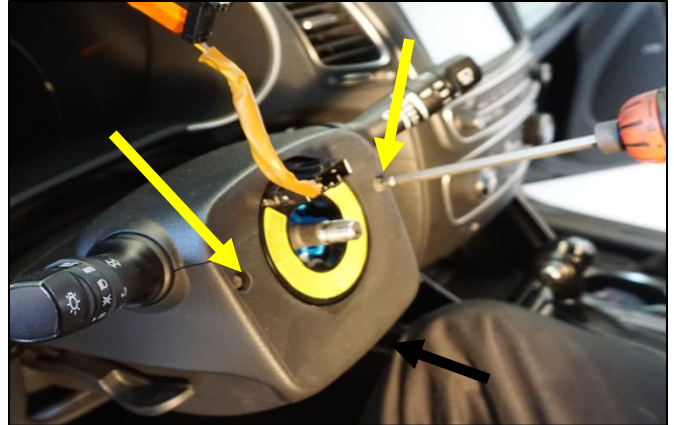
8. Remove steering column cover by removing the 3 screws.

Use caution not to damage the cover with the screw driver.

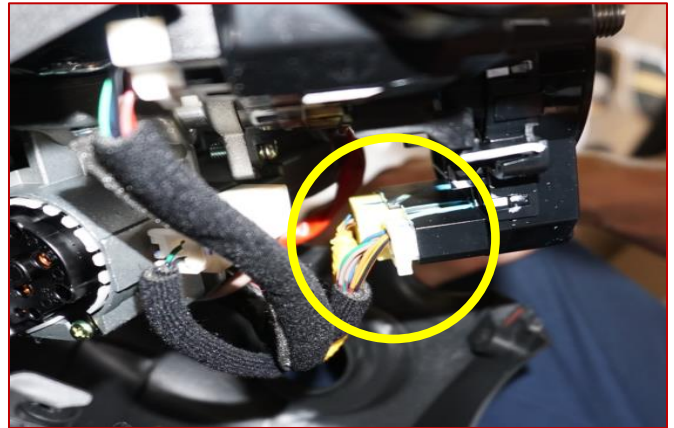
9. Disconnect the connectors behind the clock spring.

Unclip and remove the clock spring from the column.

When installing the new clock spring, leave the alignment tool in the clock spring until the steering wheel is back on to ensure that the clock spring stays in alignment with the steering wheel.
