MODEL
2014-16MY Forte (YD)

NUMBER
157

TECHNICAL SERVICE BULLETIN

SUBJECT: ENGINE VIBRATION AT IDLE

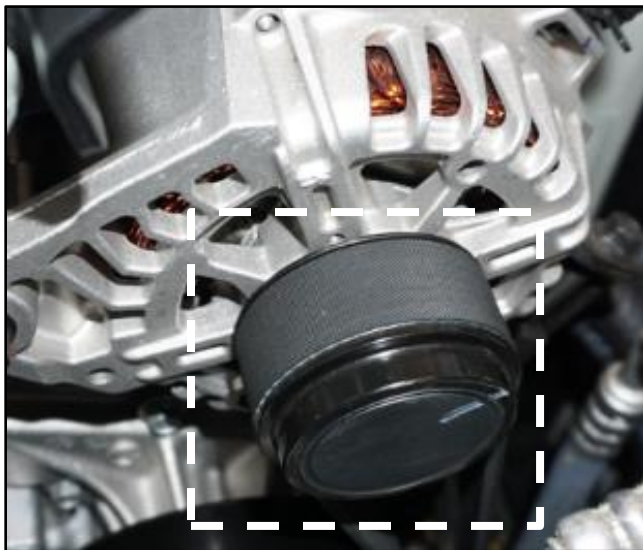
Old

This bulletin provides the procedure to replace the alternator pulley. Some 2014-16MY Forte (YD) vehicles with 1.8L and 2.0L Nu engines may experience an unusual engine vibration at idle that is sometimes more prevalent under certain electrical loads. To correct this concern, replace the existing alternator pulley with a new one following the Service Procedure below.

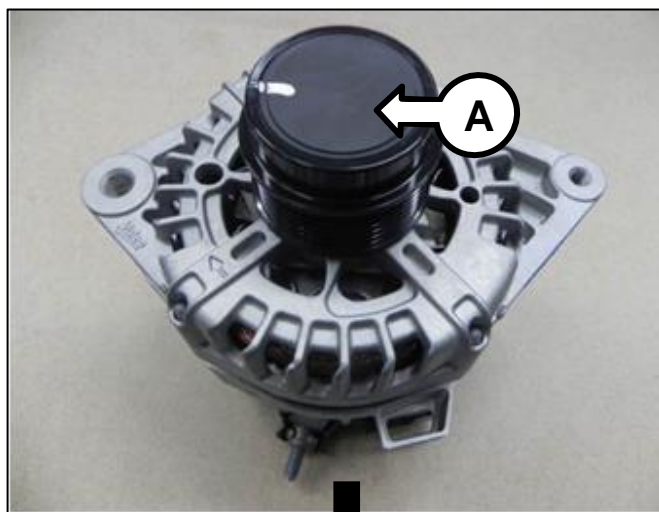
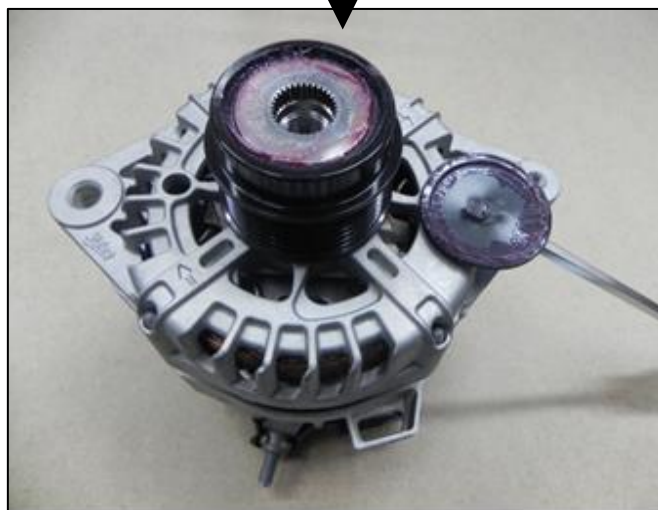
1. Remove the pulley cap (A).

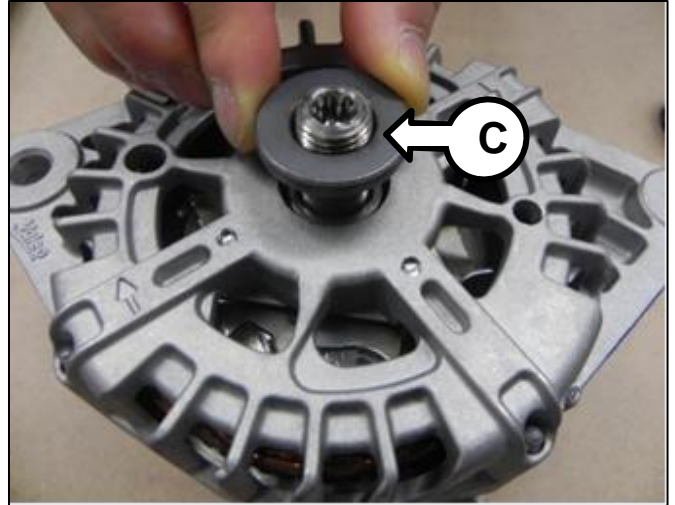
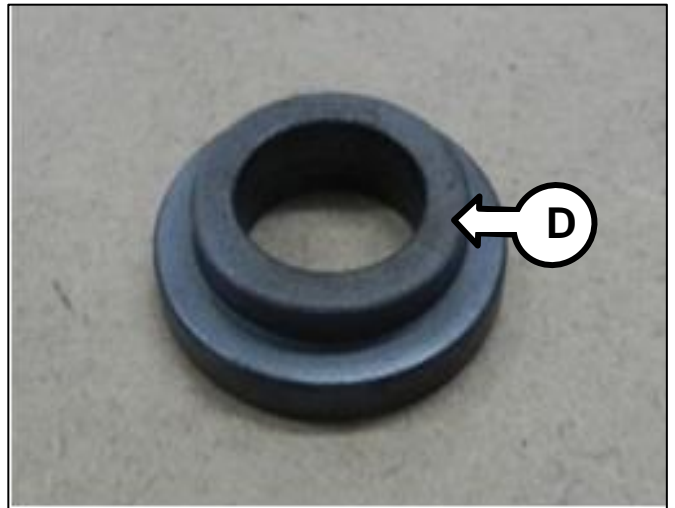
4. Install the new pulley spacer (C) onto the alternator as shown.

Install the spacer in the correct orientation. The lip (D) of the spacer must face the body of the alternator (flat side up.)

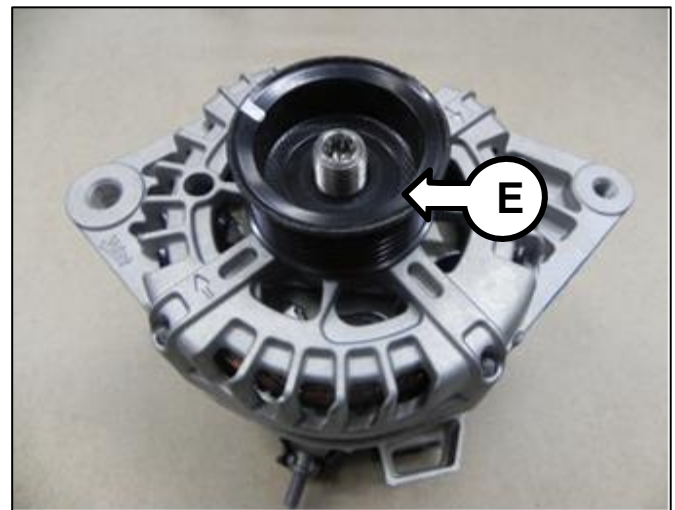
5. Install the new pulley (E) on the alternator.

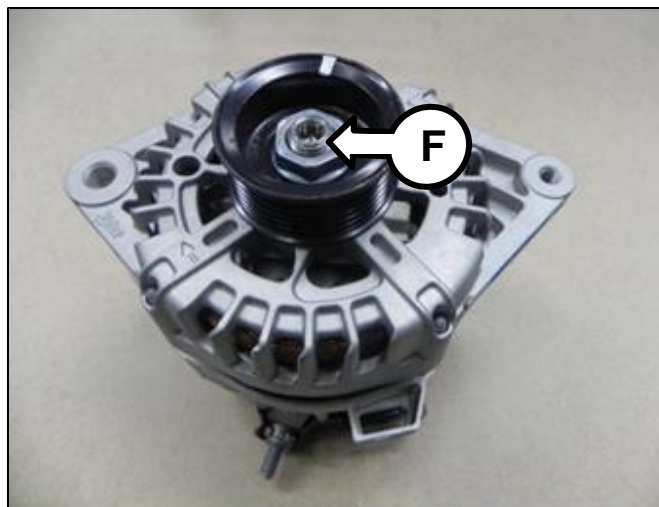
6. Tighten the new pulley nut (F) to the specified torque using a torque limiting impact extension, or equivalent tool.

Tightening torque:
59 lb-ft (80.0 N.m, 8.2 kgf.m)
