Technical Service Bulletin

GROUP CAMPAIGN	NUMBER 16-01-070
DATE DECEMBER 2016	MODEL(S) VELOSTER (FS)

SUBJECT: MANUAL HEATER CONTROL UNIT REPLACEMENT (SERVICE CAMPAIGN TY6)

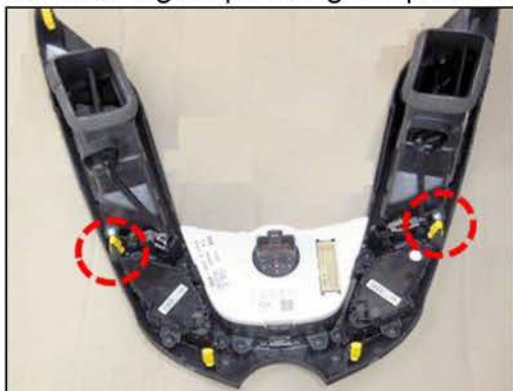
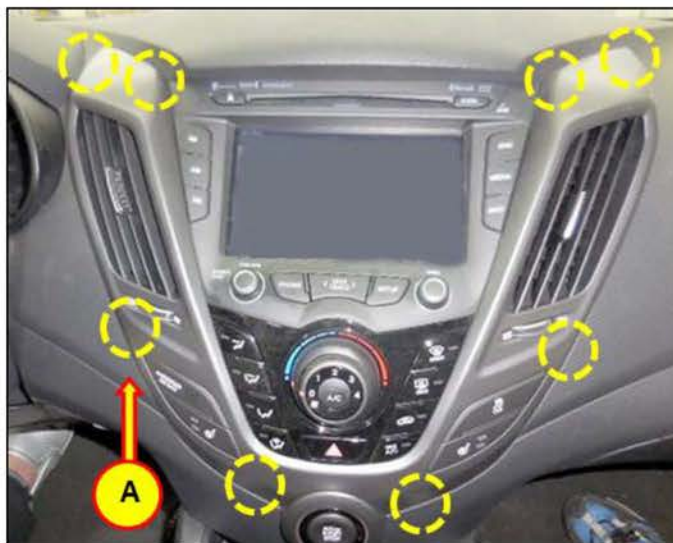
1. Turn the ignition to **OFF**.
2. Release the center fascia panel mounting clips (A) in the following steps using the puller tool.

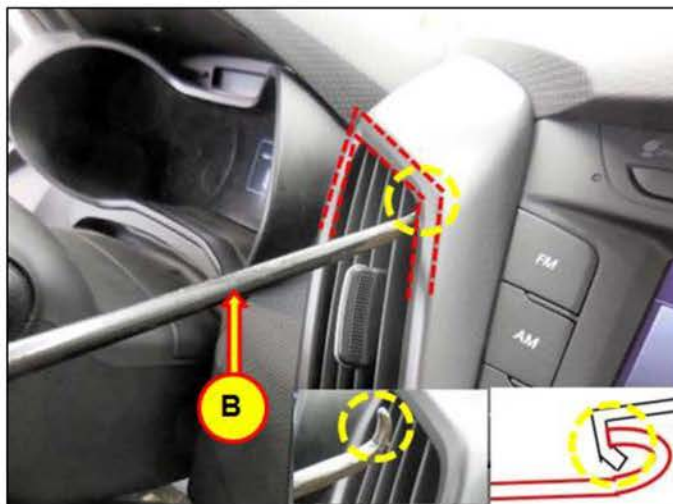
3. Insert the hook end of the puller tool (B) positioned into the air vent hole as shown for the removal process.

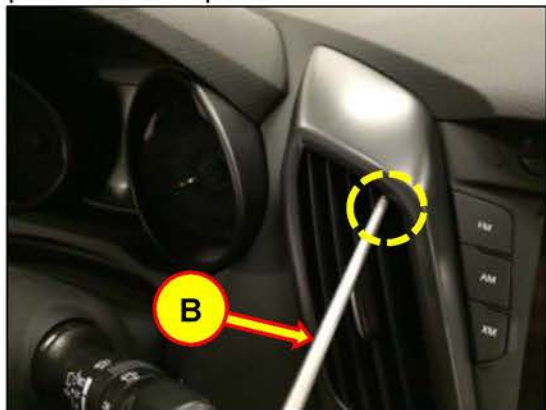
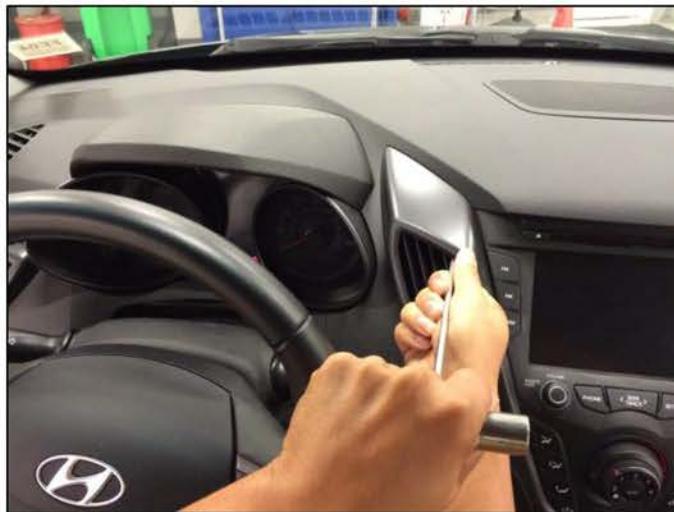
4. Securely position the puller tool to the upper right corner of the **LH Center Vent** and release the clips with a firm pull.

Use one hand to stabilize the hook end of the tool against the recessed portion of the center vent inner lip while pulling. This will help prevent slipping and scratching the center fascia panel near the vent. Firmly tug the T-handle of the tool to release clips.

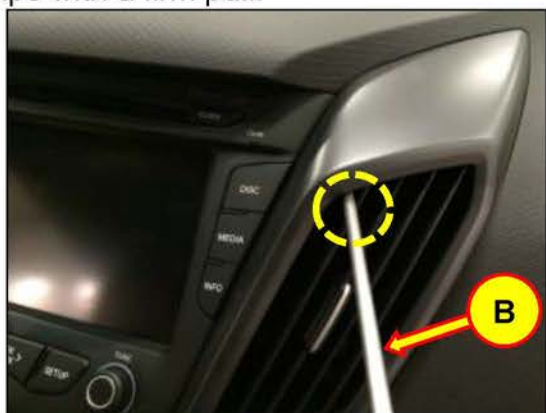
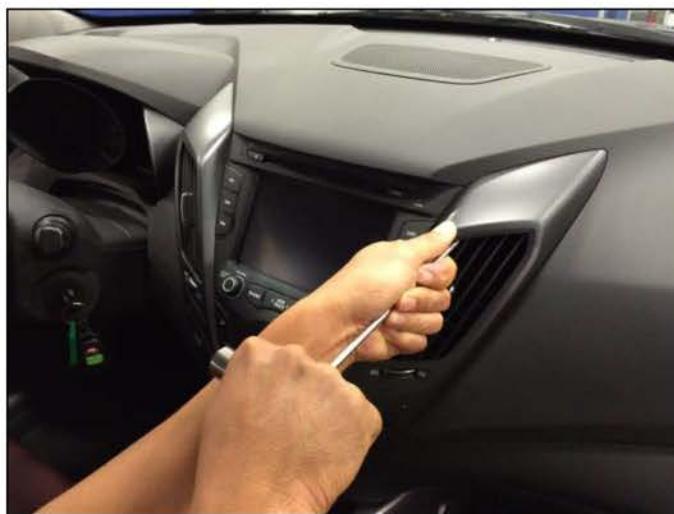
5. Securely position the puller tool to the upper left corner of the **RH Center Vent** and release the clips with a firm pull.

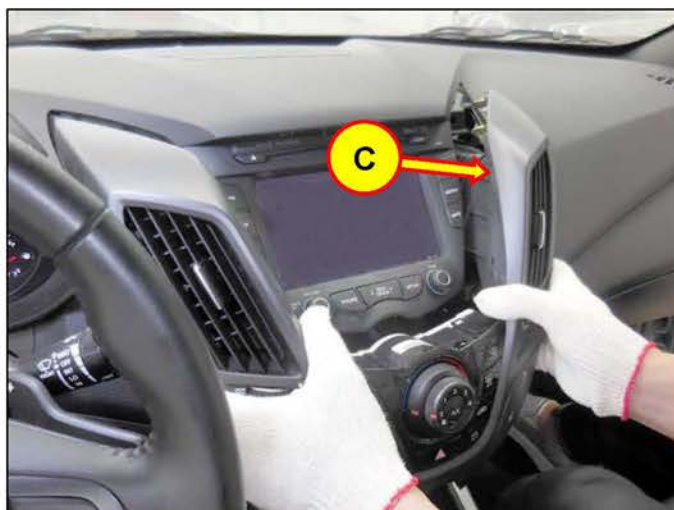
6. Once the holding clips are released, carefully separate the center fascia panel (C) to access the rear connectors.

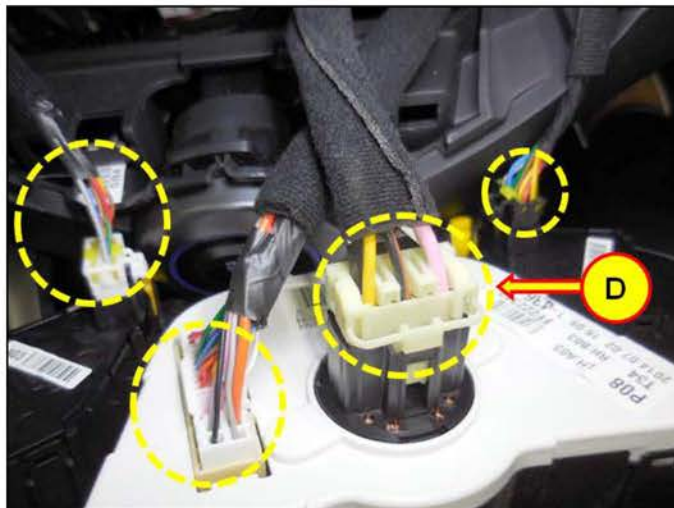
7. Disconnect the connectors (D) as shown.

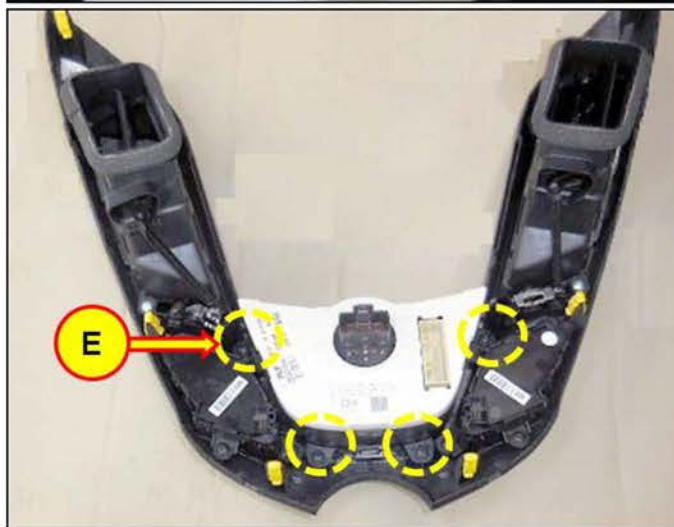
8. Loosen the manual heater control unit mounting screws (E).

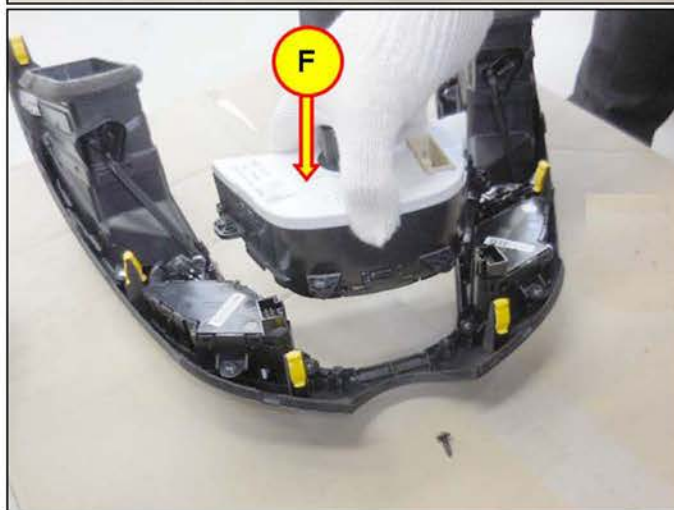
9. Remove the old heater control unit (F) from the center fascia panel and replace it with the new heater control unit.

Red box area on the right shows the general location at the back of the unit where the P/N can be found.
