**HYUNDAI**NEW THINKING.  
NEW POSSIBILITIES.**Technical Service Bulletin**

**16-01-068**

**SANTA FE SPORT (AN)****SUBJECT:** FUEL TANK VENT VALVE REPLACEMENT (SERVICE CAMPAIGN T1L)**★ IMPORTANT****\*\*\* Dealer Stock and Retail Vehicles \*\*\***

Some 2017MY Santa Fe Sport (AN) vehicles may experience the fuel nozzle prematurely clicking off during refueling. This bulletin provides the procedure to replace the Fuel Tank Vent Valve (FLVV) to correct this condition.

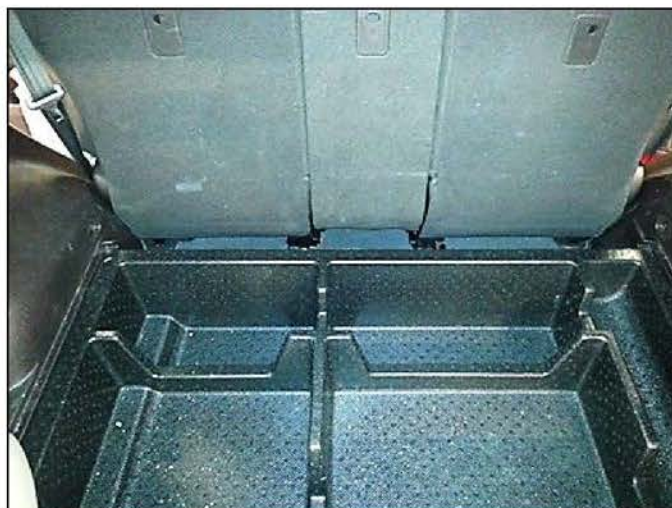
1. Remove the luggage floor package tray and left rear seat assembly.

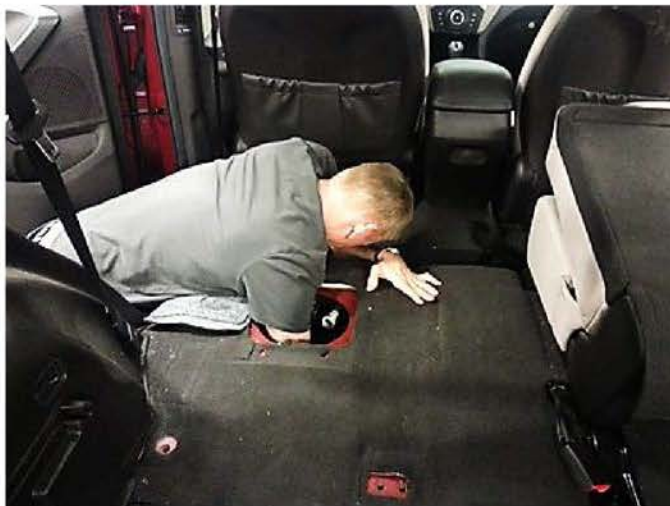
- 7. Reach through the opening to locate the FLVV valve (J) which is positioned at the top middle part of the fuel tank.

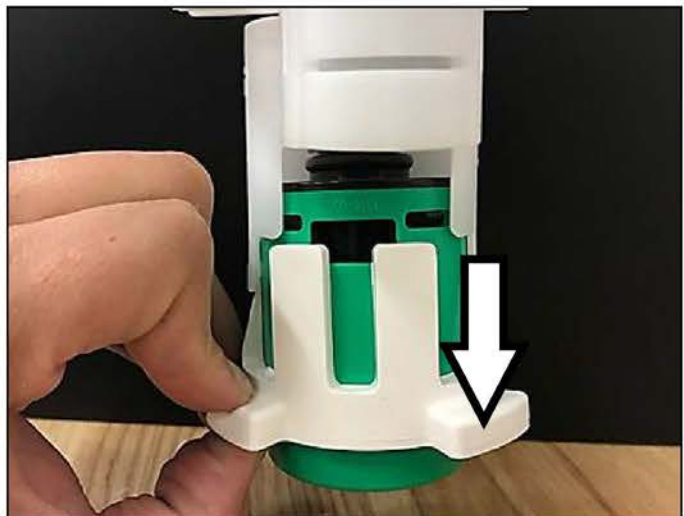
9. Once the SST is secured, pull down on the SST to remove the FLVV.

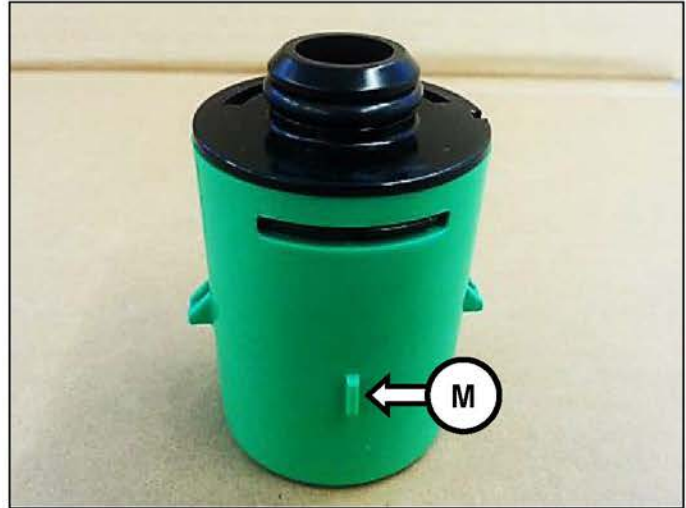
10. Insert the new FLVV valve with the guide pin (M) facing towards the front of the vehicle.

Do not use the SST to install FLVV.

Make sure a snap is heard or felt to ensure proper installation of the FLVV.

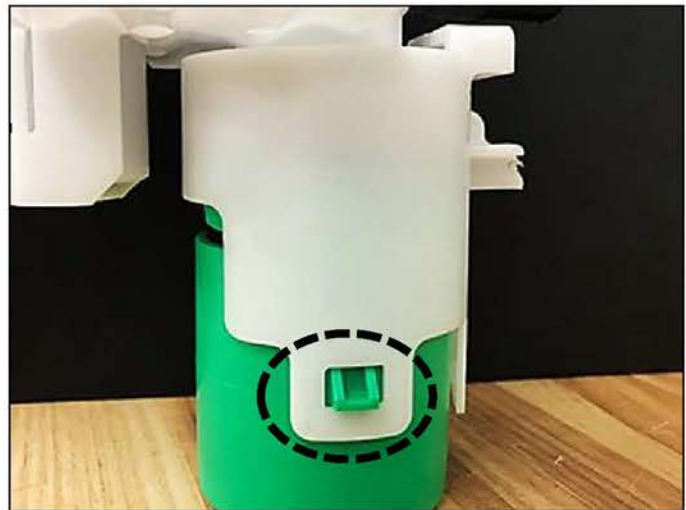
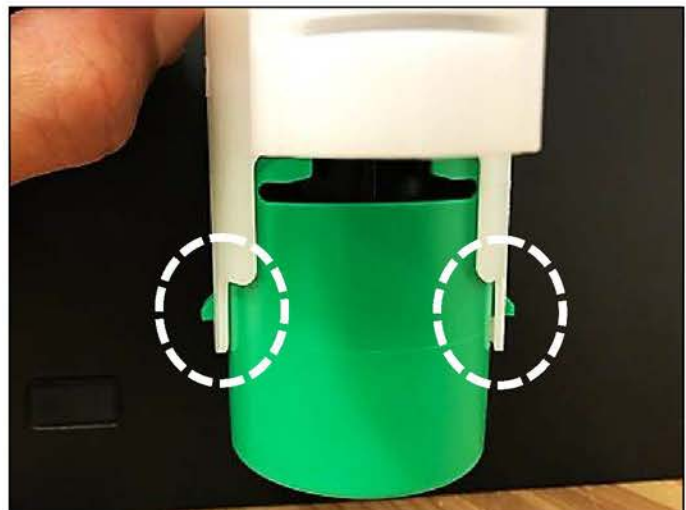
11. Feel both sides of the FLVV after installation to make sure both clips are properly engaged.

- FLVV is a directional part. Make sure to install in the proper direction/orientation. If FLVV is installed in the incorrect direction, customer may experience fuel nozzle premature clicking off condition and the FLVV could not be removable with the SST.
- FLVV needs to be fully and properly installed with both clips engaged.
- If the FLVV is not properly installed, the FLVV may not function properly.
