HYUNDAI NEW THINKING. NEW POSSIBILITIES.	GROUP AUTOMATIC TRANSMISSION	NUMBER 16-AT-010
	DATE SEPTEMBER 2016	MODEL SANTA FE SPORT 2.4L (AN) TUCSON 2.0L (LM)
SUBJECT:	ROUGH IDLE IN DRIVE WITH NEUTRAL CONTROL ENABLED

Description: Some Tucson (LM) and Santa Fe Sport (AN) may experience a rough idle in Drive after decelerating to a stop when Neutral Control is enabled. This bulletin provides a diagnosis and repair procedure for this condition.

Applicable Vehicles	2013~ Santa Fe Sport 2.4L (AN) 2010~15 Tucson 2.0L (LM)
----------------------------	---

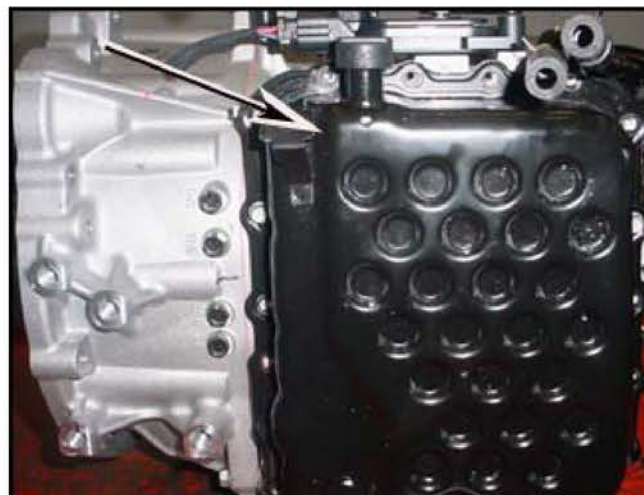
3. Record the preset radio stations.
Remove the battery and battery tray.
4. Remove the undercover below the transmission.
5. If necessary to access the solenoids, drain the radiator and remove the lower radiator hose from the radiator.
Drain the ATF.
6. Remove the oil pan bolts and remove the pan.

Use a rubber hammer to tap the oil pan cover on a corner until the cover is loose.

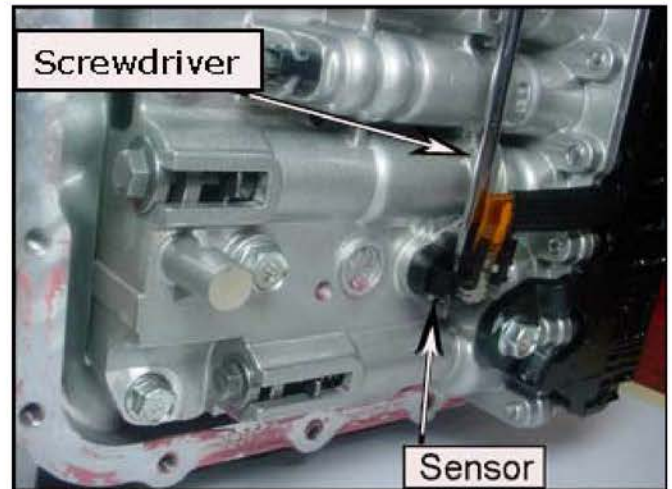
7. For transmissions with separate temperature sensor and harness: Use a small screwdriver to pry the connector from the oil temperature sensor.

For transmissions with integrated temperature sensor and harness: Go to Step 8.

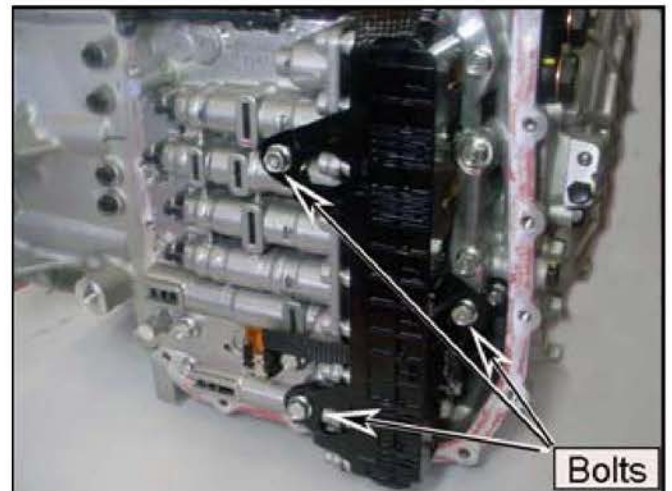
8. Use a 10mm socket and ratchet to remove three bolts to the solenoid valve connector.

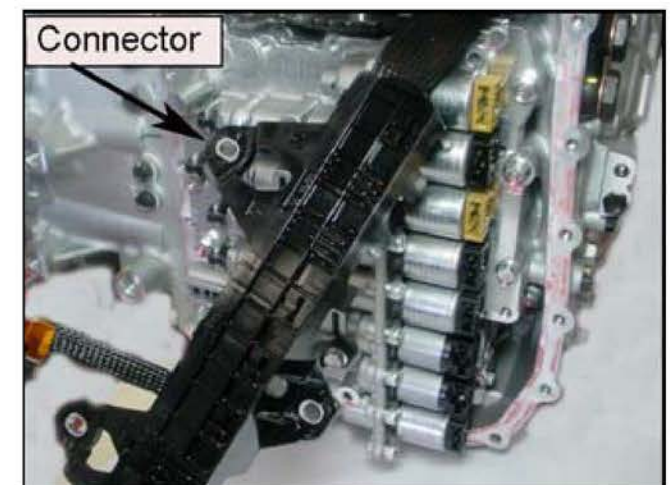
9. Pull the solenoid valve connector outward and move the connector out of position.

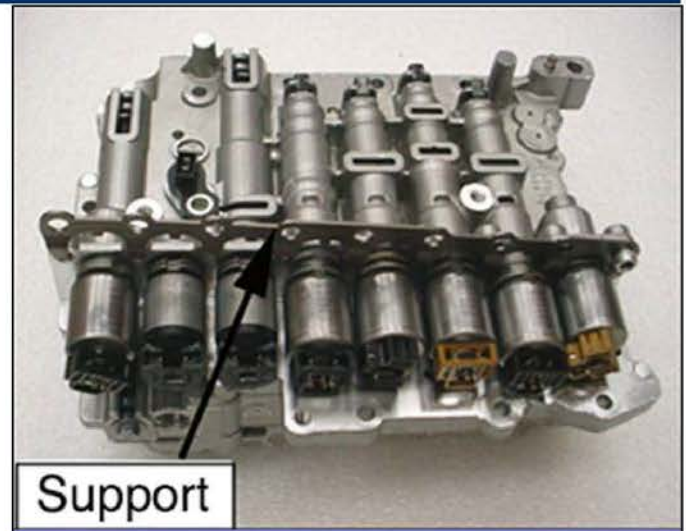
10. Use a 5mm hex socket and remove 9 Allen bolts that secure the solenoid support. Remove the solenoid support.

It is not necessary to remove the valve body from the transaxle.

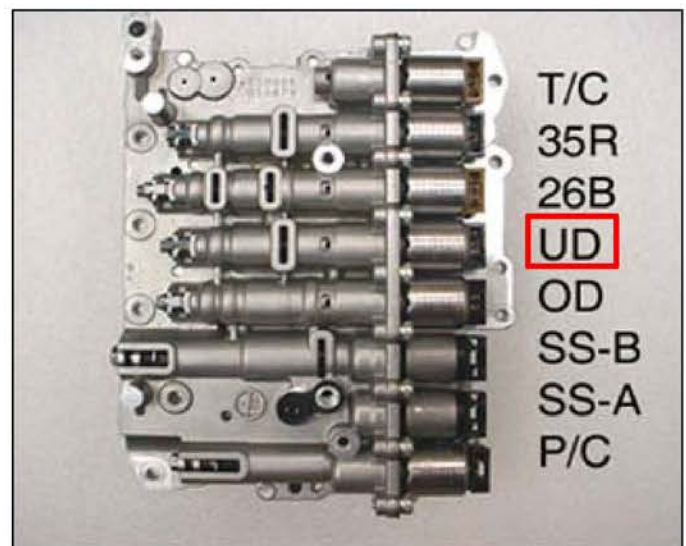
11. Remove the UD solenoid and install a new solenoid.

Reinstall the solenoid support.

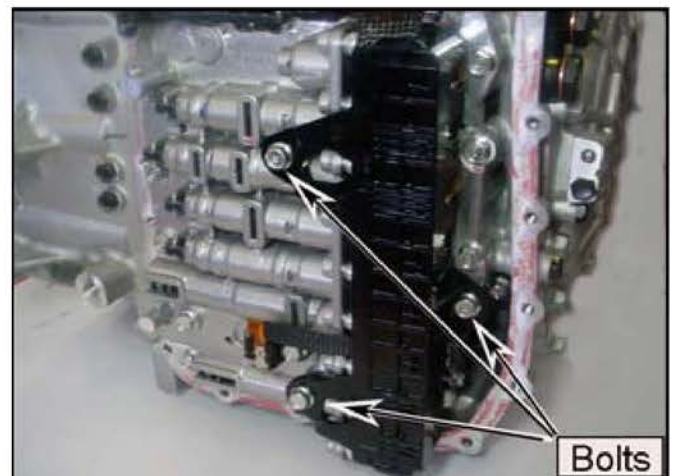
12. Reconnect the solenoid harness to the solenoids and oil temperature sensor.

Install the bolts to the solenoid harness connector and torque to specification.

Torque: 7~9 lb.ft (1.0~1.2 kgf.m/10~12 N.m)

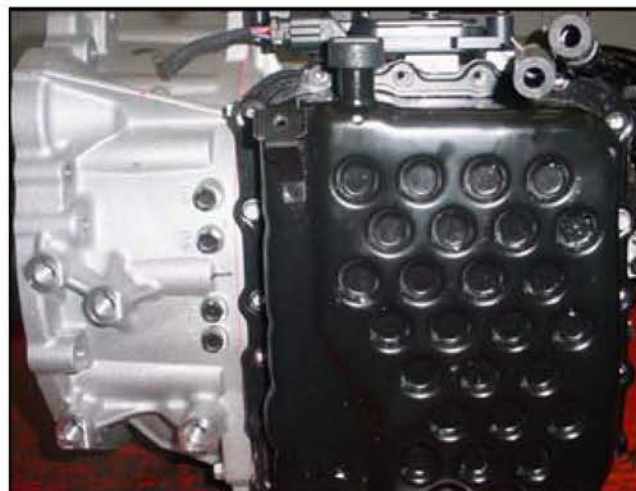
13. PLASTIC OIL PAN:

Install a new gasket to the oil pan, reinstall the pan and tighten the bolts to specification.

Torque: 10~12 lb.ft (1.4~1.6 kgf.m, 13~15 N.m)

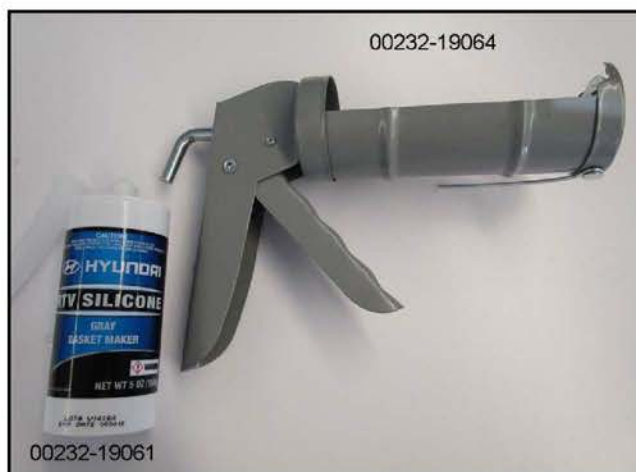
STEEL OIL PAN:

Use RTV Silicon Gray, P/N 00232-19061 and a small caulking gun, P/N 00232-19064, or equivalent and apply sealant to the oil pan.

Reinstall the pan.

Torque: 7~9 lb.ft (1.0~1.2 kgf.m, 10~12 N.m)

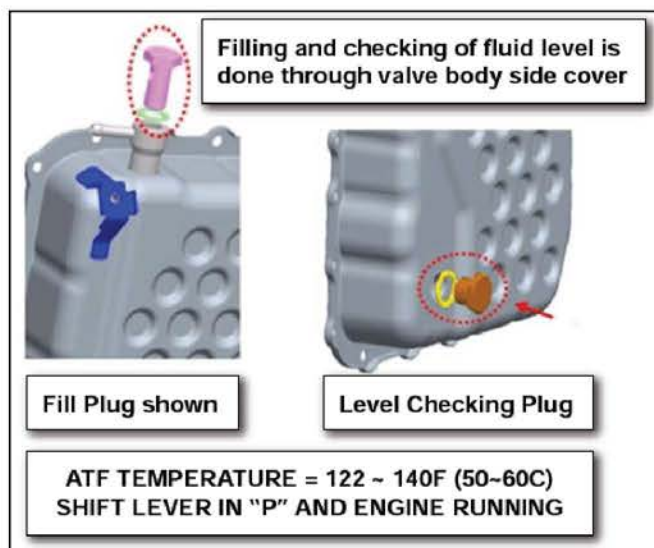
15. Remove the transaxle fill plug.

Use a funnel to add approximately 5~6 quarts of SP4-M ATF through the fill plug opening. Reinstall the fill plug.

Start the engine and shift to Park. When the ATF is 122°F~140°F (50~60°C), remove the level checking plug. The level is correct when oil flows out of the level checking plug in a thin steady stream.
